# **Aviation Investigation Final Report**

Location:	Ocala, Florida	Accident Number:	ERA20FA022
Date & Time:	October 31, 2019, 11:31 Local	Registration:	N959CM
Aircraft:	Beech 58	Aircraft Damage:	Destroyed
Defining Event:	Medical event	Injuries:	2 Fatal, 1 Serious
Flight Conducted Under:	Part 91: General aviation - Flight test

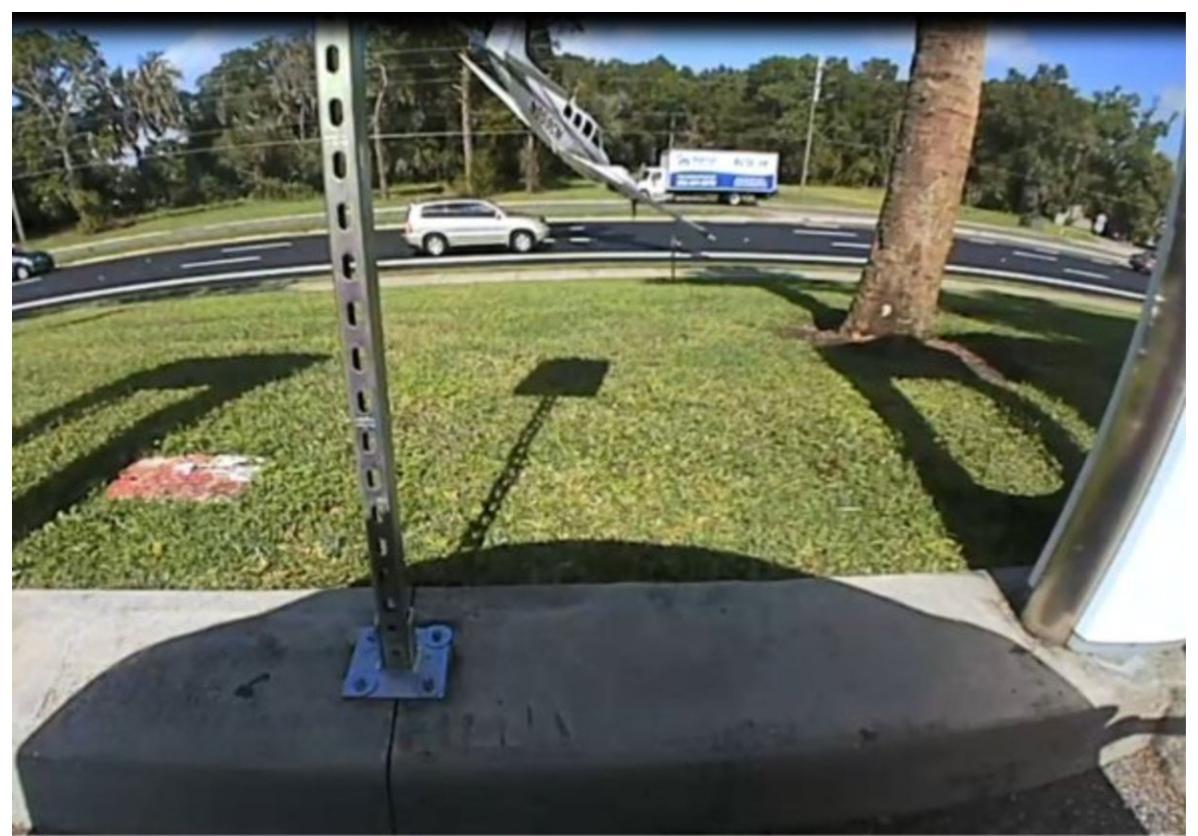
Video recovered from a parked car near the accident site captured the airplane rotating counterclockwise as it impacted a four-lane divided highway. The airplane's right wing struck the ground first before impacting a moving vehicle. The airplane then skidded across two lanes of traffic, struck a concrete curb, then spun 180° before coming to rest in a vacant lot. The deflection of the rudder just before ground impact was estimated to be 20°±4° to the left, in the direction of rotation. No airframe or engine fire and/or smoke was observed in the video. (see figure 1.)

Figure 1 Screen Capture of Automobile Video Showing Airplane Just Prior to Impact.
