Aviation Investigation Final Report

Location:	Atlanta, Georgia	Incident Number:	DCA20IA014
Date & Time:	November 6, 2019, 21:15 Local	Registration:	N117HQ
Aircraft:	Embraer ERJ170	Aircraft Damage:	None
Defining Event:	Loss of control in flight	Injuries:	9 None
Flight Conducted Under:	Part 121: Air carrier - Scheduled

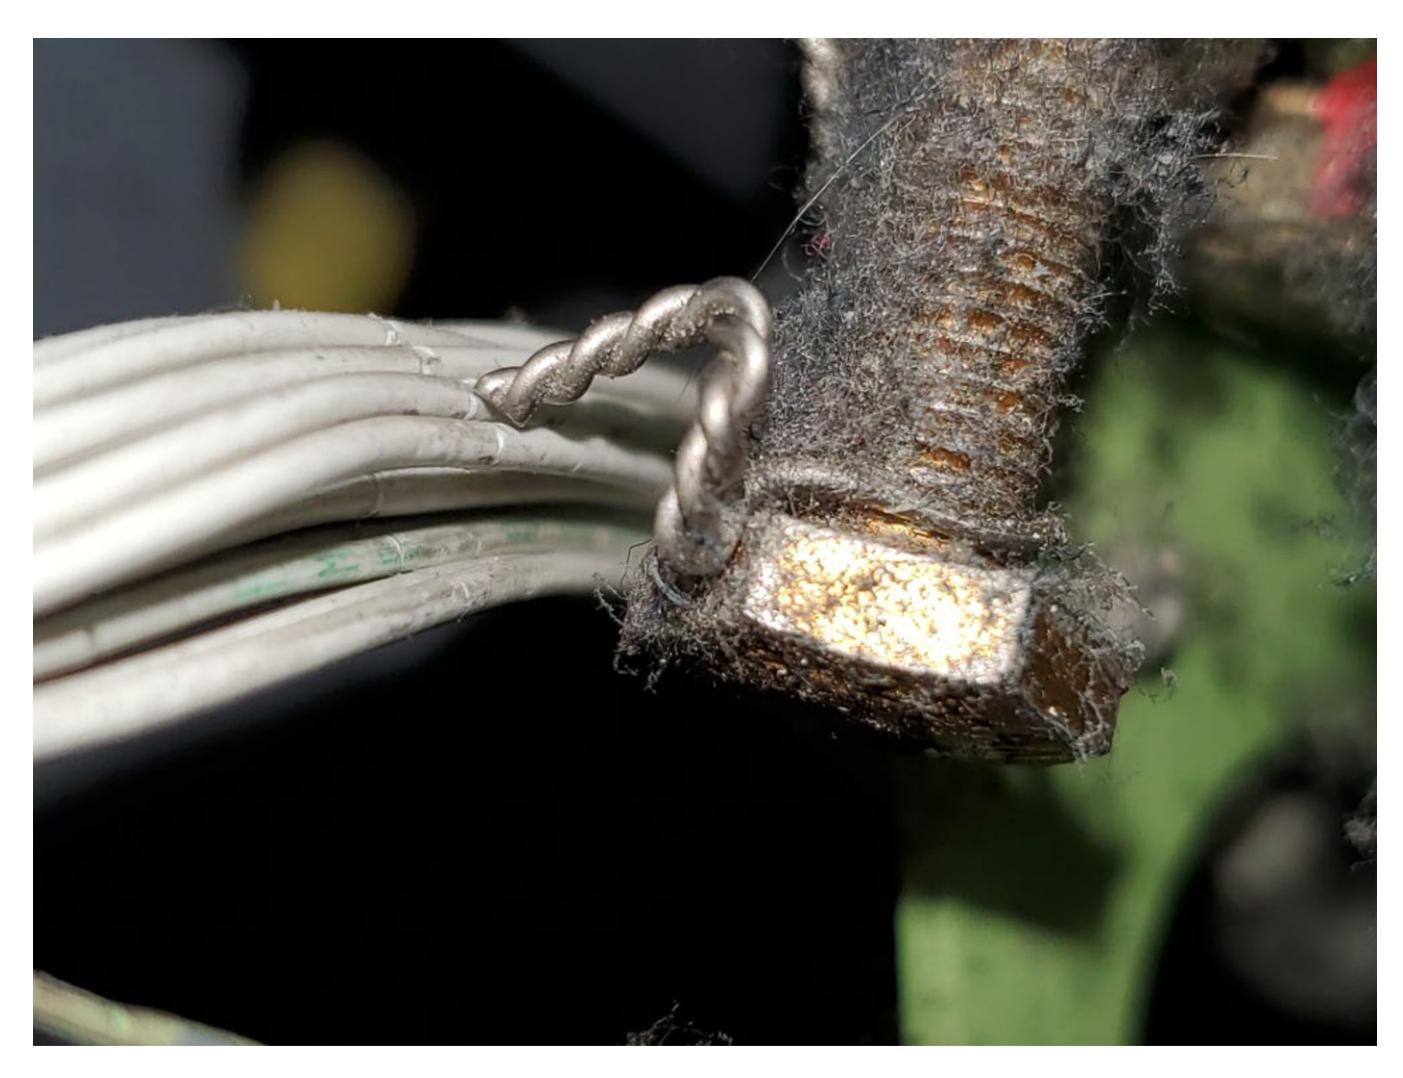
Although both wires enabling the captain's pitch trim switch trim-up command were damaged and chafed and were capable of allowing continuity to the untucked safety wire pigtail (which would result in a short to ground condition), it is unlikely that the pigtail would have made continuity to both wires at the same time. Both wires would need to short to ground simultaneously to allow the stabilizer trim to activate. If both wires shorted to ground, the horizontal stabilizer control surface movement would automatically stop after three seconds, and if the condition persisted the aural alert "TRIM" would annunciate. This alert was not reported by the crew.

Postincident examination of the area near the captain's control column revealed wires with chafed insulation. These wires connected the horizontal stabilizer actuator control electronics to the captain's pitch trim switch and autopilot/trim disconnect button. The wires contacted an

incorrectly tucked pigtail on the safety wire retaining the captain's control column forward mechanical stop bolt, as shown in in figure 2.

Figure 2. Bolt with pigtail contacting wires (Source: Republic Airways).

Subsequent laboratory testing revealed that the insulation for three wires (the captain's quick disconnect switch, the captain's nose-up trim switch A, and the captain's nose-up trim switch B) was damaged but that continuity to the internal wire strands could be achieved. Specifically, the quick disconnect switch wire insulation was damaged completely around the wire strands, and multiple exposed wire strands were severed. The nose-up trim switch A wire insulation was chafed, and a small section of exposed conducting wire showed signs of mechanical scraping. The nose-up trim switch B wire insulation was chafed and damaged, and the conducting wire strands were not visible. Continuity was achieved by using both a cotton swab soaked in soapy water placed on the damage area as well as a sample piece of cut safety wire pressed lightly on the damaged area. No evidence of arcing was observed.

Require Embraer to develop instructions for operators of Embraer EMB-170/175/190/195/Lineage 1000 series airplanes to inspect the wiring in the captain's and first officer's control columns for damage, replace where needed, and ensure proper clearance from adjacent components, including the forward mechanical stop bolt and its safety wire. (A-20-1, classified "Closed—Acceptable Action" on September 2, 2020)

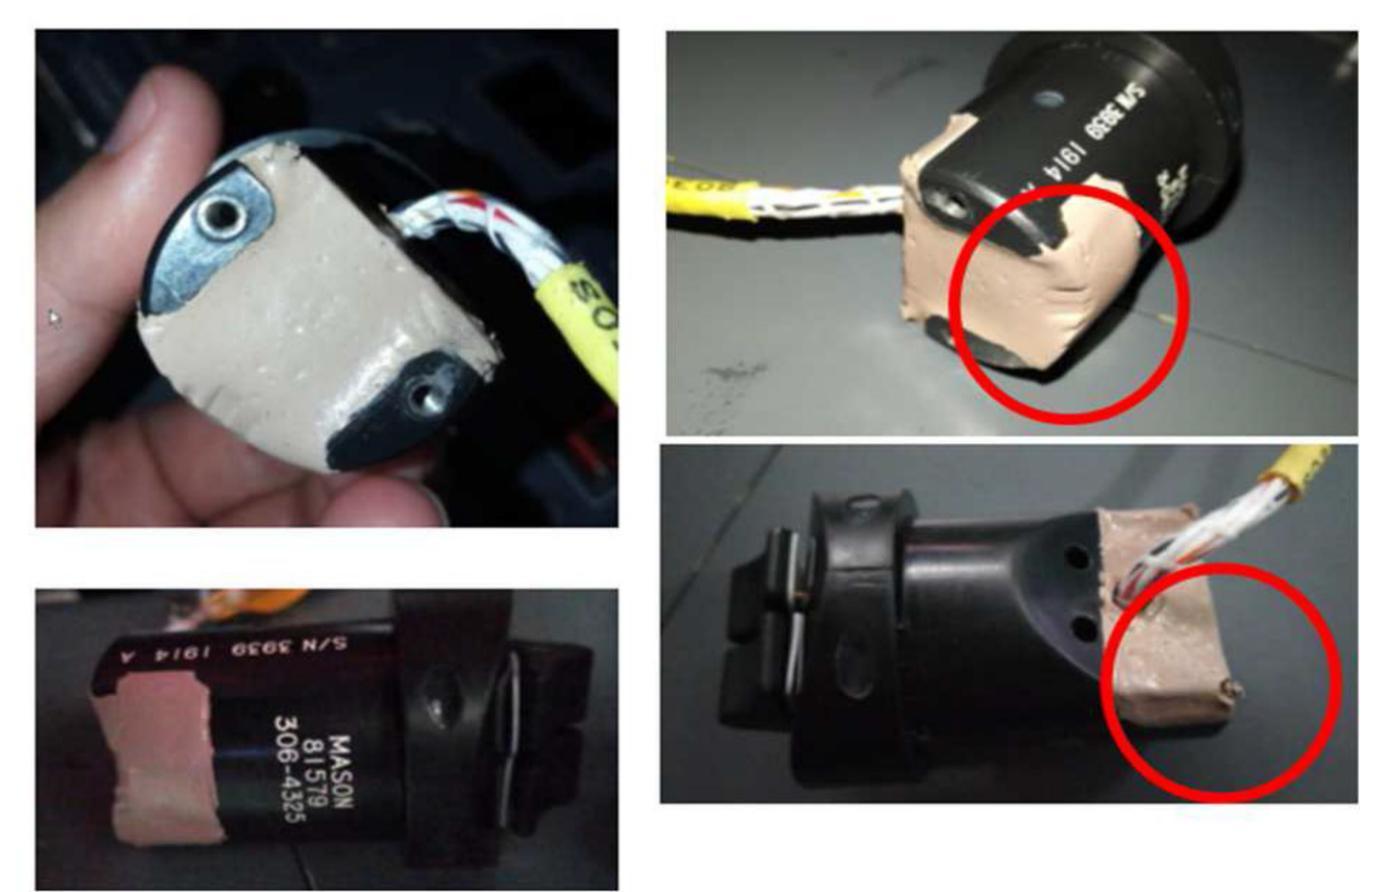
Postincident examination of the captain's pitch trim control switch identified imprint marks on the back of the switch, indicating that, at some point, the switch was installed in an inverted position. The most likely opportunity for this to occur would have been during maintenance after the first flight leg when the pitch trim switch was partially removed then reinstalled since the decision was made to defer maintenance. Since maintenance was deferred, the switch was not functionally tested.

Examination of the pitch trim control switch revealed an imprint mark in the silicone area on the back of the switch, as shown in figure 3. According to Embraer, this mark was caused by contact against a spring and was consistent with the switch being installed inverted at some point.

Figure 3. Captain-side pitch trim control switch after removal from the incident airplane (Source: Republic Airways).

Note: The red circles show the location of the imprint marks on the back of the control switch.

Embraer issued Service Bulletins (SBs) 170-27-0051, 190-27-0039, and 190LIN-27-0019 in February 2015 after reports about inverted pitch trim switches. The SBs recommended the installation of a support in the control yoke within the next 7,500 flight hours or 36 months after the SB's issuance (whichever occurred first). However, the SB 170-27-0051 had not been accomplished on the incident airplane. If the SB had been accomplished, the recommended support in the control yoke would have prevented the faulty installation.

Embraer released Service Bulletin (SB) 170-27-0051 on February 27, 2015, to alert operators of the possibility that the pitch trim switch could be installed inverted. The SB recommended the installation of a support in the control yoke to prevent the incorrect installation of the switch. The SB compliance time was 7,500 hours or 36 months, whichever occurred first. This SB had not been performed on the airplane before the incident.
