Aviation Investigation Final Report

Location:	Rogers, Minnesota	Accident Number:	CEN20FA096
Date & Time:	February 22, 2020, 11:11 Local	Registration:	N3266Q
Aircraft:	Beech A36	Aircraft Damage:	Destroyed
Defining Event:	Loss of engine power (total)	Injuries:	1 Fatal
Flight Conducted Under:	Part 91: General aviation - Personal

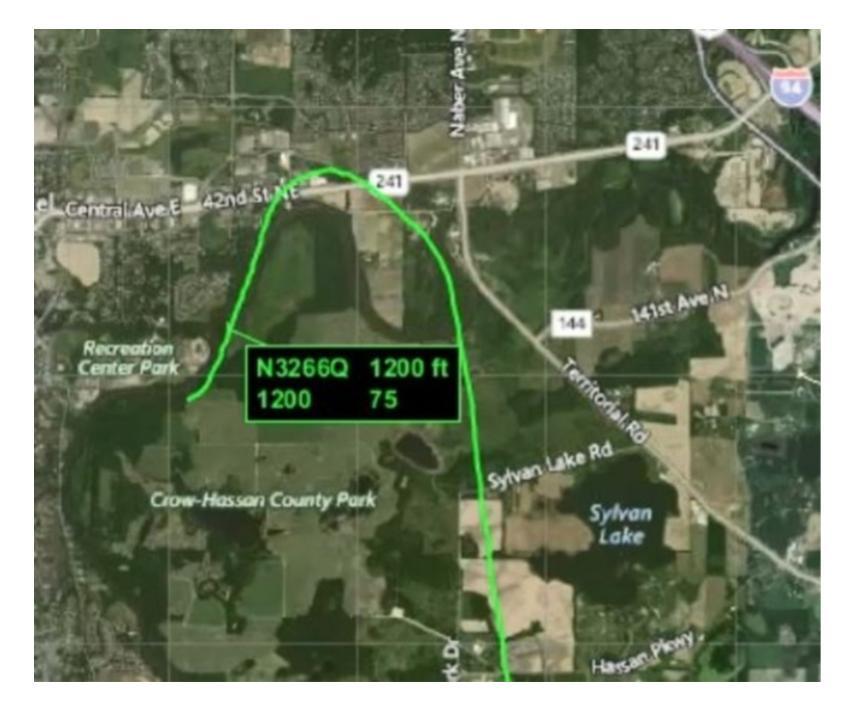
Figure 1 – Flight Path of Accident Airplane

While in cruise flight, the airplane climbed from 2,000 to 2,300 ft msl and decelerated from about 170 to 110 knots groundspeed. The airplane subsequently turned left away from populated areas and descended with a steady vertical speed at 70 to 75 knots groundspeed. At 1,100 ft msl (200 ft agl), the airplane turned right and the last ATC data recorded was 1,000 ft msl (100 ft agl), 72 knots groundspeed, and 243°.
