Aviation Investigation Final Report

Location:	Byron, California	Accident Number:	WPR20LA141
Date & Time:	May 9, 2020, 13:19 Local	Registration:	N4116Y
Aircraft:	Bellanca 8GCBC	Aircraft Damage:	Destroyed
Defining Event:	Loss of control in flight	Injuries:	1 Fatal
Flight Conducted Under:	Part 91: General aviation - Glider tow

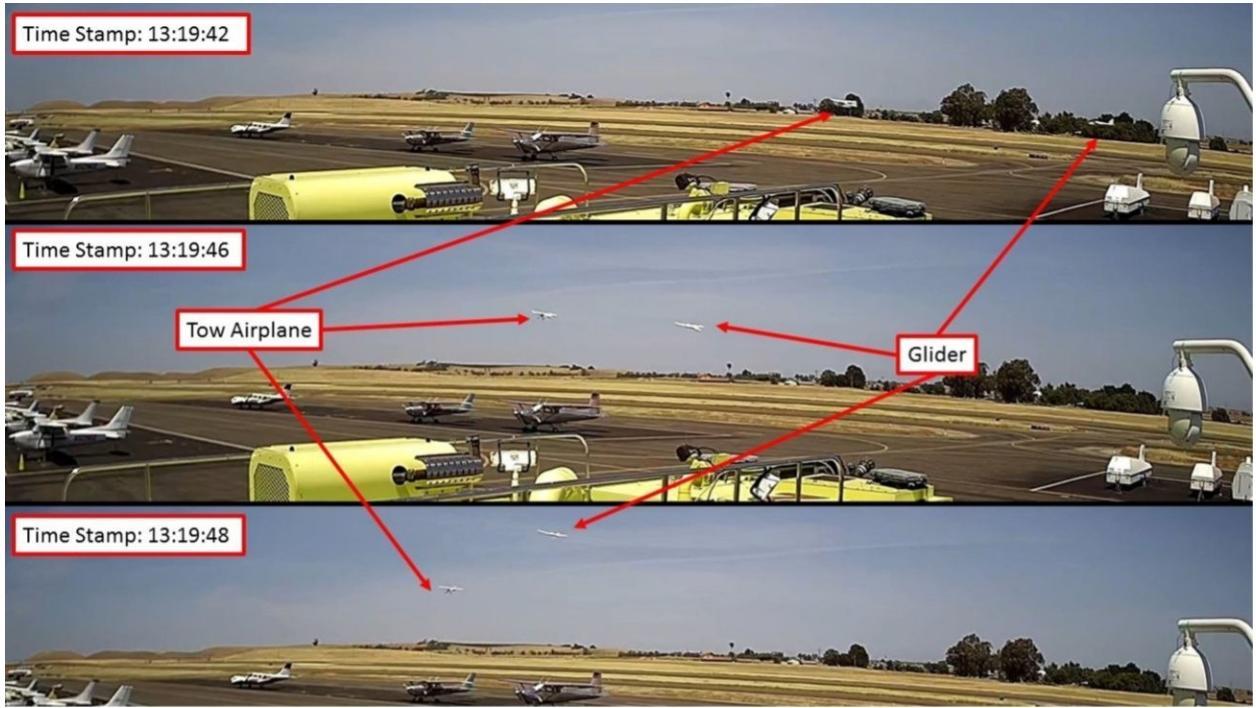
Figure. Screenshots of the accident sequence from a security camera recording (Source: Byron Airport).

The open canopy likely distracted the glider pilot, and he allowed the glider to ascend to an excessive altitude behind the tow airplane, which forced the tow airplane into a nose-down attitude while at a low altitude.

The tow airplane pilot's loss of control resulting from the glider pilot's failure to maintain a proper altitude behind the tow airplane, which caused the tail of the tow airplane to be lifted upward and the tow airplane to pitch nose down while at a low altitude. Contributing to the accident was the glider pilot's distraction when the canopy opened in flight.

Airport security camera recordings as shown in the figure below, captured the accident sequence. The tow airplane became airborne about midway along the length of the runway and made a shallow climb with the glider in trail at a similar altitude. About 7 seconds after the tow airplane became airborne, the glider pitched upward and ascended to a higher altitude while the tow airplane remained in a shallow climb. Three seconds later, the tow airplane began a shallow descent. About 2 seconds later, the tow airplane and glider appeared to remain level at their respective altitudes, with the glider at a higher altitude than the tow airplane. About 4 seconds later, the tow airplane and glider appeared to descend. The glider then began to ascend about 4 seconds later, while the tow airplane pitched downward to a nose-low attitude. The tow airplane impacted the runway and nosed over, and a postimpact fire ensued. The glider executed a 180° right turn and landed uneventfully on runway 12.
