Aviation Investigation Final Report

Location:	Telluride, Colorado	Accident Number:	CEN21FA007
Date & Time:	October 5, 2020, 13:04 Local	Registration:	N4444K
Aircraft:	Beech S35	Aircraft Damage:	Substantial
Defining Event:	Loss of control in flight	Injuries:	2 Fatal
Flight Conducted Under:	Part 91: General aviation - Personal

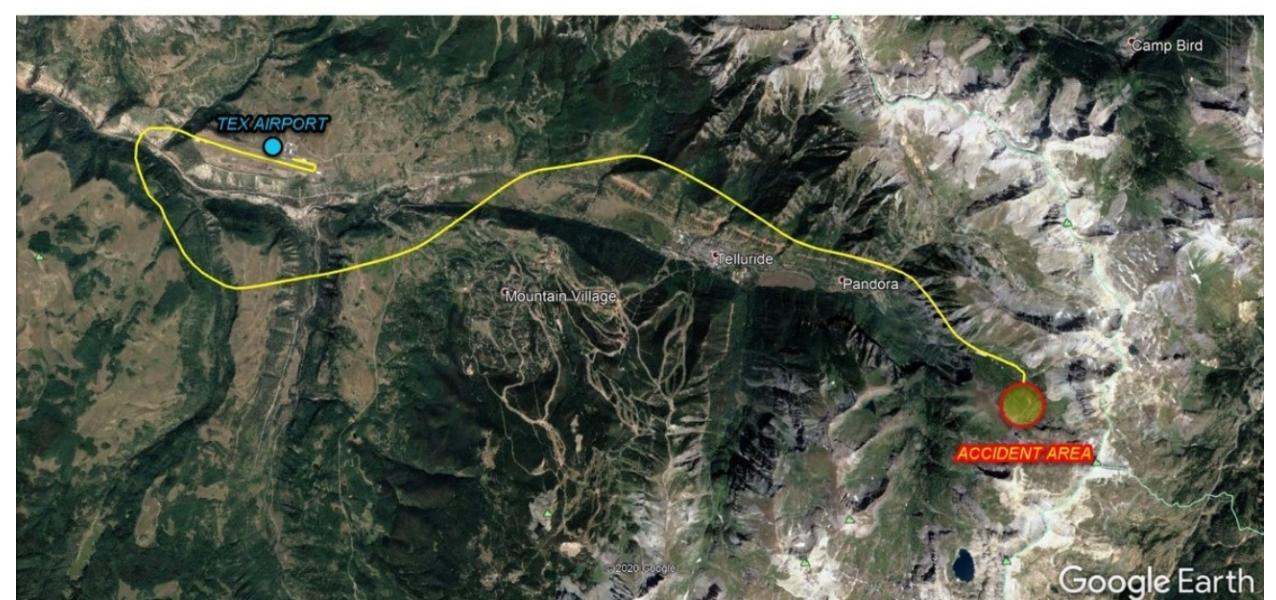
The airplane departed on a planned visual flight rules cross-country flight from runway 27 at TEX. Automated dependent surveillance-broadcast (ADS-B) data showed that the airplane had a normal takeoff and made a subsequent left turn toward the east. The airplane proceeded east into a box canyon and an area of rising terrain. The data showed that, before entering the box canyon, the airplane did not maneuver toward the west, where the terrain was lower than the surrounding terrain. The data also showed that the airplane was in a gradual climb for about 8 miles into the canyon and that the airplane then made a right turn to the south, which was immediately followed by the airplane's impact with terrain. See figures 1 and 2. No known radio distress calls were received from the pilot after takeoff.

Figure 1. ADS-B flight track from TEX to the accident location.

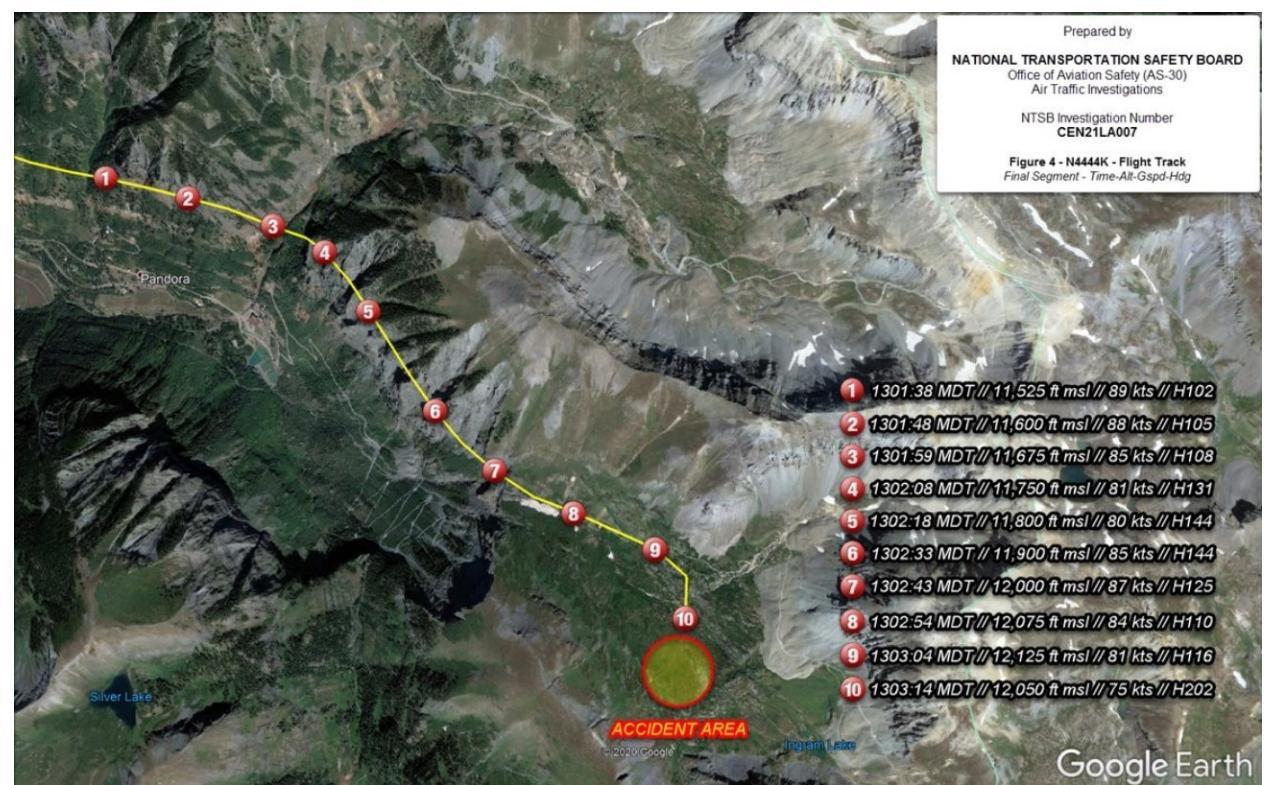
The airplane departed on a visual flight rules cross-country flight from a high-elevation (9,078 ft mean sea level) airport. Automated dependent surveillance-broadcast (ADS-B) data showed that the airplane proceeded east into a box canyon with rising terrain. The data showed that, before entering the box canyon, the airplane did not climb toward the west, where there was lower terrain. The data also showed that the airplane was in a gradual climb for about 8 miles into the canyon and that the airplane then made a right turn to the south just before impacting terrain. No known radio distress calls were received from the pilot. The airplane wreckage showed evidence of a nearly vertical impact.

Figure 2. ADS-B final portion of flight track.
