# **Aviation Investigation Final Report**

Location:	Truckee, California	Accident Number:	WPR21FA228	
Date & Time:	June 15, 2021, 10:45 Local	Registration:	N89423	
Aircraft:	CIRRUS DESIGN CORP SR20	Aircraft Damage:	Substantial	
Defining Event:	Loss of control in flight	Injuries:	1 Fatal, 1 Serious	
Flight Conducted Under:	Part 91: General aviation - Instructional

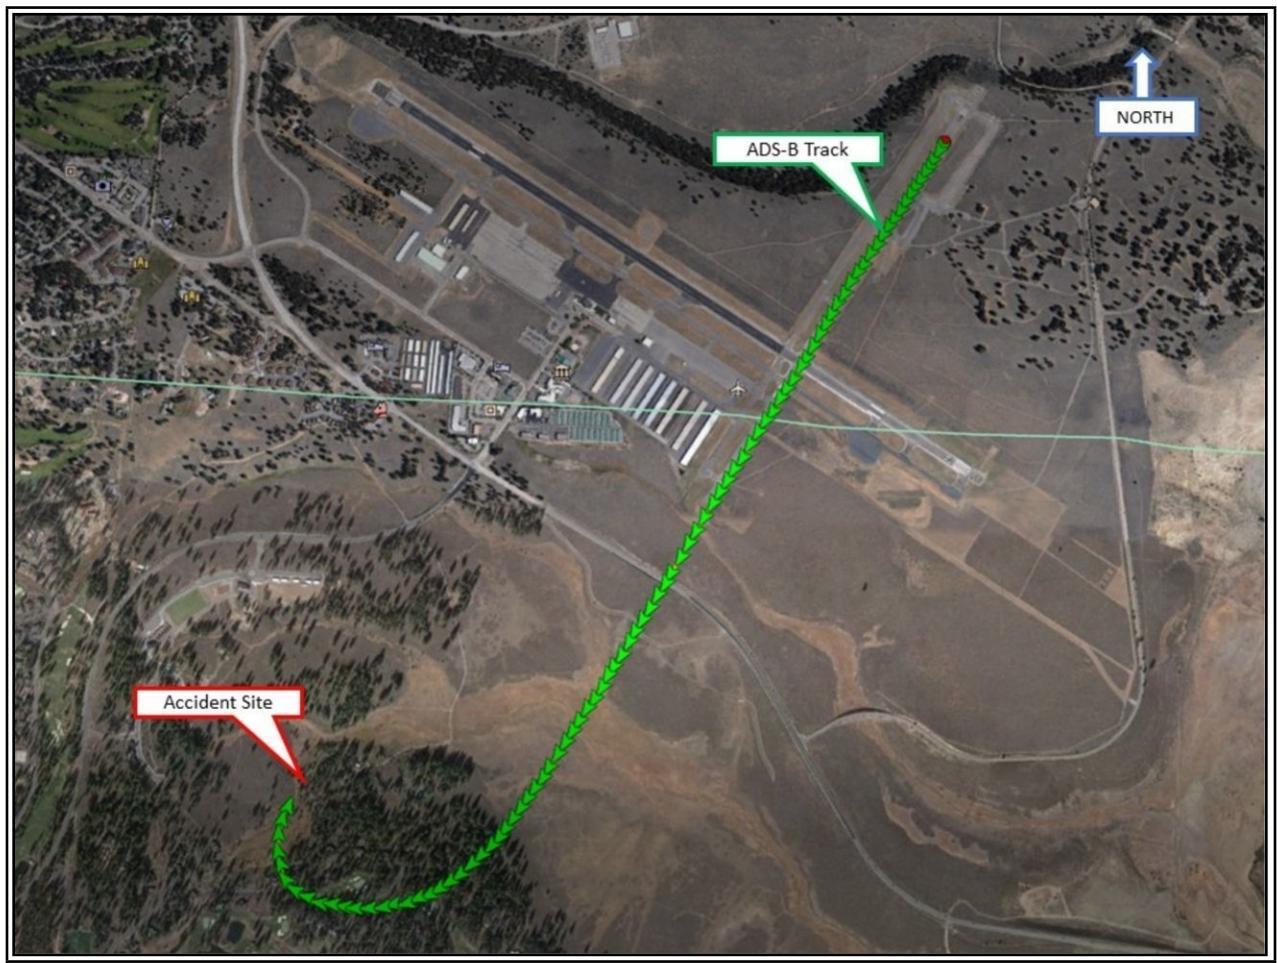
Recorded automatic dependent surveillance-broadcast (ADS-B) data provided by the Federal Aviation Administration (FAA) showed that the airplane departed at 1042:49 and that, at 1044:05, it had climbed to an altitude of 6,325 ft and was flying along a southwesterly heading. At 1044:14, the airplane was at an altitude of 6,300 ft and on a northerly heading. The airplane remained on a northerly heading and continued to descend. The last ADS-B data point, at 1044:21, indicated that the airplane was at an altitude of 6,050 ft and was about 116 ft south of the accident site. Figure 1 shows the airplane's flight track.

Figure 1. Airplane flight track based on ADS-B data.

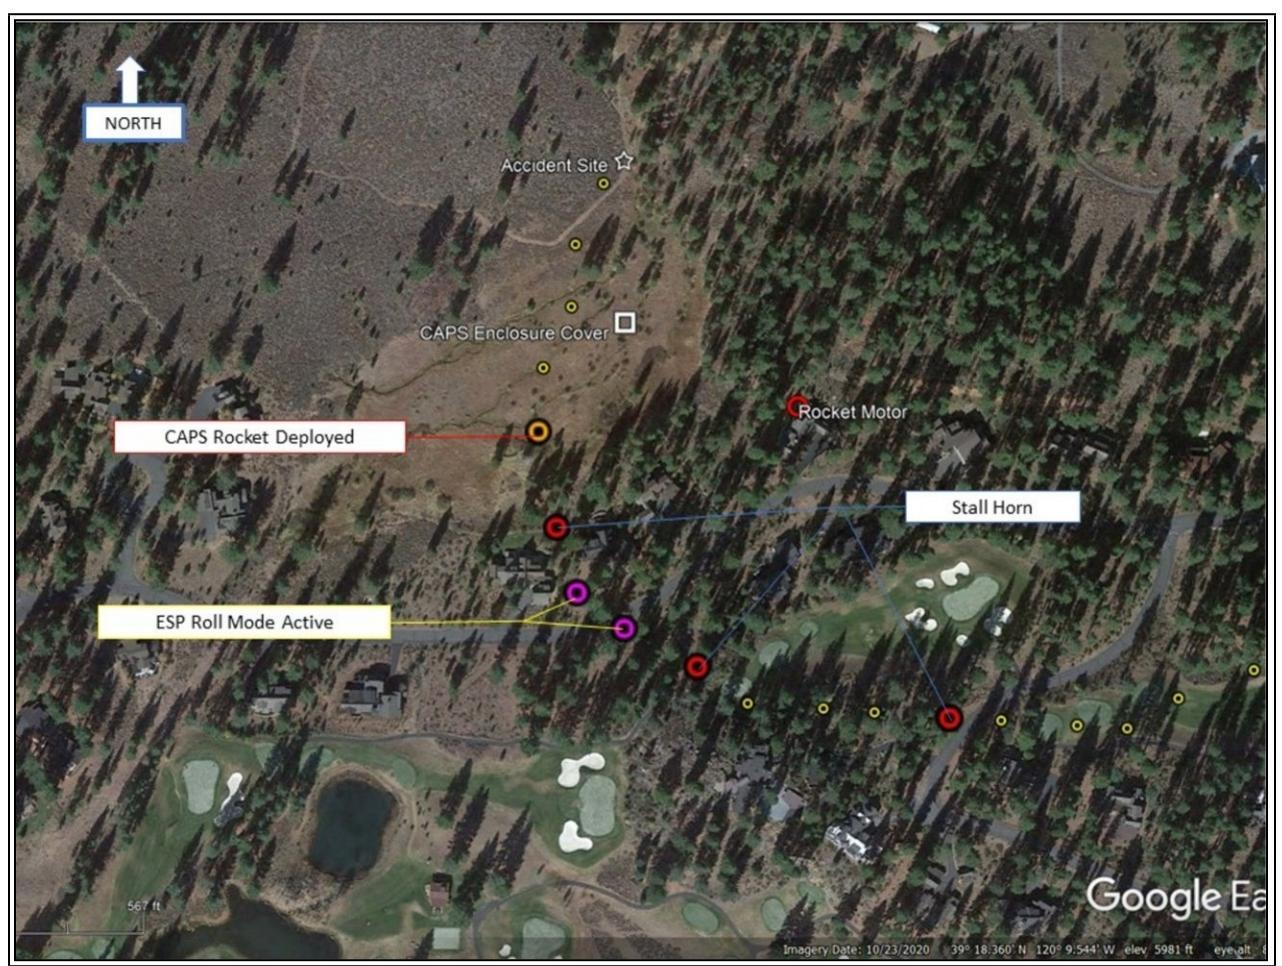
The airplane's RDM showed that, throughout the flight, the flap switch was at the 50% position. The RDM also showed that the stall warning activated three times: at 1044:09 with an indicated airspeed of 69 knots, a 12° pitch attitude, and an 11° bank; at 1044:13 with an indicated airspeed of 78 knots, a 4° pitch attitude, and a 36° bank; and at 1044:16 with an indicated airspeed of 71 knots, a -16° pitch attitude, and an 81° bank. The ESP system activated in roll mode at 1044:14 and 1044:15 as the airplane entered a steep right roll. The

CAPS activated shortly thereafter, and the recording ended at 1044:21. Figure 2 shows the RDM data overlaid on an image of the area surrounding the accident site.

Figure 2. Airplane's flightpath along with RDM-recorded events.
