# **Aviation Investigation Final Report**

Location:	Harrison, Michigan	Accident Number:	CEN22FA029
Date & Time:	November 5, 2021, 09:37 Local	Registration:	N16TG
Aircraft:	Vans RV	Aircraft Damage:	Destroyed
Defining Event:	Loss of control in flight	Injuries:	1 Fatal
Flight Conducted Under:	Part 91: General aviation - Personal

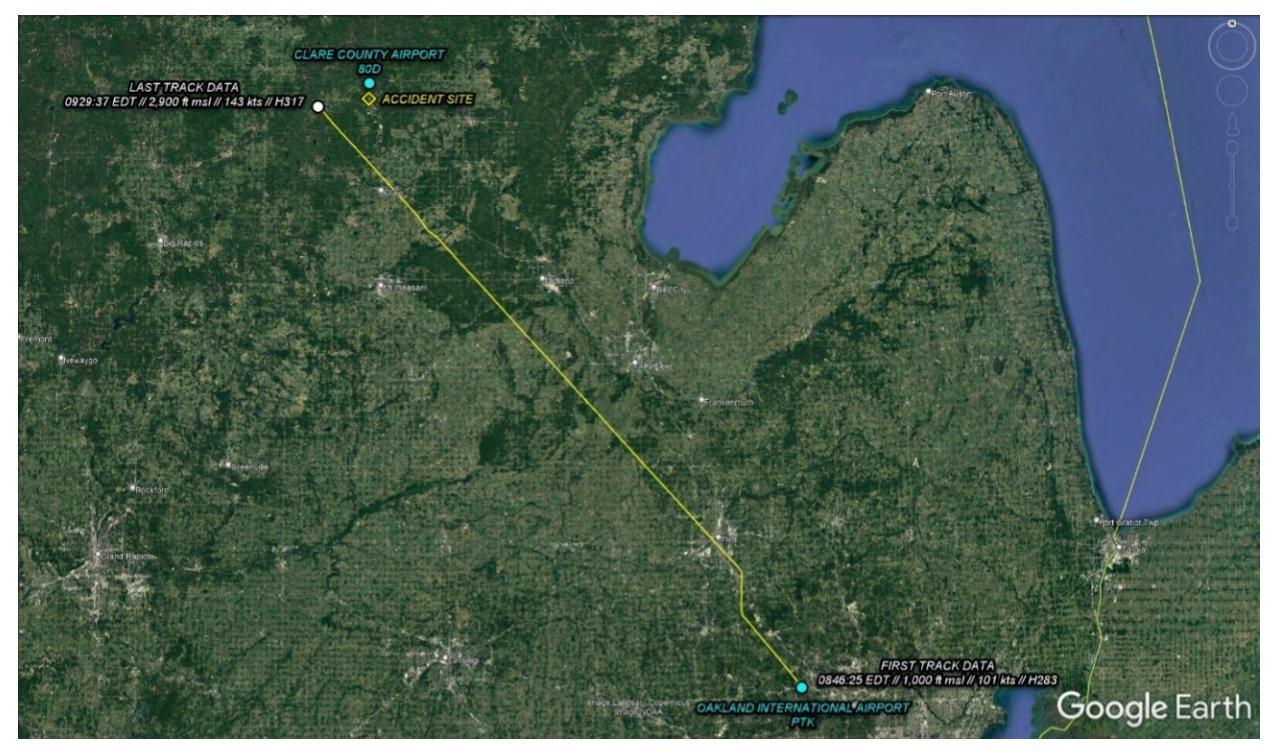
ADS-B data indicated that the airplane departed runway 27L at Oakland International Airport (PTK), Pontiac, Michigan at 0846. After departure the airplane made a climbing right turn and flew northwest for about 12 nm, then turned north for about 5 nm, then back to a northwest heading. The airplane reached a cruise altitude of about 3,000 ft mean sea level and remained on the northwest heading until track data was lost about 0905. The last ADS-B position was about 56 nm and 143° from the accident site. Discrete radar beacon returns showed that the airplane continued a straight-line course for another 60 nm after the loss of ADS-B data. The radar data showed that the airplane was in straight and level flight before the end of the data. The accident site was located about 1 nm south of the approach end of runway 36 at the Clare County Airport (80D), Harrison, Michigan.

Figure 1. Plot of ADS-B track data for the entire flight.

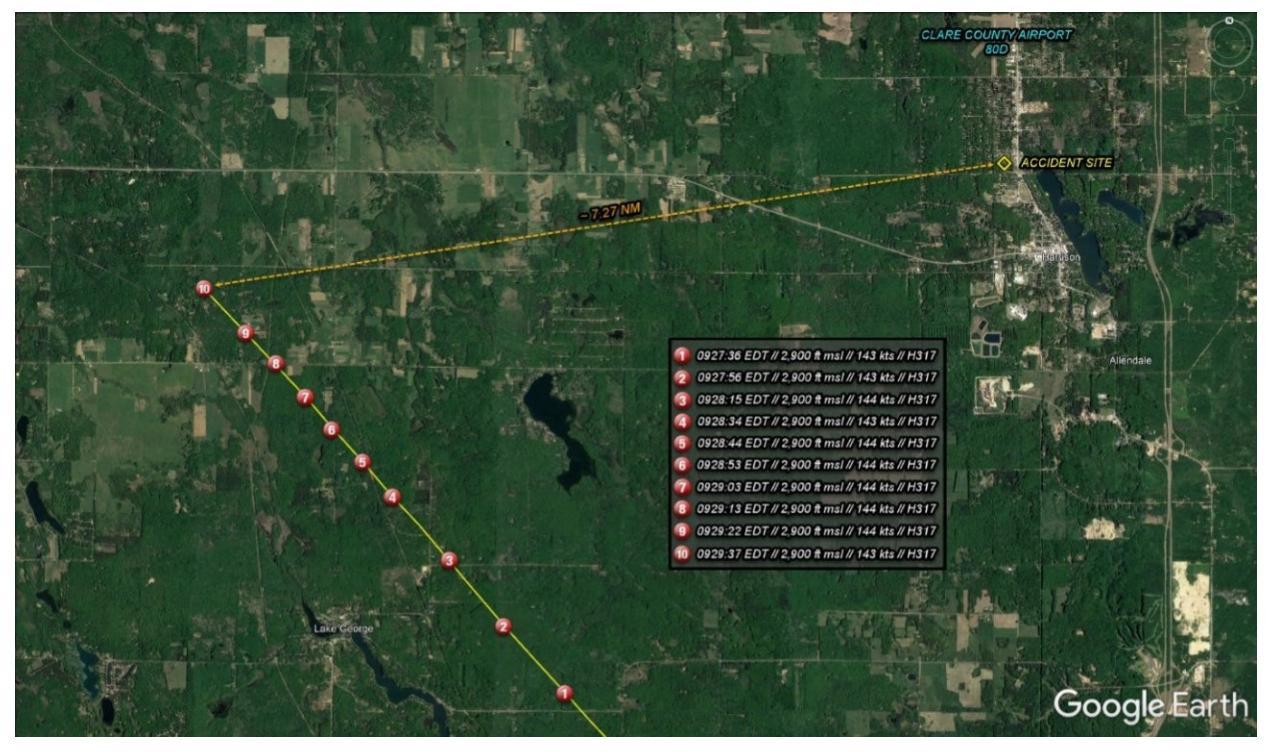
The accident site was located about 7.3 nautical miles (nm) to the east of the last recorded track and about 1 nm south of the approach end of an airport runway. The location of the accident site suggests that the pilot had diverted from his original course and was attempting to land at the nearby airport. The loss of automatic dependent surveillance-broadcast (ADS-B) flight track data and discrete radar beacon returns indicated an interruption of transmission of the data from the airplane.

Figure 2. Plot of the final portion of the accident flight.

No manufacturer published glide ratio data were found for the accident model airplane; however, builder data from online sources indicated that a glide ratio of about 7:1 was achievable. The distance and altitude from the last radar return to the accident site would have required a glide ratio of about 23:1.

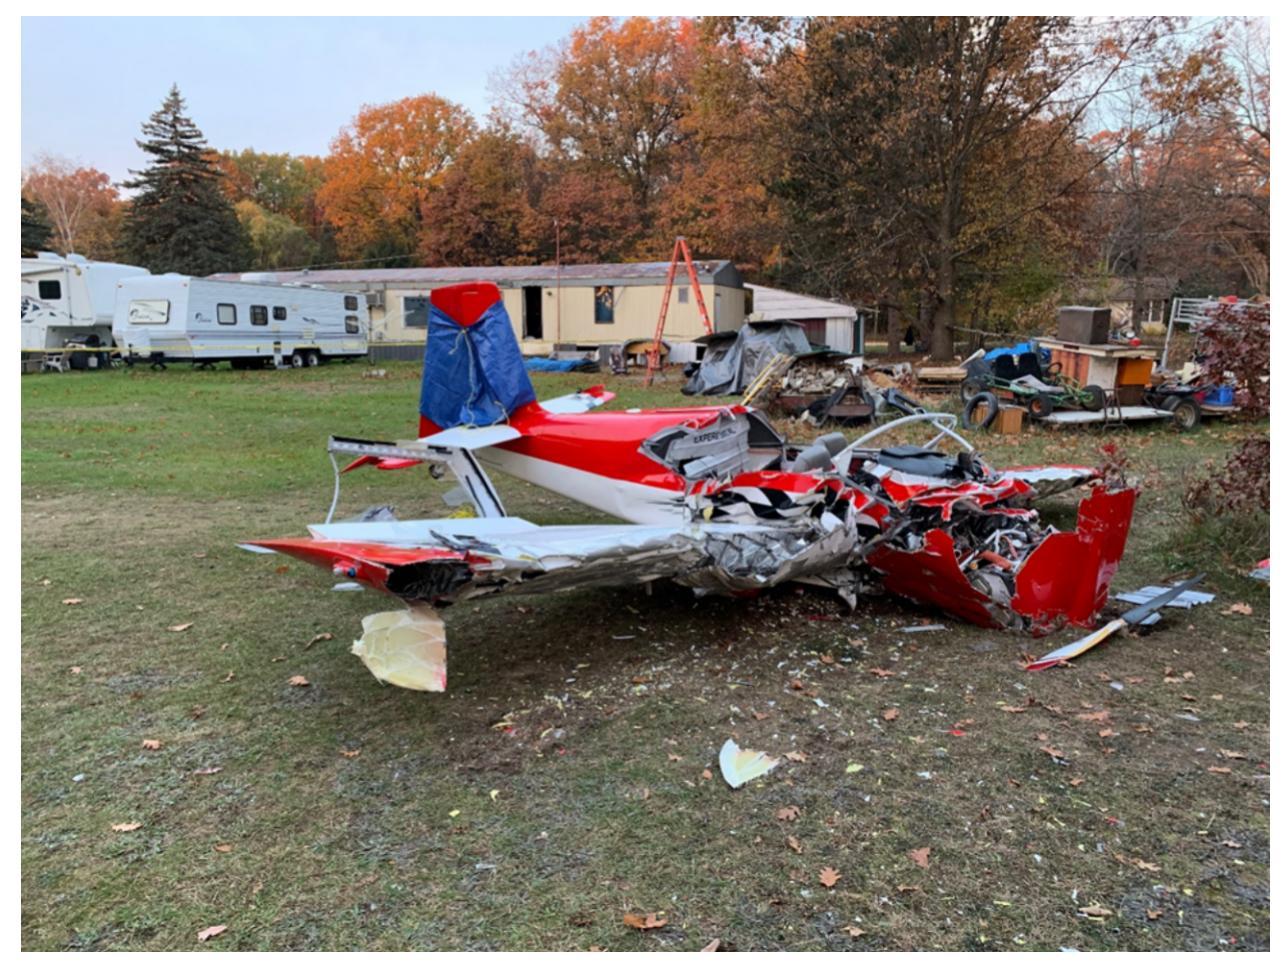
The airplane impacted the back yard of a residence. Impact signatures indicated that the airplane struck the ground about 45° nose low. The initial impact point was located directly

beneath the airplane. The airplane remained predominately intact with all major airframe components still connected. The engine was partially attached to the fuselage. The three-blade wood core propeller was attached to the engine. One blade was broken off near the blade root. None of the propeller blades were splintered and they were predominately intact, consistent with low or no engine power at impact.

Figure 3. Airplane at accident scene.
