Aviation Investigation Final Report

Location:	Statesboro, Georgia	Accident Number:	ERA22FA083
Date & Time:	December 7, 2021, 21:24 Local	Registration:	N5776B
Aircraft:	Cessna 182	Aircraft Damage:	Destroyed
Defining Event:	VFR encounter with IMC	Injuries:	1 Fatal
Flight Conducted Under:	Part 91: General aviation - Personal

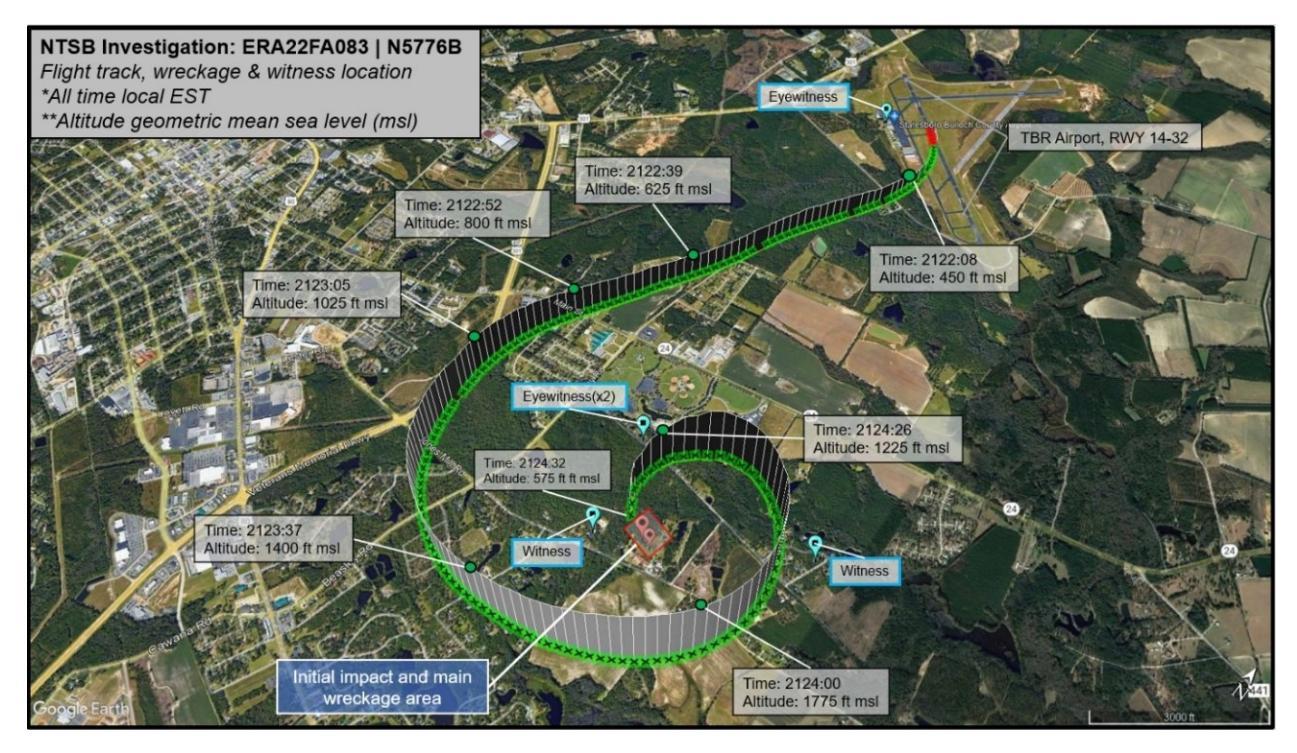
Review of automatic dependent surveillance-broadcast (ADS-B) data found that the airplane departed runway 14 at 2121. Shortly after takeoff, the flight track turned south, climbed to about 1,000 ft msl, which was about 800 ft agl, and then about 1.8 nautical miles south of TBR, the airplane entered a left turn. The airplane continued in a left 360° tightening turn where a maximum altitude of about 1,800 ft msl was reached, which was subsequently followed by a rapid descent.

The final position recorded at 2124:32 was about 0.1-miles from the accident site and showed the airplane headed east at an altitude of 575 ft msl (about 375 ft agl). Figure 1 displays the ADS-B flight track, main wreckage area, and witness locations.

Figure 1: Overview of the flight track, wreckage, and witness locations.

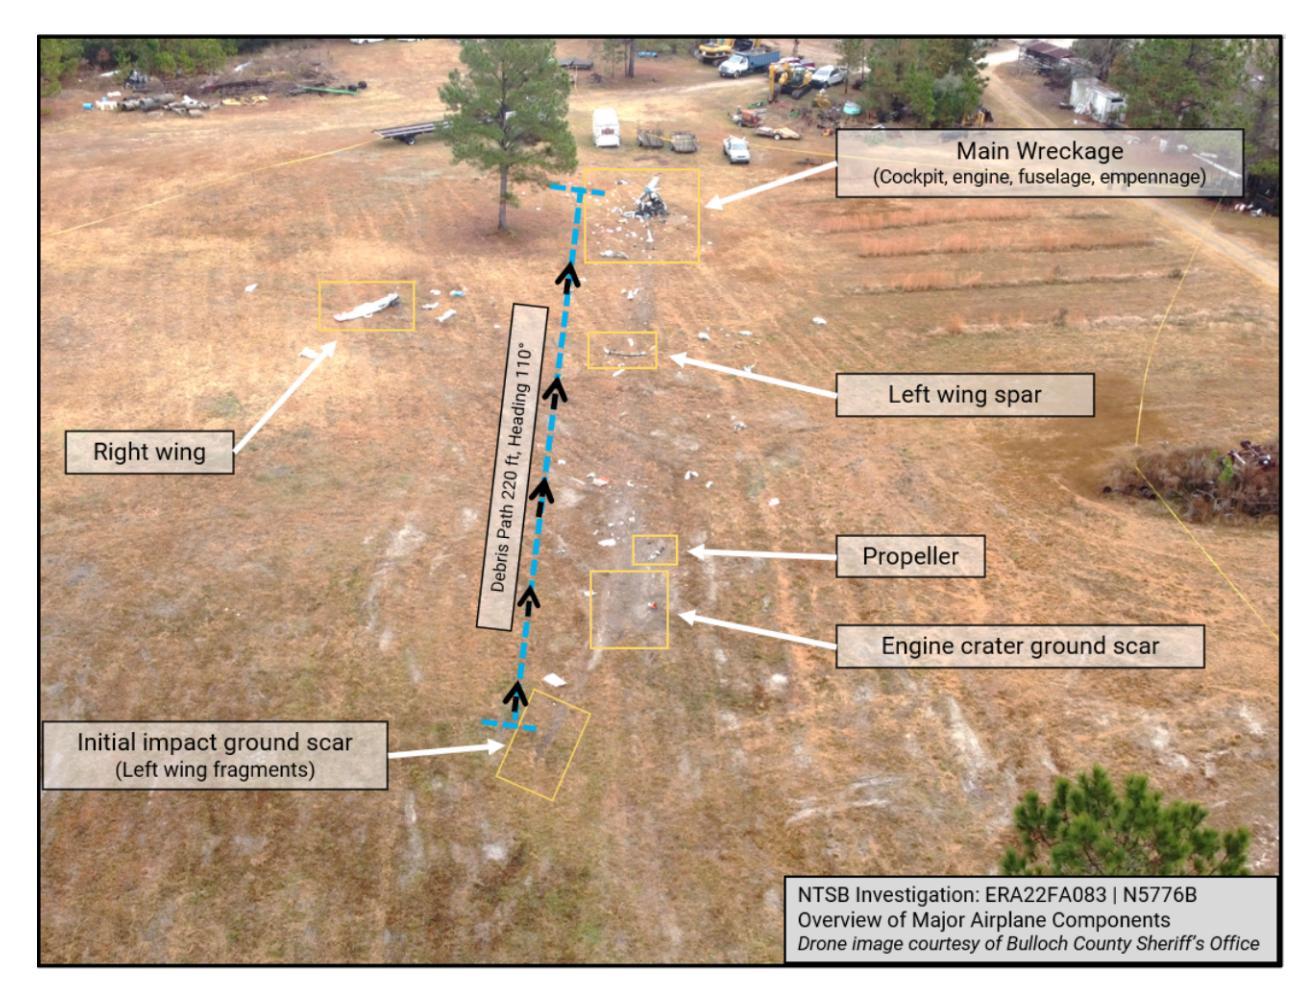
The wreckage was highly fragmented and was oriented on a debris path of about 110° magnetic. The initial impact ground scar was located about 220 ft from the main wreckage final resting location, and the elevation was about 175 ft msl. Figure 2 provides an overview of the major components of the airplane located at the accident site.

Figure 2: Overview of the major airplane components as located in the debris path.

All major components of the airplane were located in the debris path. The left-wing tip and additional left-wing fragments were located in the initial impact scar, which was consistent with the airplane impacting terrain in a descending left bank. There was no evidence of an inflight fire; however, the wreckage was thermally damaged during a postcrash fire.
