Aviation Investigation Final Report

Location:	Fairfield, New Jersey	Accident Number:	ERA22FA257
Date & Time:	June 4, 2022, 12:01 Local	Registration:	N98ZA
Aircraft:	BELL HELICOPTER TEXTRON CANADA 407	Aircraft Damage:	Substantial
Defining Event:	Loss of control in flight	Injuries:	1 Serious
Flight Conducted Under:	Part 91: General aviation - Positioning

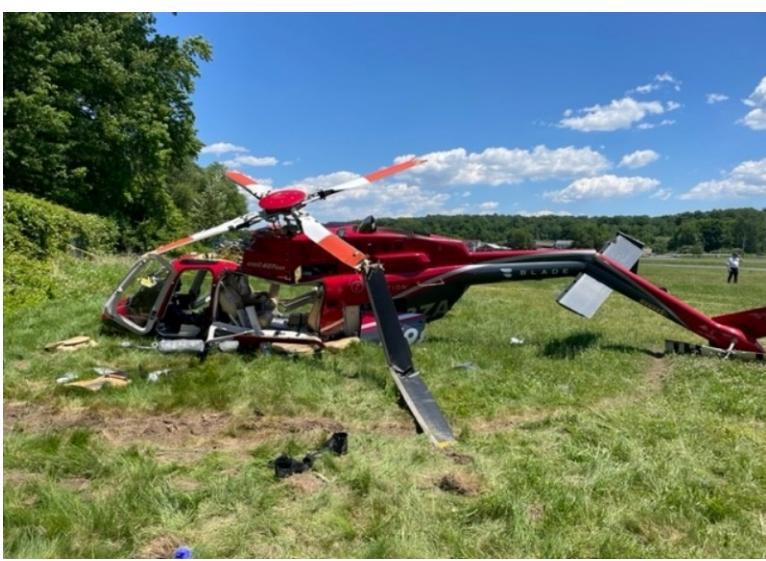
descend as the helicopter rotated right around the main rotor mast. The helicopter completed several 360° rotations before impacting terrain north of runway 28, which caused substantial damage to the fuselage and tailboom, as shown in figure 1.

Figure 1. Helicopter after ground impact (Source: FAA).

Airport surveillance video captured the helicopter's approach, its alignment with the runway, and its decreasing airspeed as the nose pitched upward. The video showed that, as the helicopter slowed, its nose yawed to the right, and the helicopter became unstable and started to descend vertically while rotating around the main rotor mast. About 3 seconds into the vertical descent, the right yaw slowed and then stopped, and the helicopter rotated to its left as it descended and contacted the ground. After ground contact, the main rotor continued to turn, and the main rotor blades continued to strike the ground, shedding about 50% of the span of each blade.

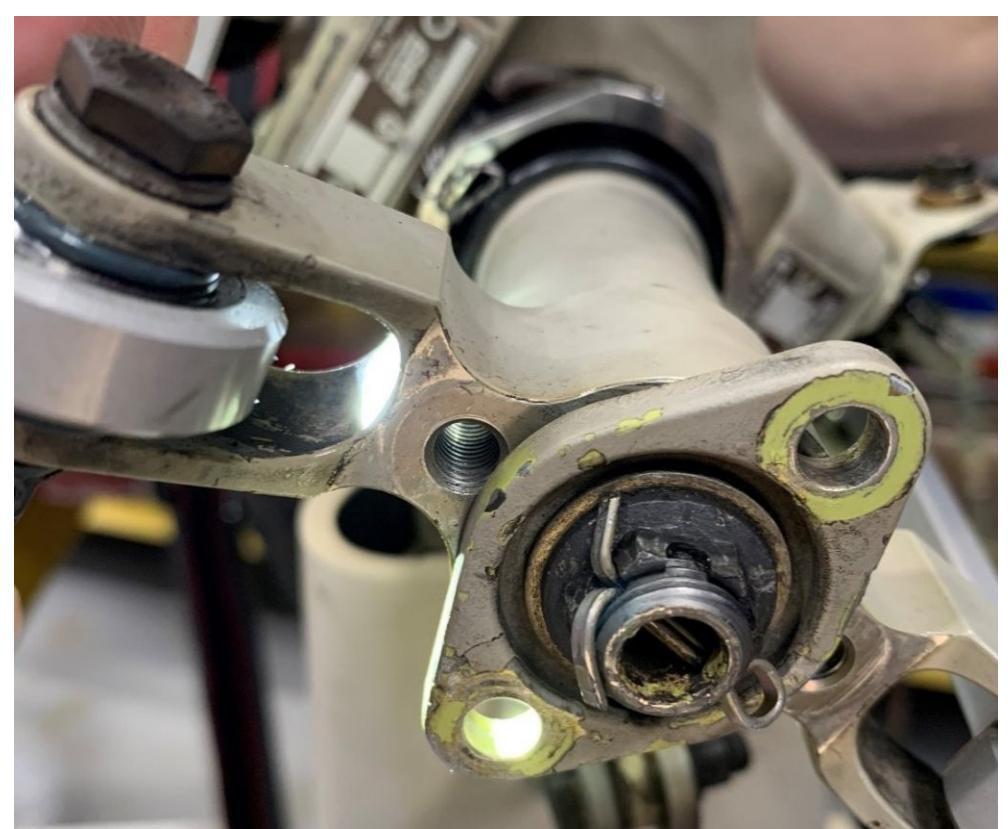
Postaccident examination of the helicopter revealed that the tail rotor crosshead drive plate, which was positioned behind the pitch change rod attachment nut, was not bolted to the tail rotor crosshead. The two attachment bolts were not present, and no remnants of any bolts were found in the threaded receptacles in the crosshead. The threads were undamaged and showed no signs of corrosion, deformation, smearing, or cross-threading, indicating that the attachment bolts were likely not installed.

The failure of maintenance personnel to properly secure the tail rotor crosshead drive plate and the failure of maintenance personnel, the maintenance pilot, and the accident pilot to detect the error, which led to the helicopter's loss of tail rotor antitorque. Also causal was the pilot's failure to maintain the helicopter's airspeed at or above effective translational lift and perform a run-on landing, which resulted in a loss of control.

Postaccident examination revealed that the tail rotor crosshead drive plate, which was positioned behind the pitch change rod attachment nut, was not bolted to the tail rotor crosshead, as prescribed in the maintenance manual. The two attachment bolts were not present, and no remnants of any bolts were found in their threaded receptacles in the

crosshead drive plate, as shown in figure 2. The threads were undamaged and showed no signs of corrosion, deformation, smearing, or cross-threading.

Figure 2. Tail rotor crosshead/drive plate attachment bolt bore threads (Source: Bell Helicopters).

As a result of this investigation, the operator developed a required inspection program, which was published and amended to the *General Operating Manual*. The program was submitted to the appropriate FAA Certificate Holder District Office, and the manual revisions were accepted.
