Aviation Investigation Final Report

Location:	Kerrville, Texas	Accident Number:	WPR22FA229
Date & Time:	June 25, 2022, 18:23 Local	Registration:	N4267H
Aircraft:	Mooney M20J	Aircraft Damage:	Destroyed
Defining Event:	Sys/Comp malf/fail (non-power)	Injuries:	2 Fatal
Flight Conducted Under:	Part 91: General aviation - Personal

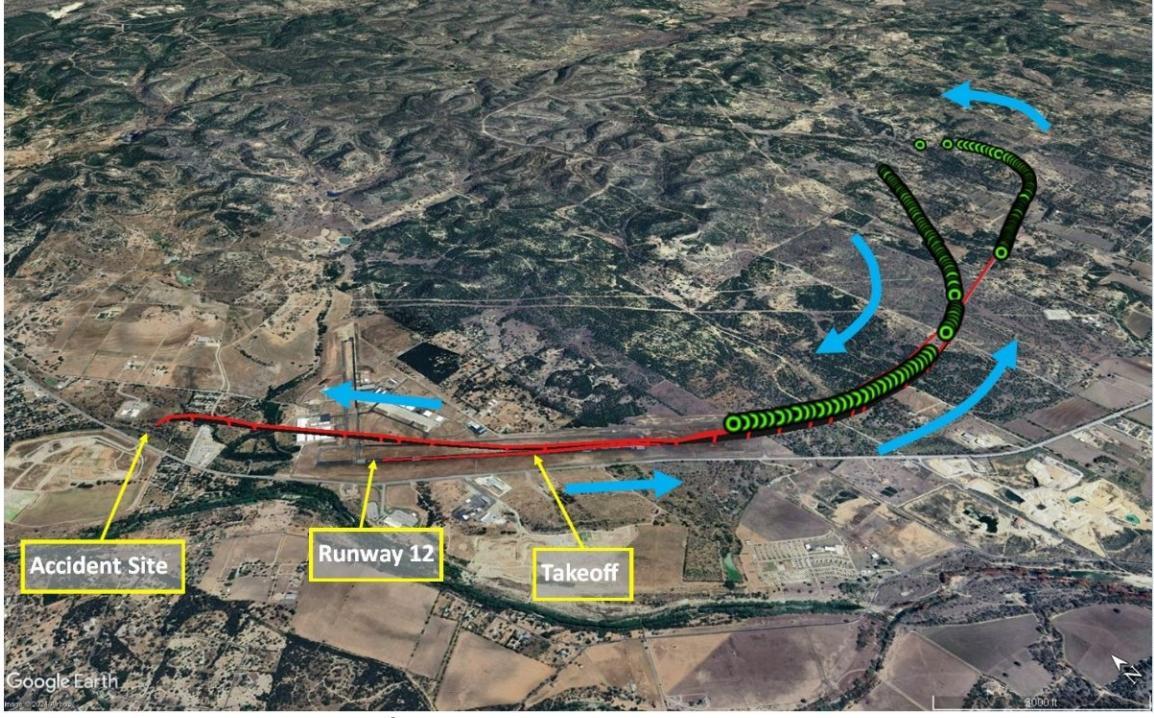
Another witness traveling along the same highway observed a Mooney airplane flying over runway 30, but not climbing. He assumed it had just taken off and was concerned because the wind favored the opposite runway, and the weather was hot. He watched as the airplane continued traveling in a northwest direction, in a manner that he described as "mushing." It was very close to the treetops when it appeared to make a turn to the left. The witness thought this was a left base turn for runway 12, but the bank angle became very steep, and the airplane disappeared behind trees (see Figure 1).

ADS-B data provided by a publicly available collection service (ADS-B Exchange) recorded position data during the return leg to the airport. The data appeared to match the witness observations and showed that the airplane flew directly over the takeoff runway at an altitude of about 100 ft agl before making a 10° turn to the right. The airplane continued at the same altitude for the next 1.25 miles before beginning a left turn almost 800 ft southeast of the accident site.

Figure 1 – Composite flight track. Green: FAA ADS-B. Red: ADS-B Exchange.

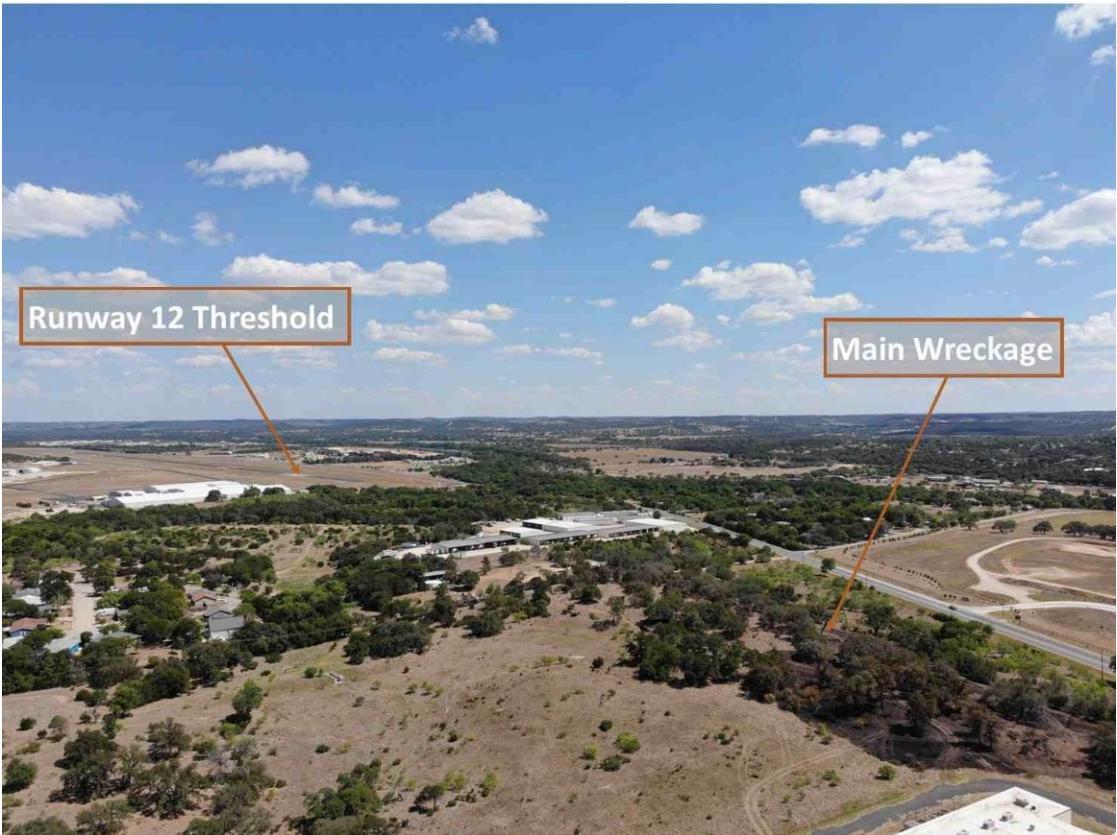
The airplane came to rest at an elevation of about 1,600 ft on the slope of a hill about 4,200 ft beyond the runway 12 threshold and 20° offset from the runway centerline (see Figure 2). The first identified point of impact was a cleanly cut swath of tree branches and limbs at an angle of 60° relative to the horizon (Figure 3). The airplane was located about 30 ft southwest of the swath at the base of a felled 50-ft tall oak tree. The tree exhibited impact damage along its north face.

Figure 2 – Wreckage location and runway threshold.

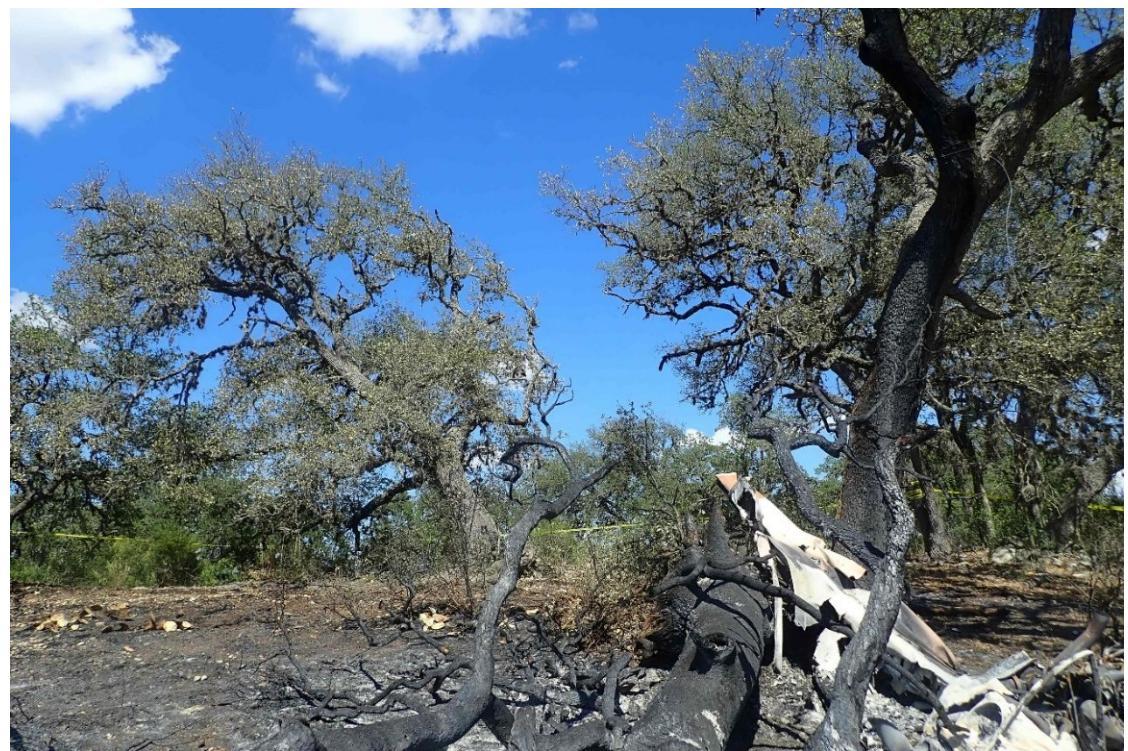
Figure 3 – Facing north, a 60° swath of cut tree limbs and branches, with the main wreckage in the foreground.
