Aviation Investigation Final Report

Location:	Topeka, Kansas	Accident Number:	WPR22FA254
Date & Time:	July 16, 2022, 11:53 Local	Registration:	N283S
Aircraft:	STUCKY STEVEN D RV-7	Aircraft Damage:	Substantial
Defining Event:	Loss of control in flight	Injuries:	1 Fatal
Flight Conducted Under:	Part 91: General aviation - Personal

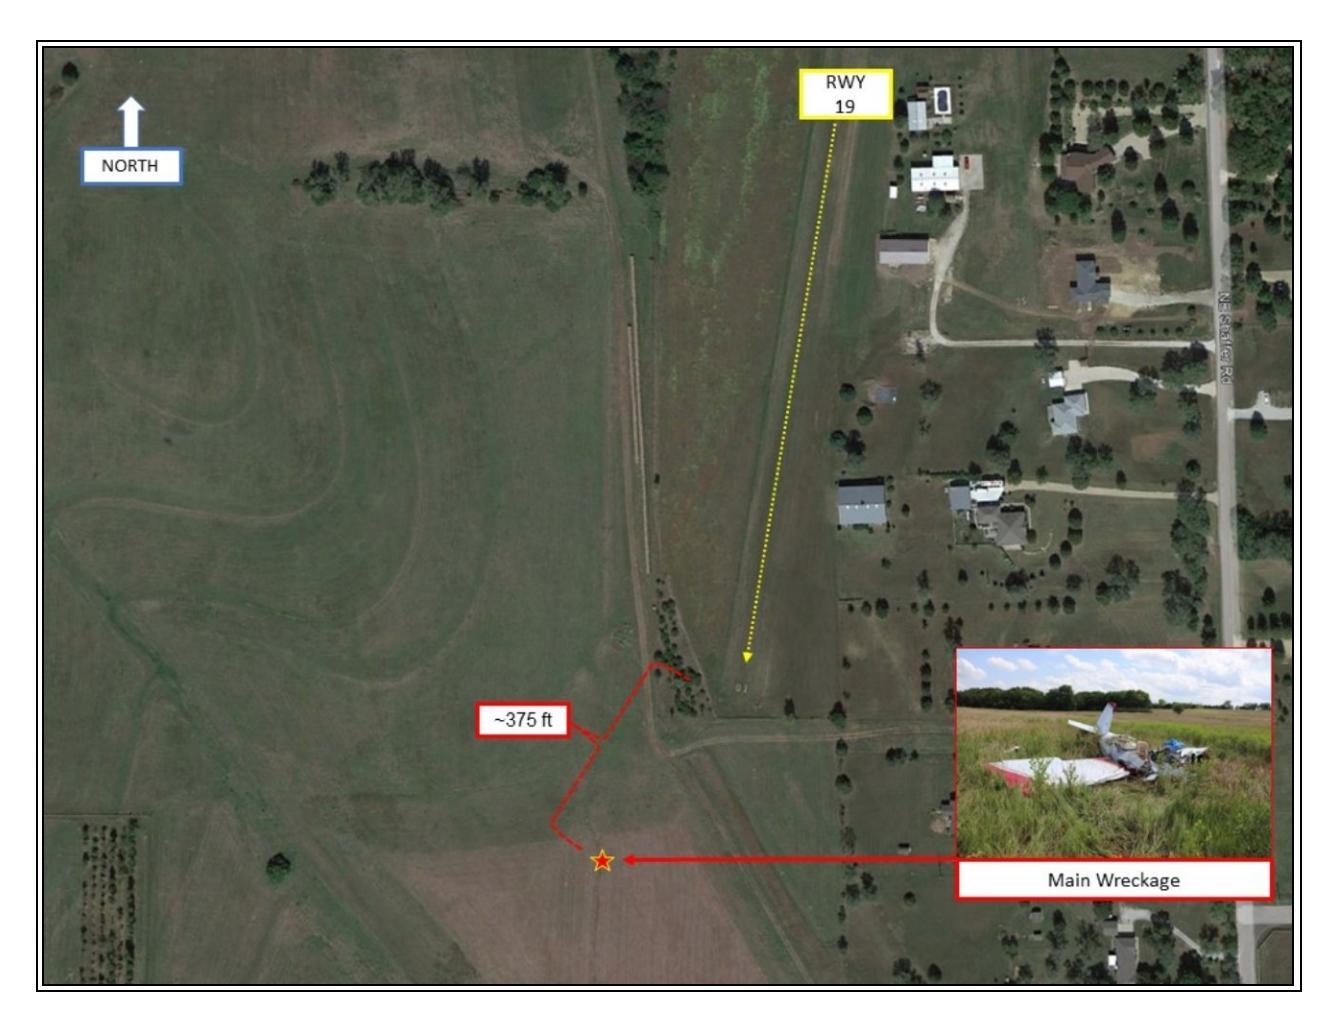
Examination of the accident site revealed that the airplane came to rest upright after it impacted an open grass field about 375 ft southwest of the departure end of runway 19. The wreckage came to rest on a heading of about 340° magnetic. No visible ground scars were observed in the area near the wreckage. All major structural components of the airplane were located at the accident location.

Figure 1: View of the accident site diagram.
