Aviation Investigation Final Report

Location:	Tryon, Nebraska	Accident Number:	WPR22FA266
Date & Time:	July 25, 2022, 08:39 Local	Registration:	N192MH
Aircraft:	HOLLAND MIKE RV9A	Aircraft Damage:	Destroyed
Defining Event:	Loss of control in flight	Injuries:	2 Fatal
Flight Conducted Under:	Part 91: General aviation - Personal

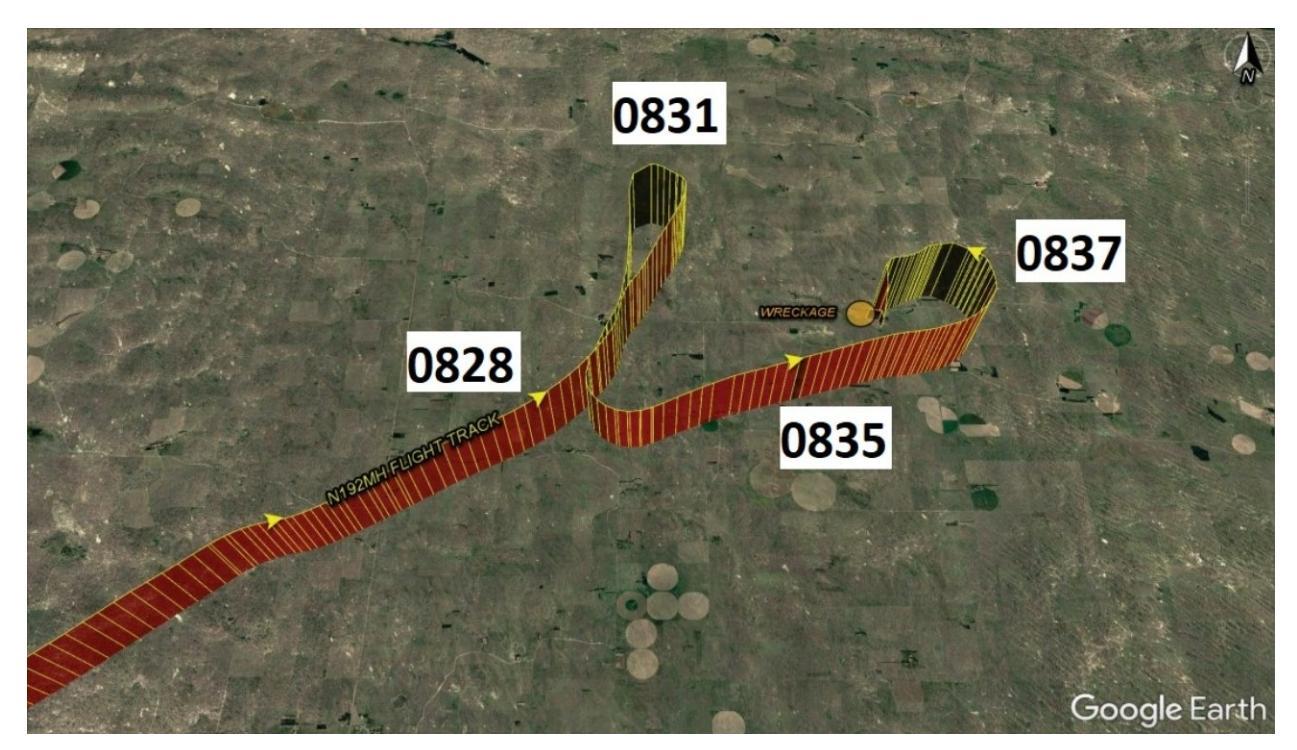
Figure 1 – Flight Track

At 0837, the pilot reported they were at 12,300 ft and "still in the soup." The airplane remained at that altitude about 90 seconds before the airplane started a descending left-hand turn. The following 20 seconds of radar data indicated that the airplane descended about 4,800 ft and accelerated past its maximum airspeed of 182 knots TAS to about 249-264 knots TAS before the radar data ended (see figures 1 and 2).

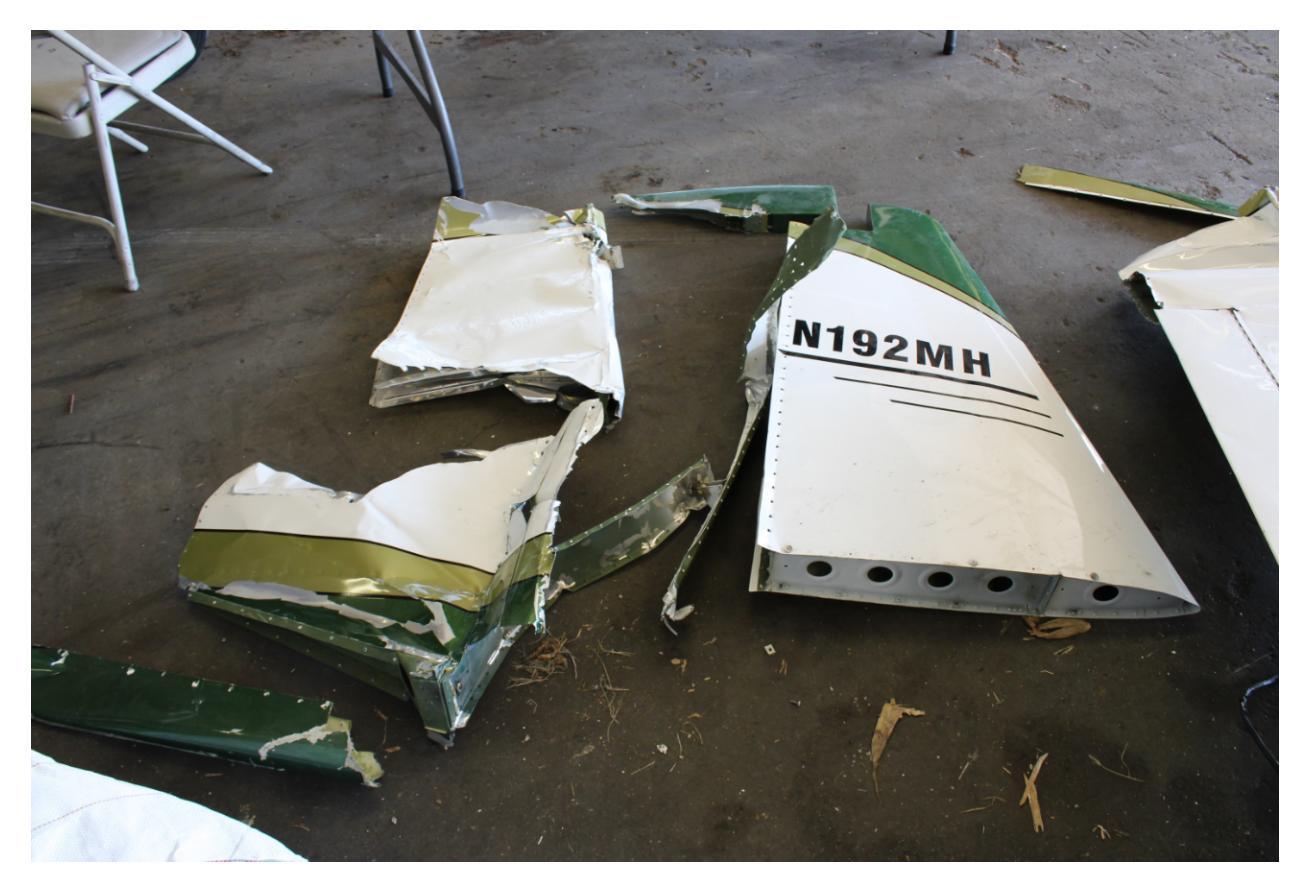
The vertical stabilizer separated mostly intact from the empennage. The front spar was fractured and deformed aft at the fracture location. The rear spar was pulled from the vertical stabilizer and the vertical stabilizer skins were splayed open. The rudder was separated and fractured into 5 pieces. The rudder counterweight was separated from the top of the rudder. The upper half of the rudder was mostly intact, but the riveted trailing edge was splayed open. A section of the left center rudder skin was recovered separately, and a section of the right center rudder skin was not recovered. The lower section of rudder remained attached to the vertical stabilizer rear spar at the center hinge. The vertical stabilizer rear spar had diagonal buckling damage along most of its length. The upper rudder hinge plates were pulled from the spar and the upper half of the spar was deformed and twisted to the right. The lower rudder cap was separated.

Figure 3 - Separated vertical stabilizer and rudder.

The observed damage was consistent with structural failure initiated by flutter of the rudder and no anomalies were found during examinations of the wreckage.
