Aviation Investigation Final Report

Location:	Scio, Oregon	Accident Number:	WPR22FA312
Date & Time:	August 21, 2022, 14:03 Local	Registration:	N184DJ
Aircraft:	JACKSON DENNIS RV-8	Aircraft Damage:	Substantial
Defining Event:	Collision with terr/obj (non-CFIT)	Injuries:	2 Fatal
Flight Conducted Under:	Part 91: General aviation - Personal

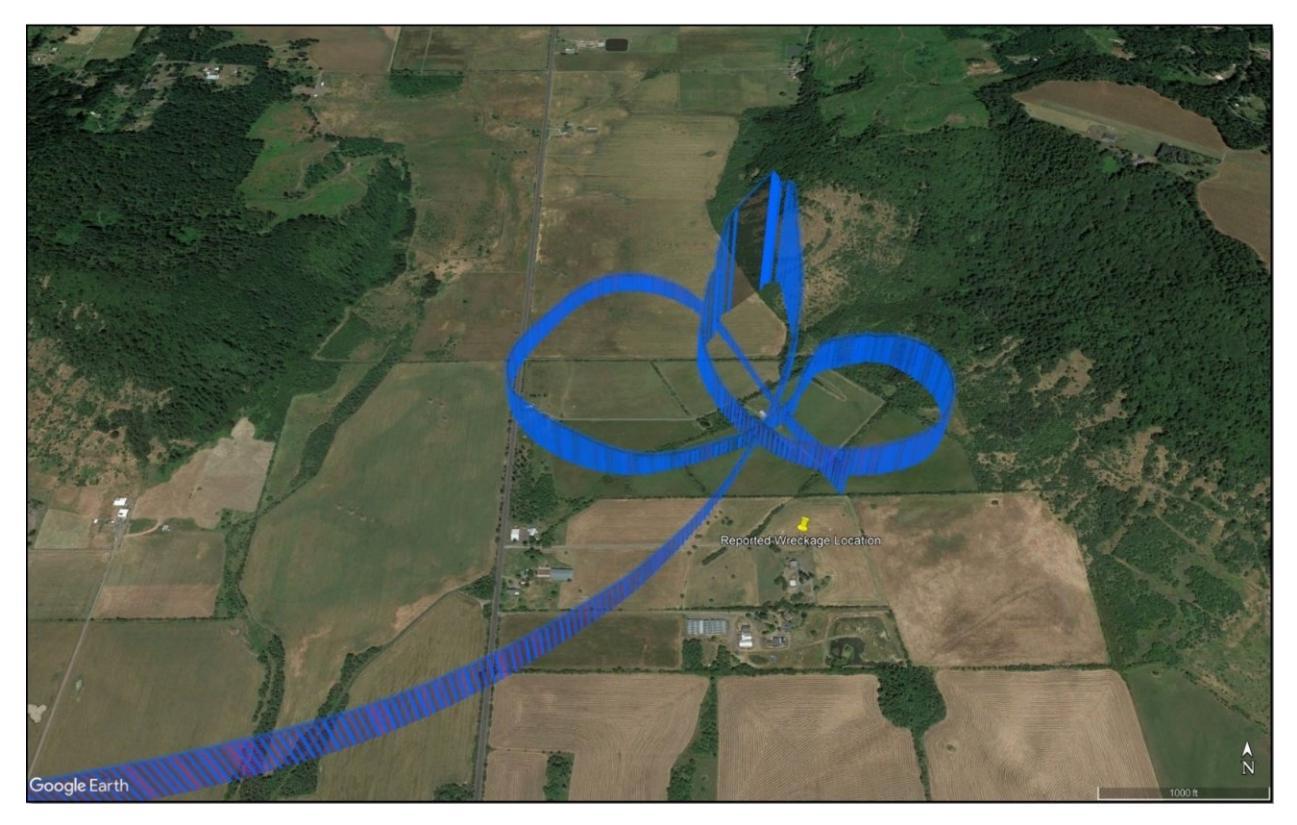
Relatives of the pilot told investigators the pilot would often conduct low-altitude flights and perform aerobatic maneuvers over their home, and they were aware he was going to overfly their home on the day of the accident. Flight data recovered from a Dynon SV-D1000 unit onboard the airplane showed the airplane departed Albany Municipal Airport (S12), Albany, Oregon, about 1353, and proceeded easterly towards the relative's home. The airplane then entered the area of the accident from the west to the east and performed a series of maneuvers near the accident site (Figure 1).

Figure 1. The accident airplane's flight path.
