# **Aviation Investigation Final Report**

Location:	Preston, Idaho	Accident Number:	WPR22FA347
Date & Time:	September 14, 2022, 10:55 Local	Registration:	N992KS
Aircraft:	SKILES KENNETH C RV-6A	Aircraft Damage:	Substantial
Defining Event:	VFR encounter with IMC	Injuries:	2 Fatal
Flight Conducted Under:	Part 91: General aviation - Personal

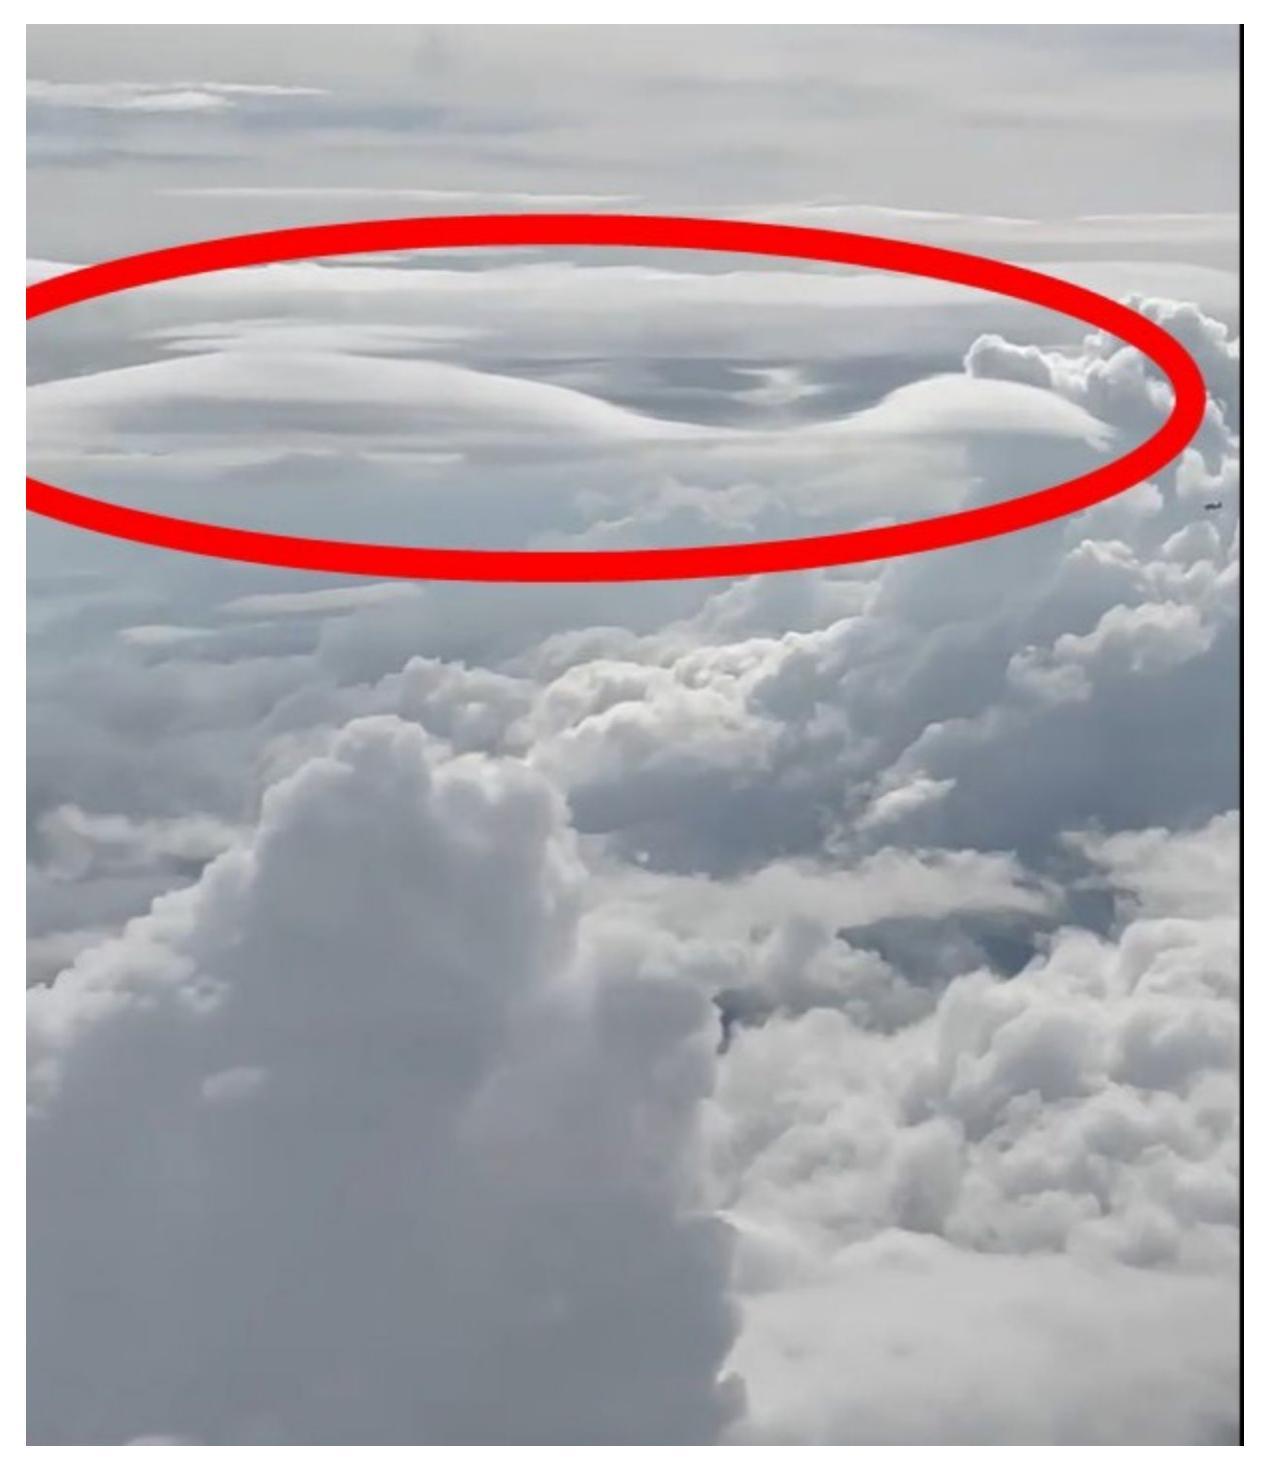
The cellular phone video footage from the second airplane depicted what appeared to be standing lenticular clouds. These clouds are generally the result of standing wave action, but do not guarantee hazardous conditions or turbulence. The video also depicted cumulonimbus and cumulostratus clouds ahead of the accident airplane (Figure 1).

Figure 1: Photo of accident airplane in the vicinity of clouds.
