# **Aviation Investigation Final Report**

Location:	Boulder City, Nevada	Accident Number:	WPR23LA003
Date & Time:	October 2, 2022, 20:00 Local	Registration:	N511W
Aircraft:	Cessna 182C	Aircraft Damage:	Substantial
Defining Event:	Loss of engine power (total)	Injuries:	1 Minor, 1 None
Flight Conducted Under:	Part 91: General aviation - Personal

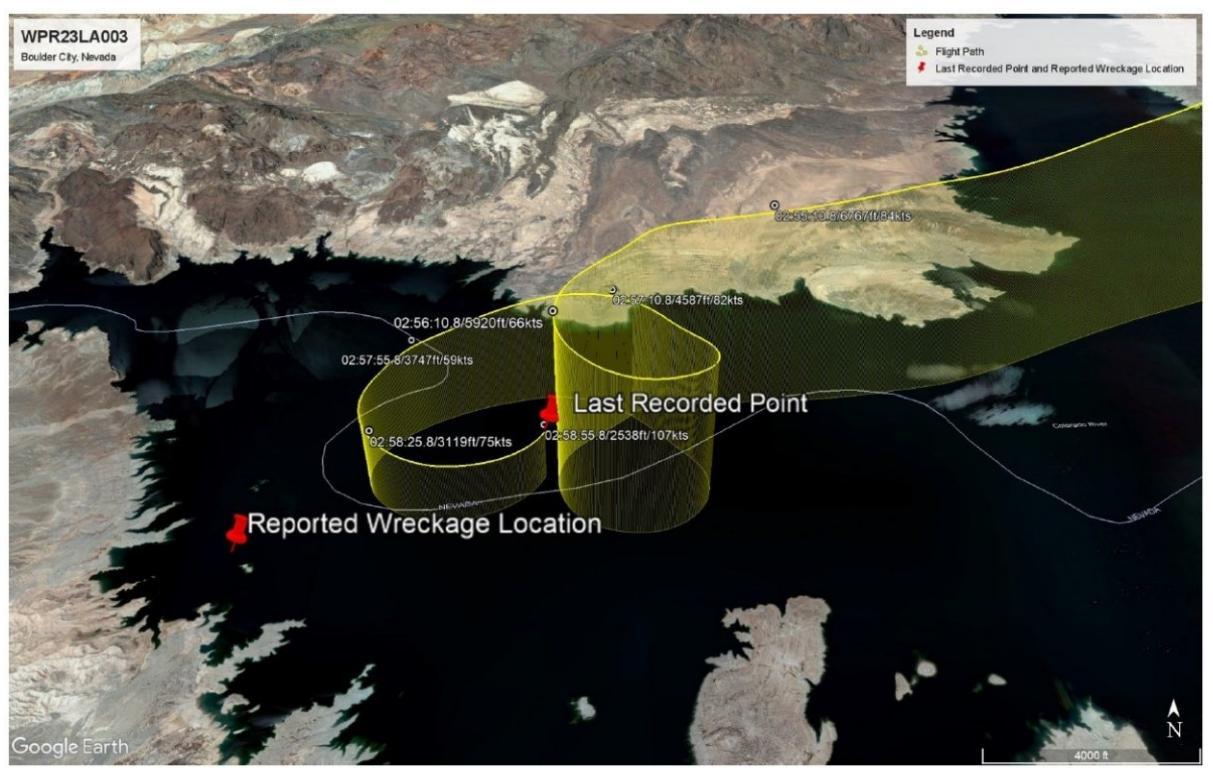
Figure 1: Google Earth overlay of final segment track log recorded on Appareo Stratus 3

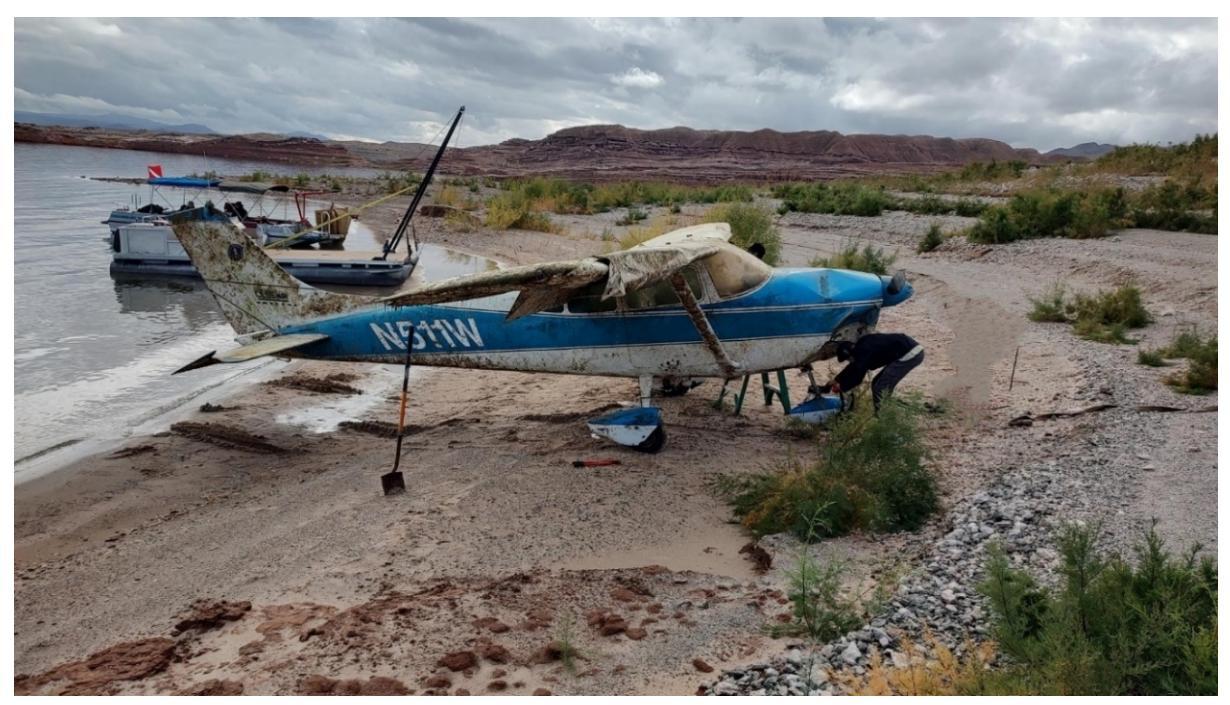
After the airplane touched down on the water, it nosed over, came to rest inverted, and sank. The pilot and passenger were able to exit the airplane and swim about 200 yards to shore. Law enforcement personnel located and rescued them a few hours later.

Figure 2: Recovery of airplane out of Lake Mead.

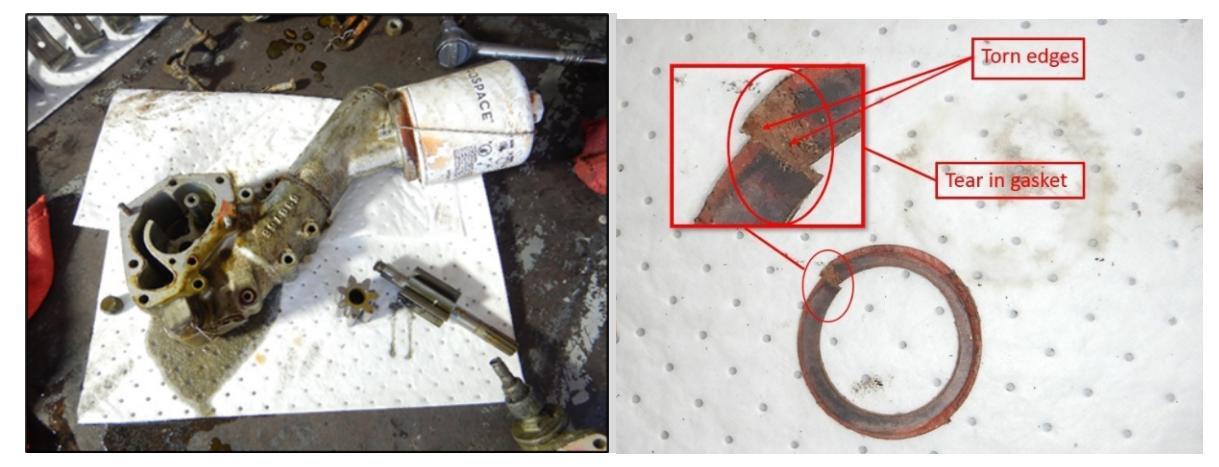
Postaccident examination of the engine revealed discoloration of the cylinder and bearing surfaces consistent with high heat signatures due to oil starvation. The engine examination revealed no preimpact mechanical anomalies except for the oil filter adapter housing, which was loose, and the gasket was torn and deformed. As the oil level was likely normal at the pilot's previous stop and the pilot did not notice any unusual reductions in oil quantity during the service life of the engine, it is likely that the oil started to leak during the accident flight. The failure of the gasket likely allowed engine oil to exit the crankcase rapidly, resulting in oil starvation and the subsequent catastrophic failure.

A total loss of engine power due to oil starvation resulting from the failure of an engine oil filter adapter fiber gasket.

Examination of the engine revealed a large hole located in upper side of the crankcase halves between cylinders No. 3 and 4 and was about 3 to 4 inches wide. The number 4 connecting rod was not recovered. The discoloration of the cylinder and bearing surfaces were consistent with high heat signatures due to oil starvation. The engine examination revealed no preimpact mechanical anomalies. The engine was void of any oil. An examination of the oil filter adapter revealed a loose fit between the oil pump housing and oil filter adapter sleeve. The oil filter adapter fiber gasket was torn and deformed, and the gasket was stretched and protruded (extruded) out beyond the adapter flange edge. The safety wire securing the spool and the sleeve remained attached. The oil pump could be moved by hand and no contaminant blockages were found in the oil scavenge screens and oil filters.

Figure 3: Oil filter adapter housing and filter. Figure 4: Oil filter adapter housing gasket.

As a result, on February 22, 2022, the FAA published Airworthiness Directive (AD) 2022–04–04, "Continental Aerospace Technologies, Inc. and Continental Motors Reciprocating Engines," which requires replacing the oil filter adapter fiber gasket (fiber gasket) with an oil filter adapter copper gasket (copper gasket), prohibits any future use of the fiber gasket, and mandates compliance with Stratus Mandatory SB-001 Rev B..

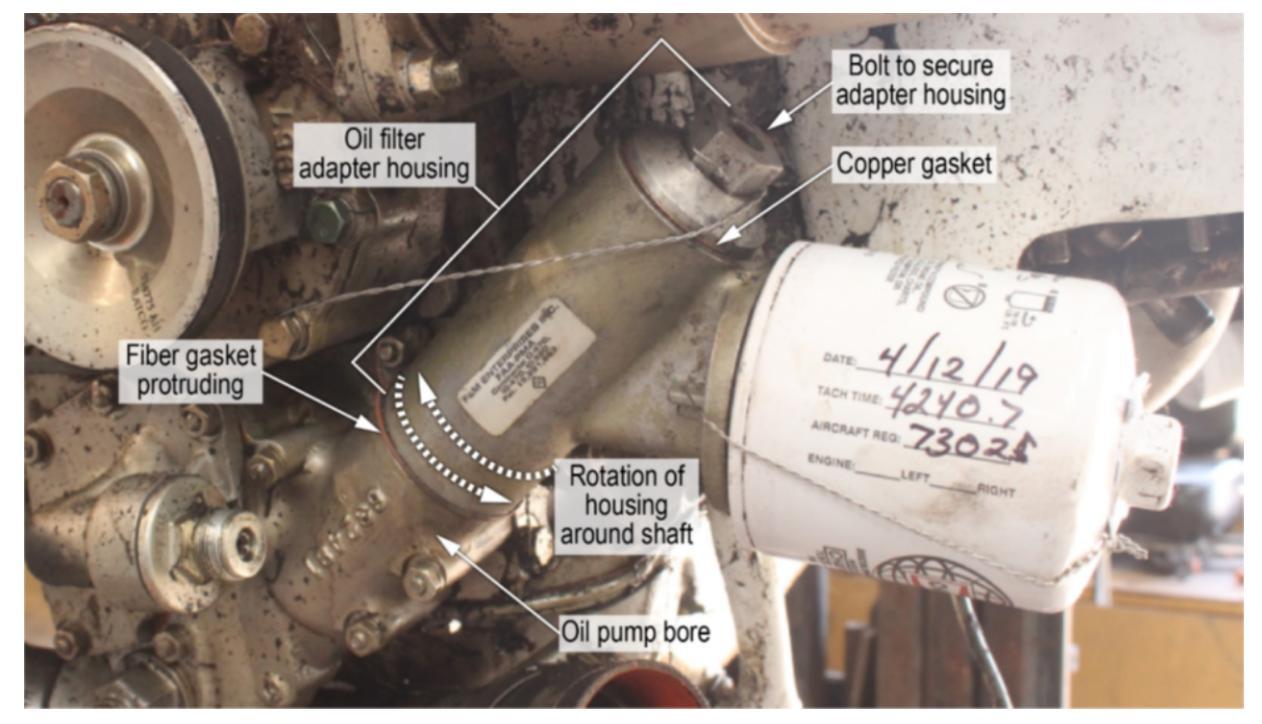
Figure 5: Additional example of Mill Creek, California accident oil filter adapter attached to similar engine.

Other oil filter adapter gasket failures resulting in oil starvation were investigated by the National Transportation Safety Board (NTSB). On December 3, 2020, the NTSB recommended that the Federal Aviation Administration (FAA), "Issue an Airworthiness Directive to address the unsafe conditions of F&M Enterprises Inc. or Stratus Tool Technologies (Stratus) oil filter adapters that have led to oil starvation and loss of engine power by requiring owners of airplanes equipped with the adapters to repetitively inspect and, if necessary, reinstall the adapters in compliance with Stratus' service bulletin SB-001.".
