Aviation Investigation Final Report

Location:	Pewaukee, Wisconsin	Accident Number:	CEN23LA037
Date & Time:	November 15, 2022, 15:00 Local	Registration:	N247DH
Aircraft:	Fairchild SA227-AT	Aircraft Damage:	Substantial
Defining Event:	Loss of control in flight	Injuries:	2 Minor, 1 None
Flight Conducted Under:	Part 135: Air taxi & commuter - Non-scheduled

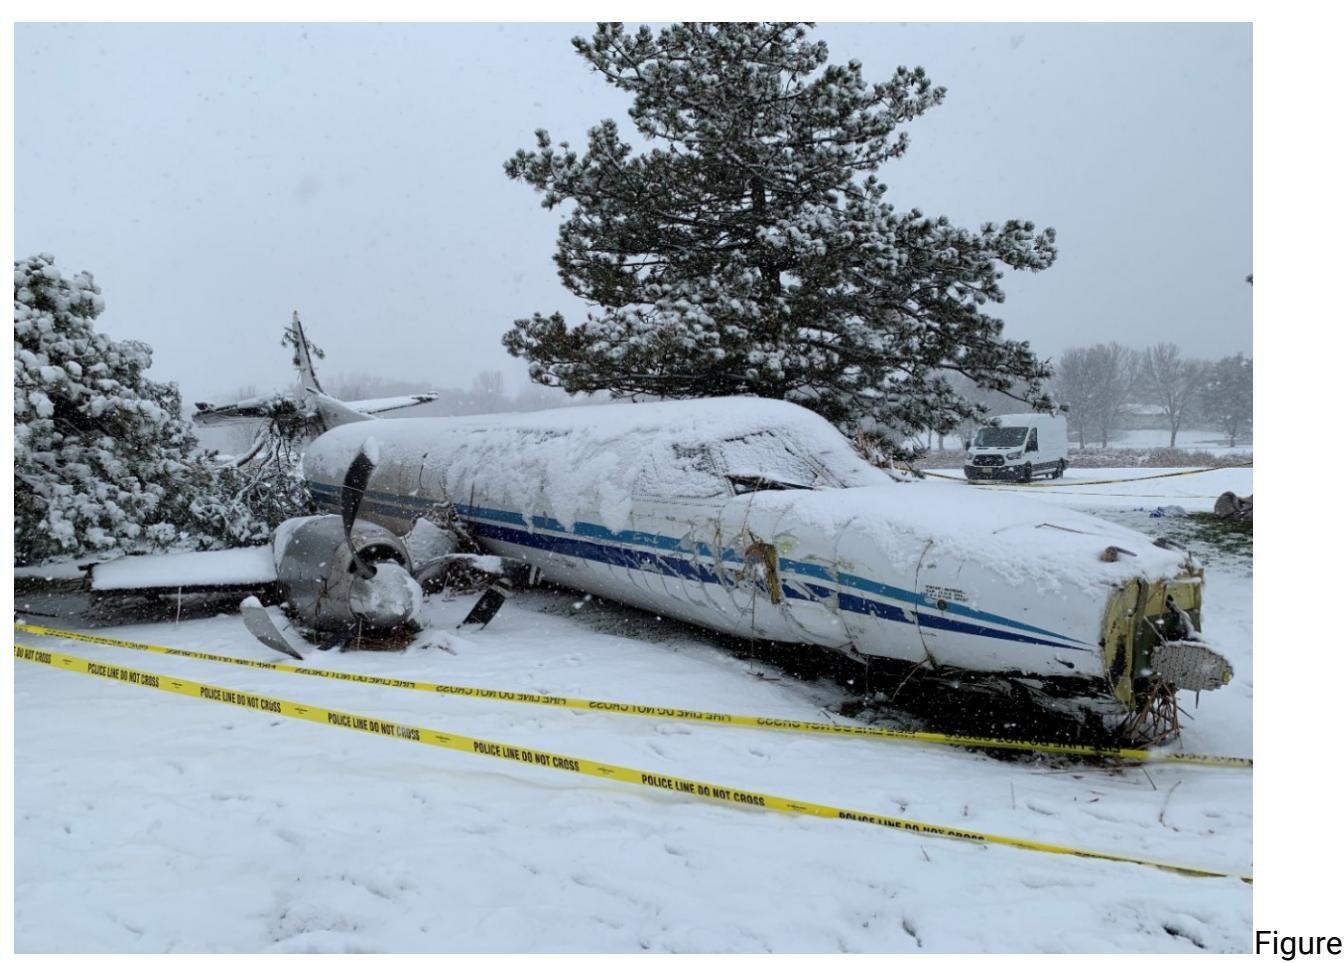
During the accident sequence the airplane contacted trees, separating the wings from the airplane and resulting in substantial damage to the wings and fuselage.

1: The airplane at the accident site. (Photo courtesy of FAA)
