# **Aviation Investigation Final Report**

Location:	Santa Monica, California	Accident Number:	WPR23FA073
Date & Time:	December 22, 2022, 15:18 Local	Registration:	N7032X
Aircraft:	Cessna 150A	Aircraft Damage:	Substantial
Defining Event:	Loss of engine power (partial)	Injuries:	1 Fatal, 1 Minor
Flight Conducted Under:	Part 91: General aviation - Personal

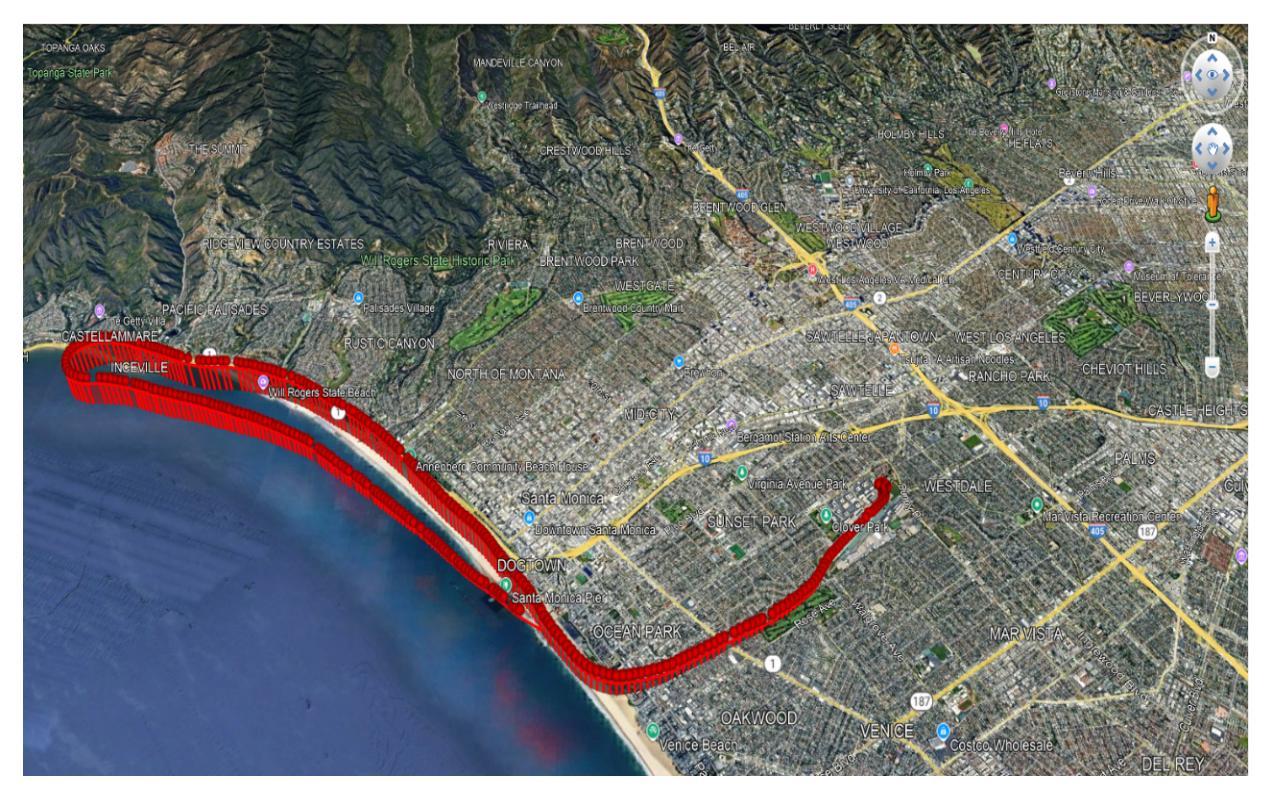
The pilot reported that the accident flight was to be local, following a route northwest along the Pacific Ocean coastline with a pilot-rated passenger. The pilot reported that after topping off the airplane's fuel tanks, the airplane seemed "sluggish" during the taxi to runway 21. The pilot canceled his takeoff request, taxied to his hangar, and shut down the engine to troubleshoot the anomaly. Initially he believed that it may have been due to low tire pressure, so he verified the tire pressure and started the engine. While taxiing from the hangar to the runway, a magneto check and carburetor heat check were within normal limits. The pilot contacted ground control, taxied to the runway, and departed runway 21 to the southwest. During the initial climb, about 575 ft agl, the pilot intercepted the coast near Ocean View Park and turned to the right to follow the coastline northwest (Figure 1).

ADS-B data indicated that four minutes into the flight, while over Sunset Beach, the airplane had climbed to 1,025 ft agl with a consistent airspeed of about 70 mph. The pilot reported that he ensured that the carburetor heat was off, the mixture was rich, the throttle was in the maximum position, and that the ignition switch was in the Both position. Subsequently, he heard what he described as a "bang" and made a left 180° turn. The pilot contacted the SMO tower controller and attempted to return to SMO. However, the airplane's descent rate increased, and the pilot initiated a forced landing to the shoreline about 2,200 ft south of the Santa Monica Pier. The airplane touched down heading south in the shallow water of the shoreline and nosed over.

Figure 1: View of the accident airplane's ADS-B flight path
