# **Aviation Investigation Final Report**

Location:	Lindenhurst, New York	Accident Number:	ERA23FA137
Date & Time:	March 5, 2023, 14:59 Local	Registration:	N8149R
Aircraft:	Piper PA-28-161	Aircraft Damage:	Destroyed
Defining Event:	Fire/smoke (non-impact)	Injuries:	1 Fatal, 2 Serious
Flight Conducted Under:	Part 91: General aviation - Instructional

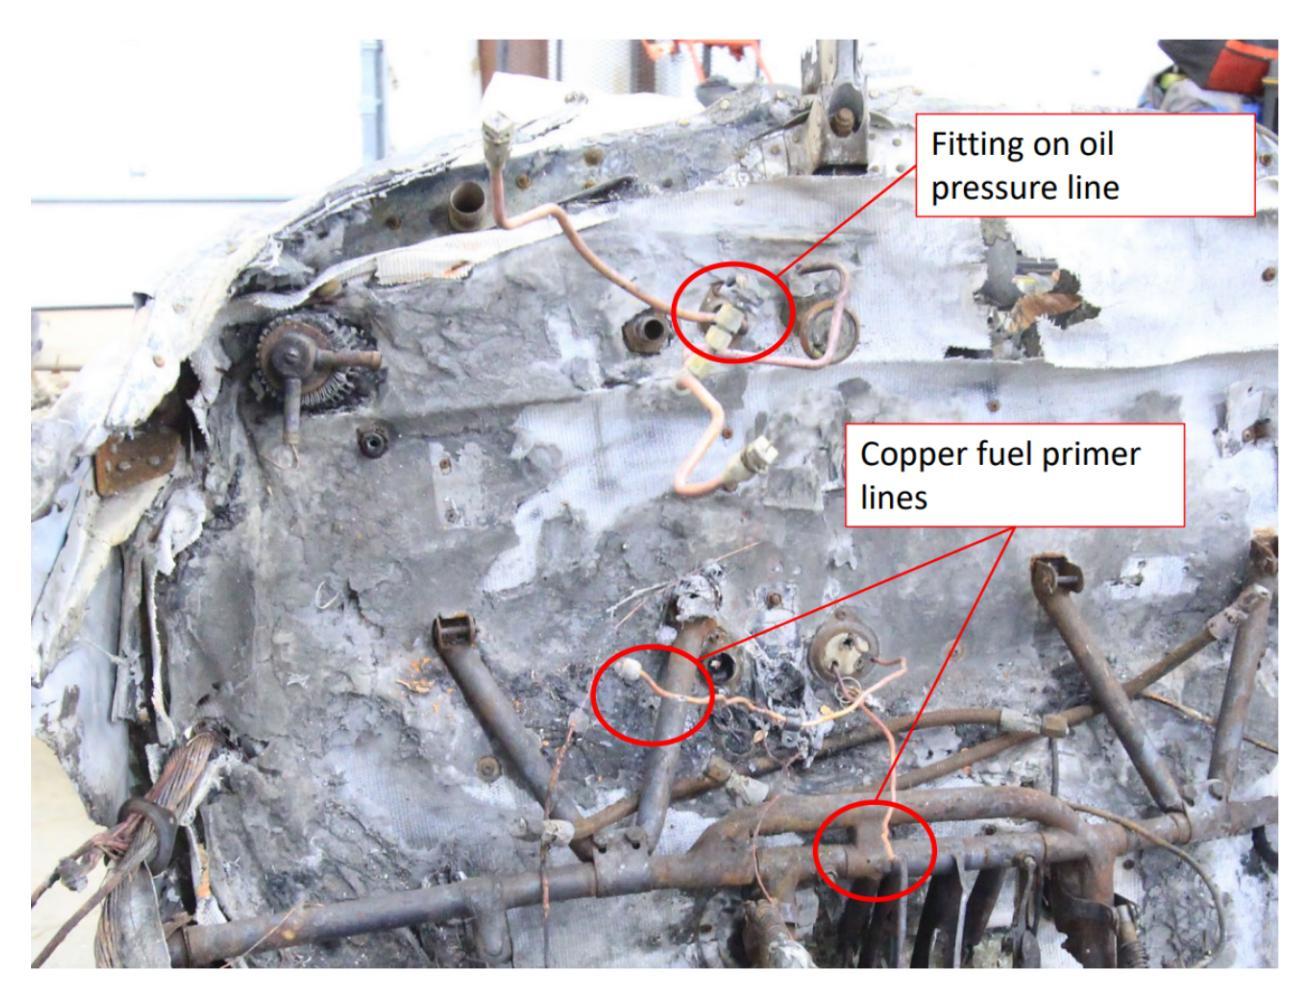
Examination of the firewall and components remaining attached to the cockpit side of the firewall did not reveal any concentrated thermal damage on the firewall panel but did identify two copper tubes associated with the fuel primer pump and a fitting on a copper tube associated with the oil pressure line that exhibited localized areas of melting. (See Figure 1.) These components exhibited a sharp demarcation between the melted area and the adjacent material. The fuel primer lines were standard equipment consistent with the aircraft design. The fitting on the oil pressure line was not standard equipment and was not consistent with the design of the original oil pressure line. Both the fuel primer lines and the fitting on the oil pressure line was not standard.

Figure 1. Cockpit side of engine firewall exhibiting overall thermal damage, with localized areas of melting identified.

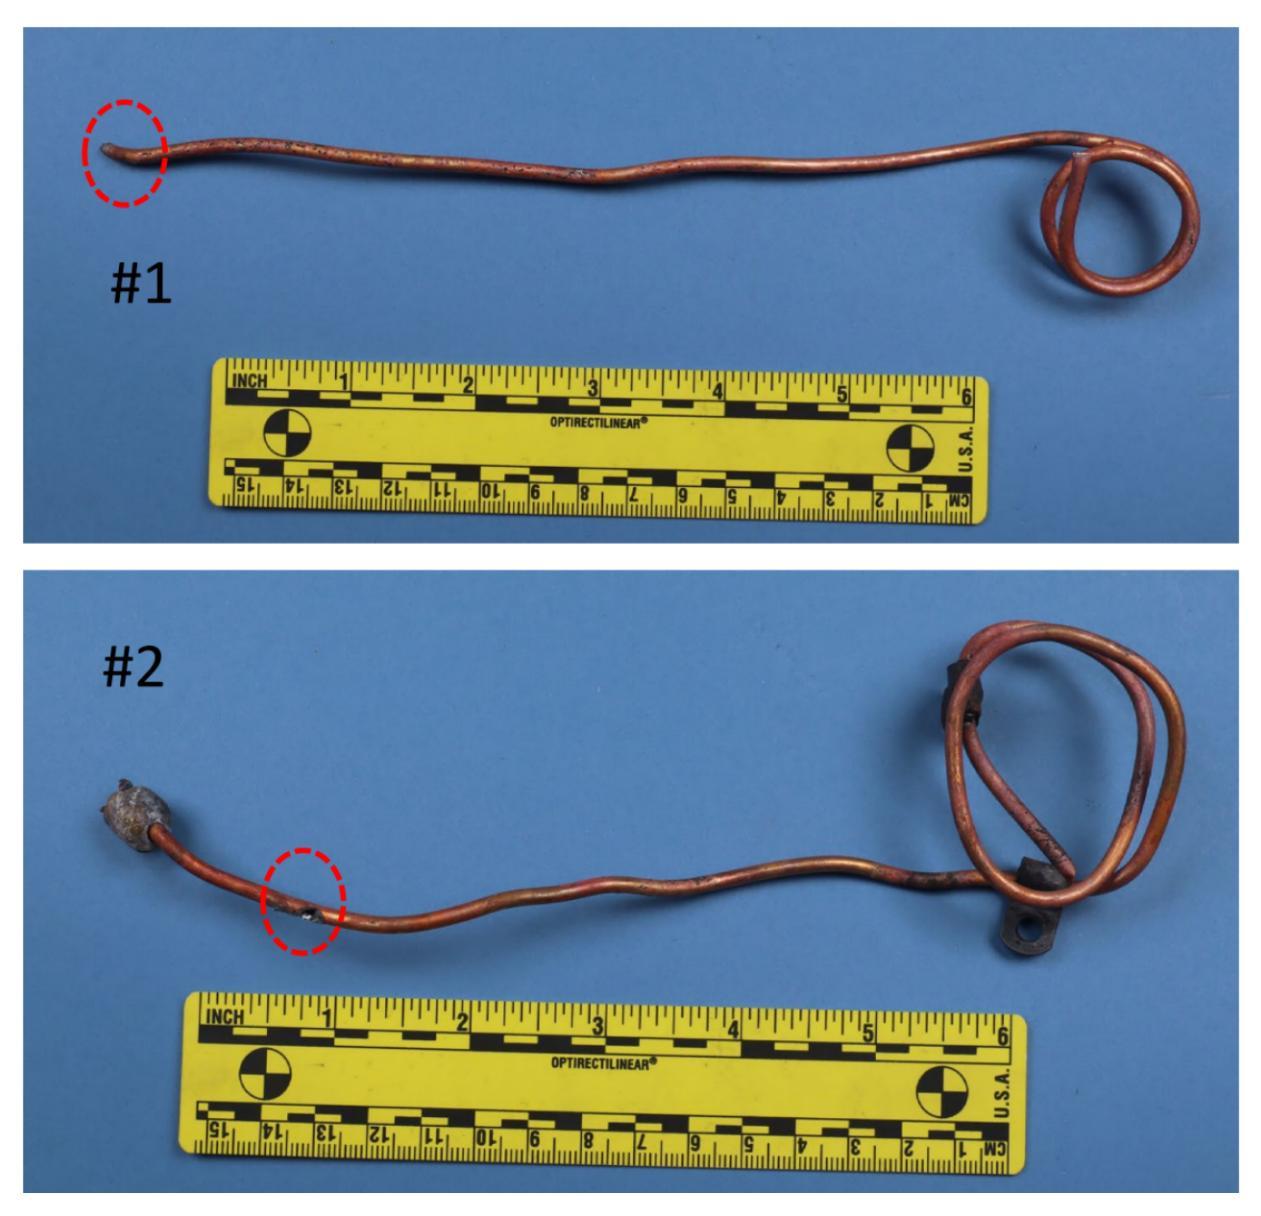
Additional examination revealed that the fuel primer lines comprised 99.6% copper tubing that measured about 0.125 inches in diameter. The lines could not be positively correlated to the suction and pressure sides of the pump. One of the lines exhibited a melted and tapered end. The other line exhibited areas of varying damage, including areas consistent with melting and re-solidification, as well as an area where the damage had penetrated the tubing through its full thickness. (See Figure 2.)

Figure 2. Localized melting of fuel primer lines

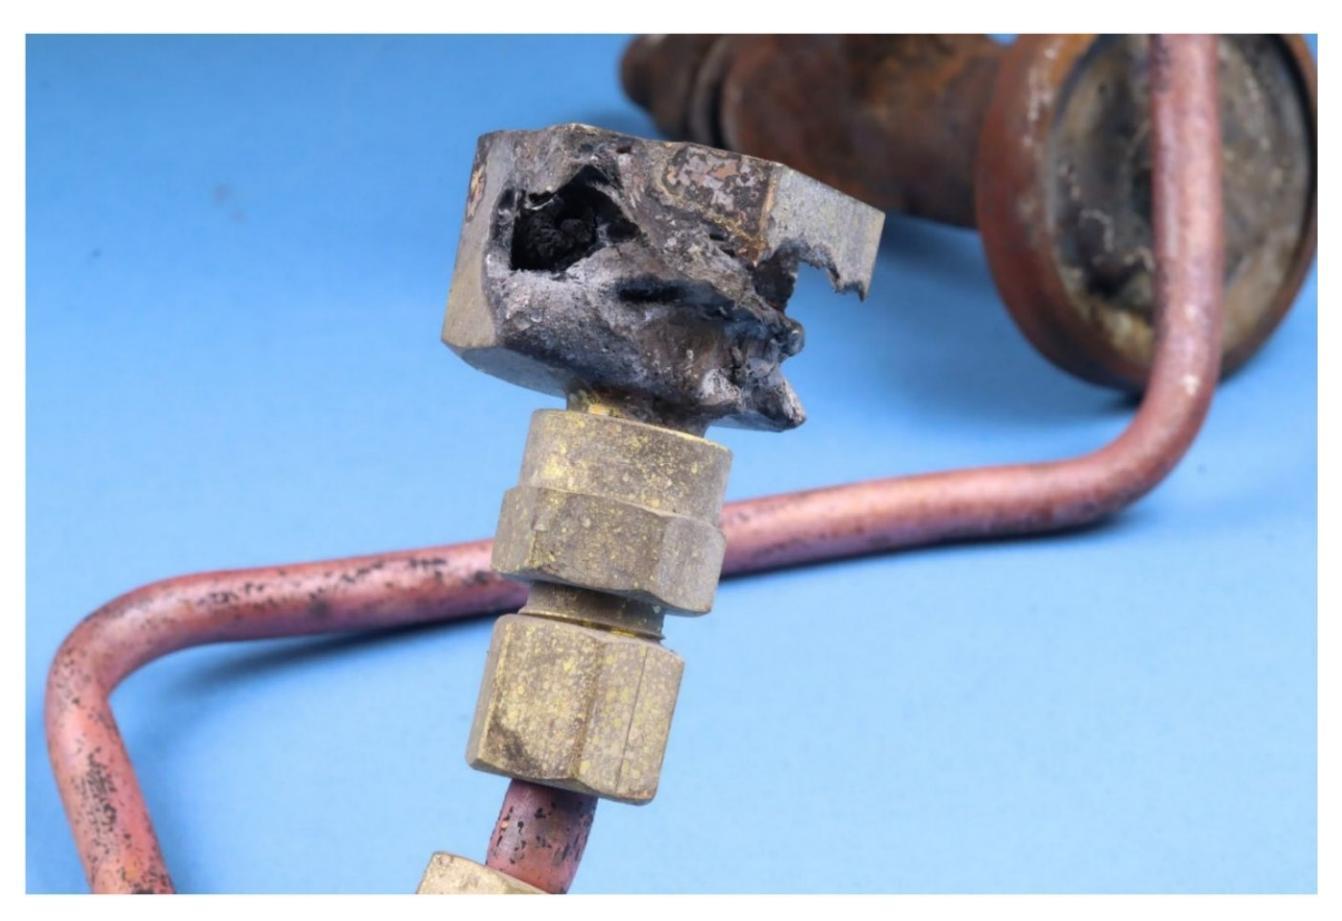
It is likely that an intermittent electrical short circuit took place involving the fitting on the end of the oil pressure indicating line. Repeated electrical arcing eventually compromised the fitting enough to allow oil leakage and eventual ignition of the leaking oil, which resulted in an in-flight fire.

The tee fitting exhibited a concentrated region of melted and missing material. In some areas, the melted region was flanked by intact material on either side. Some of the margins between the melted and intact material exhibited a scalloped-like appearance. (See Figure 3.) The morphology of the melting exhibited by the fitting was consistent with localized extreme temperature, such as that generated by electrical arcing. The tee fitting, branch line, and melted end fitting were not part of the original oil pressure line design, and what had been connected to the melted fitting was not determined.

Figure 3. Localized melting of oil pressure line tee fitting.
