Aviation Investigation Final Report

Location:	Alcova, Wyoming	Accident Number:	WPR23FA137
Date & Time:	March 21, 2023, 16:01 Local	Registration:	N314FR
Aircraft:	Cessna 182S	Aircraft Damage:	Substantial
Defining Event:	Loss of control in flight	Injuries:	1 Fatal
Flight Conducted Under:	Part 91: General aviation - Aerial observation

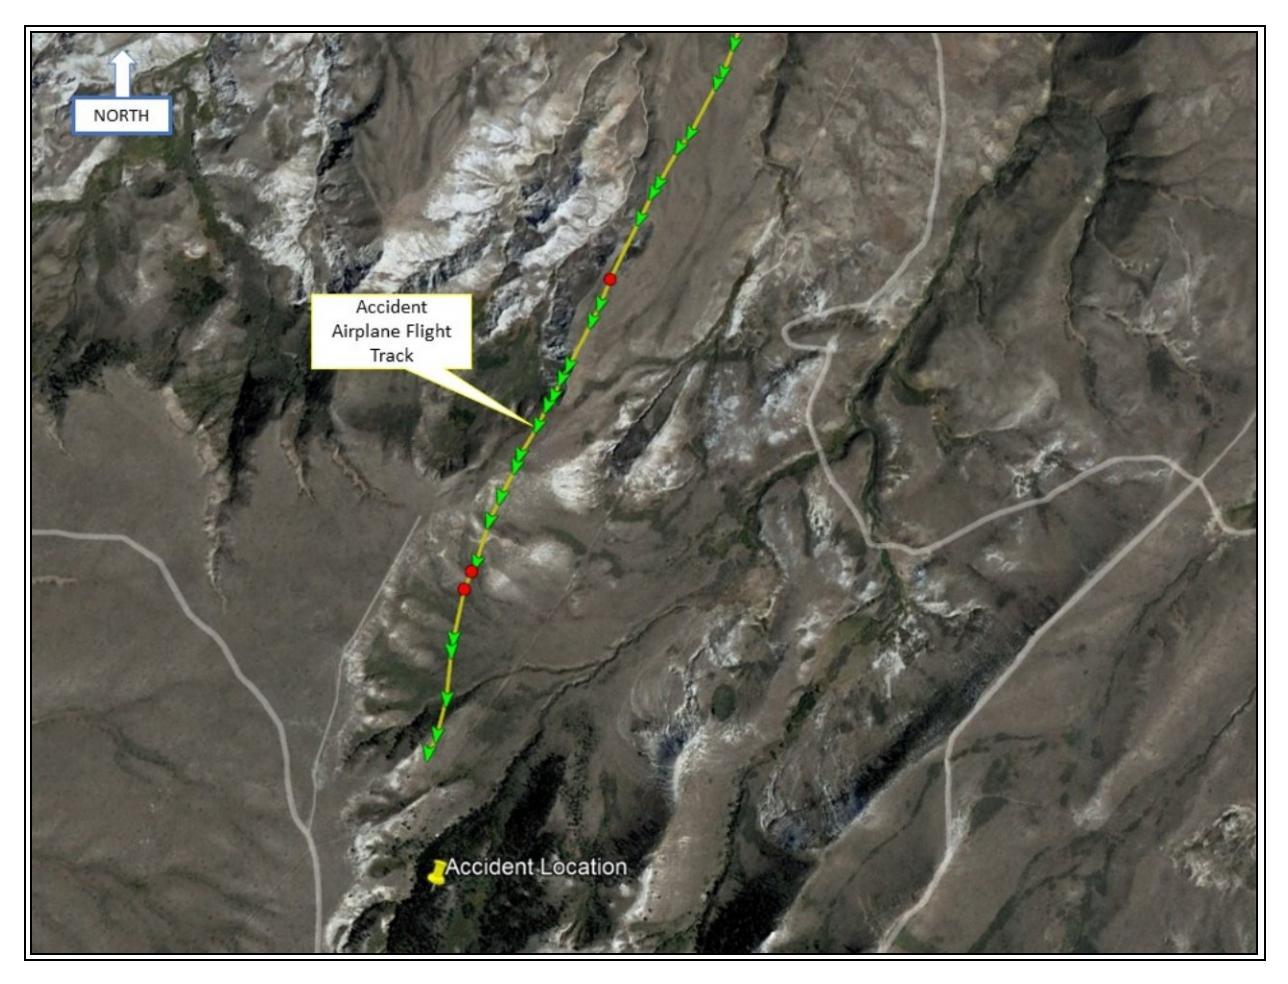
Figure 1. View of accident airplane ADS-B flight track data

The pilot was conducting a low-altitude pipeline patrol flight in day visual meteorological conditions when the airplane descended and impacted terrain. According to the flight track data, the airplane overflew Casper, Wyoming, and then turned to a southwest heading for about 30 miles until radar contact was lost; the airplane's altitude was about 600 ft above ground level (agl) and about 950 ft northwest of the accident site.

Recorded automatic dependent surveillance-broadcast (ADS-B) data showed that the accident airplane overflew Casper at 15:40:48 and turned to a southwest heading for about 30 miles until data was lost at 16:00:44, about 950 ft northwest of the accident site, as seen in Figure 1.
