Aviation Investigation Final Report

Location:	Port Allen, Louisiana	Accident Number:	CEN23FA142
Date & Time:	March 26, 2023, 02:38 Local	Registration:	N441PD
Aircraft:	ROBINSON HELICOPTER COMPANY R44 II	Aircraft Damage:	Destroyed
Defining Event:	VFR encounter with IMC	Injuries:	2 Fatal
Flight Conducted Under:	Part 91: General aviation - Aerial observation

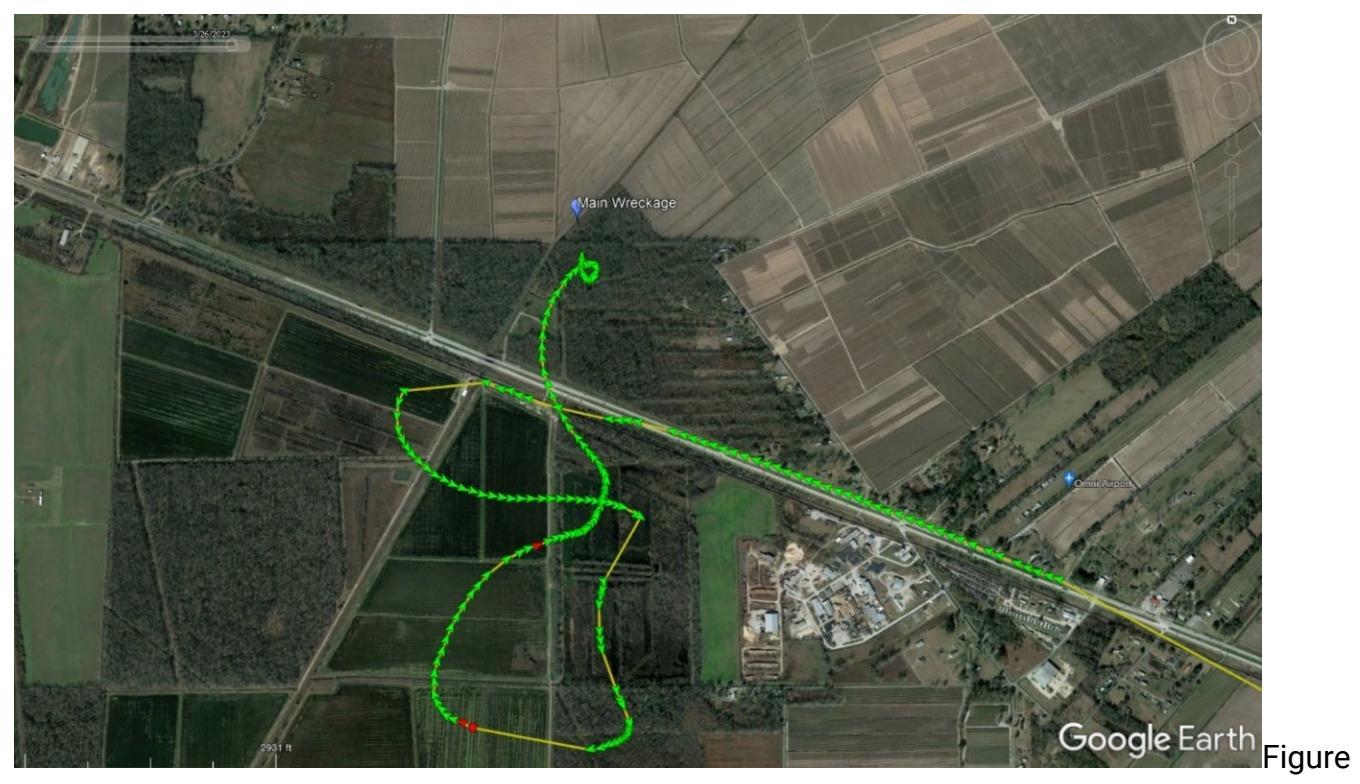
According to Baton Rouge Police Department (BRPD) personnel and ADS-B data, the BRPD helicopter, call sign Air 1, departed the Baton Rouge Metropolitan Airport (BTR), Baton Rouge, Louisiana, about 0226, to provide aerial support to BRPD ground units that were conducting a high-speed pursuit of a fleeing vehicle. Air 1 advised dispatch and ground units via radio that they were assisting and requested updates to the vehicle movement and location. ADS-B data showed the helicopter depart BTR to the south, turned west, then overfly Highway 190, west of Baton Rouge. Unable to maintain a safe pursuit of the vehicle, BRPD dispatch terminated the pursuit to all BRPD units, including the helicopter, via radio at 0235. There were no further communications received from the helicopter. About that time, the data showed the helicopter executed a shallow left deviation to the south of Highway 190. Following the deviation, a left turn was initiated and the turn rate increased. The initial turn was followed by a series of turns and altitude changes (see Figures 1 and 2). The ADS-B data ended at 0238 at an altitude of about 1,450 agl. There were no witnesses to the accident.

1. ADS-B data overlayed on Google Earth.

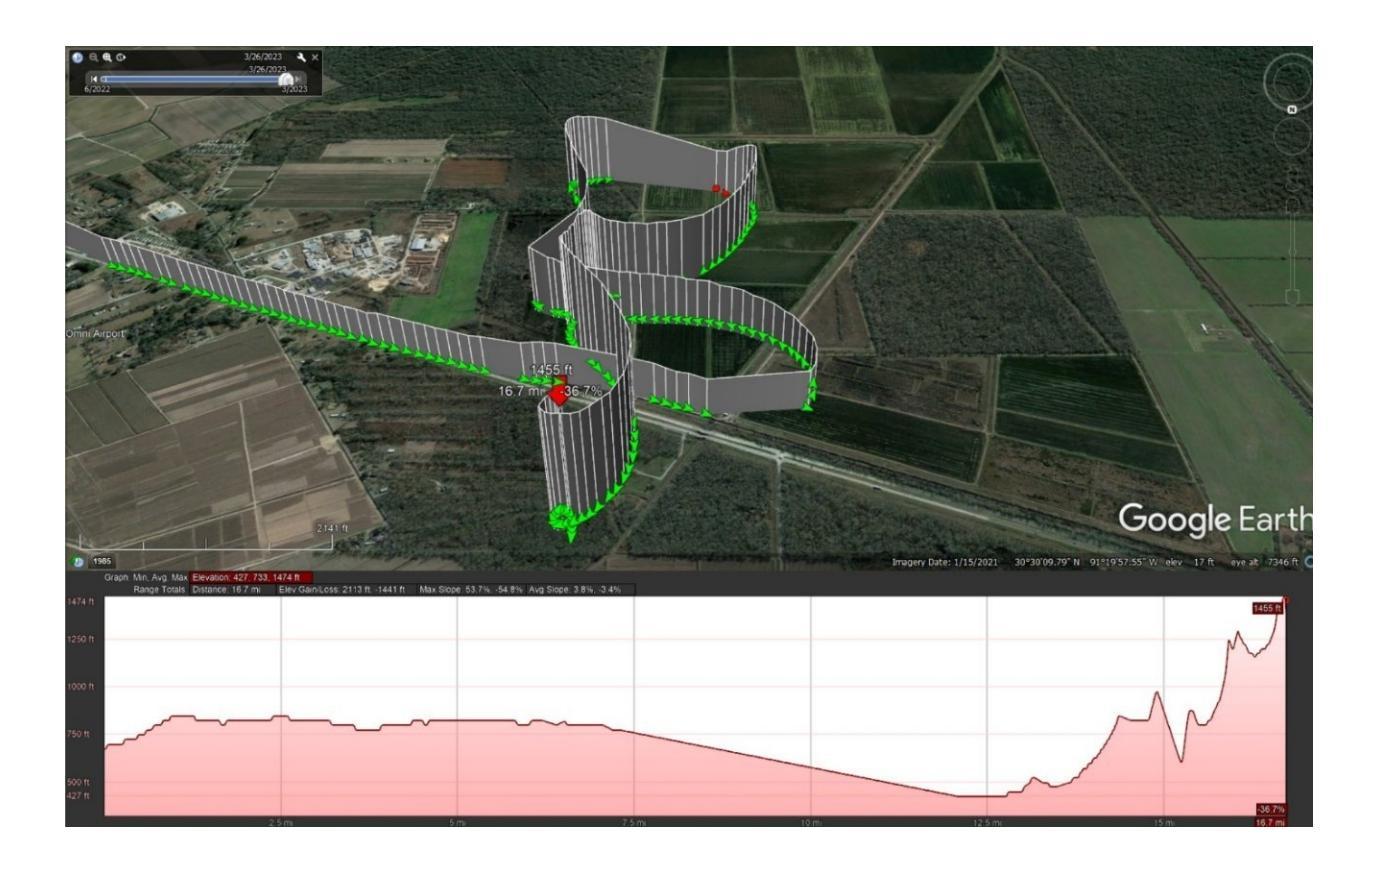
Based on available flight data and weather information, it is likely that the pilot continued the vehicle pursuit into deteriorating weather conditions. After termination of the pursuit, the helicopter's erratic maneuvers are consistent with the pilot experiencing spatial disorientation, a loss of control in flight, and inability to recover the helicopter.

Figure 2. ADS-B data overlayed on Google Earth with an altitude profile.

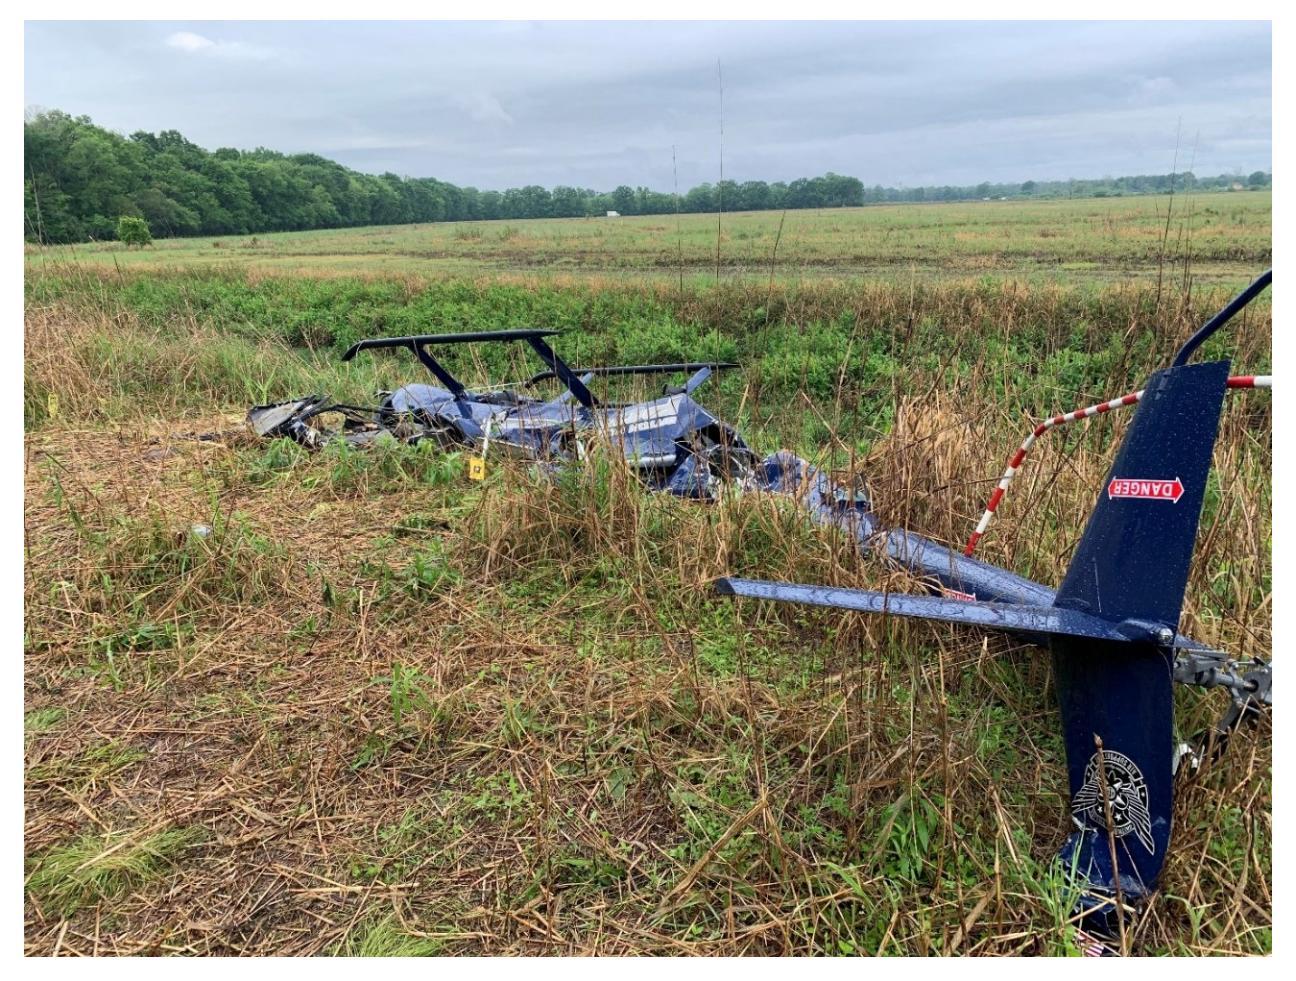
The main wreckage, which consisted of the cockpit, fuselage, and tailcone, came to rest inverted next to an irrigation ditch at the edge of a sugar cane field (see Figure 3).

Figure 3. Main wreckage at accident site.

Examination of the helicopter structure revealed impact signatures consistent with main rotor blade contact to the cabin structure above the forward looking infrared (FLIR) gimbal, to the top of the windshield bow and left seat passenger door frame. Main rotor blade leading edge damage and blade separation locations corresponded to the impact signatures on the cabin structure. Both elastomeric teeter stops were split horizontally through the middle. One main rotor blade spindle appeared to be straight or undamaged, and the other blade spindle was torn open at the coning bolt. The main rotor gearbox rotated one full revolution when it was manually rotated. The tail rotor gearbox was intact and free to rotate.
