Aviation Investigation Final Report

Location:	Covelo, California	Accident Number:	WPR24FA018
Date & Time:	October 20, 2023, 18:01 Local	Registration:	N8248K
Aircraft:	Beech A36	Aircraft Damage:	Destroyed
Defining Event:	Collision during takeoff/land	Injuries:	2 Fatal
Flight Conducted Under:	Part 91: General aviation - Personal

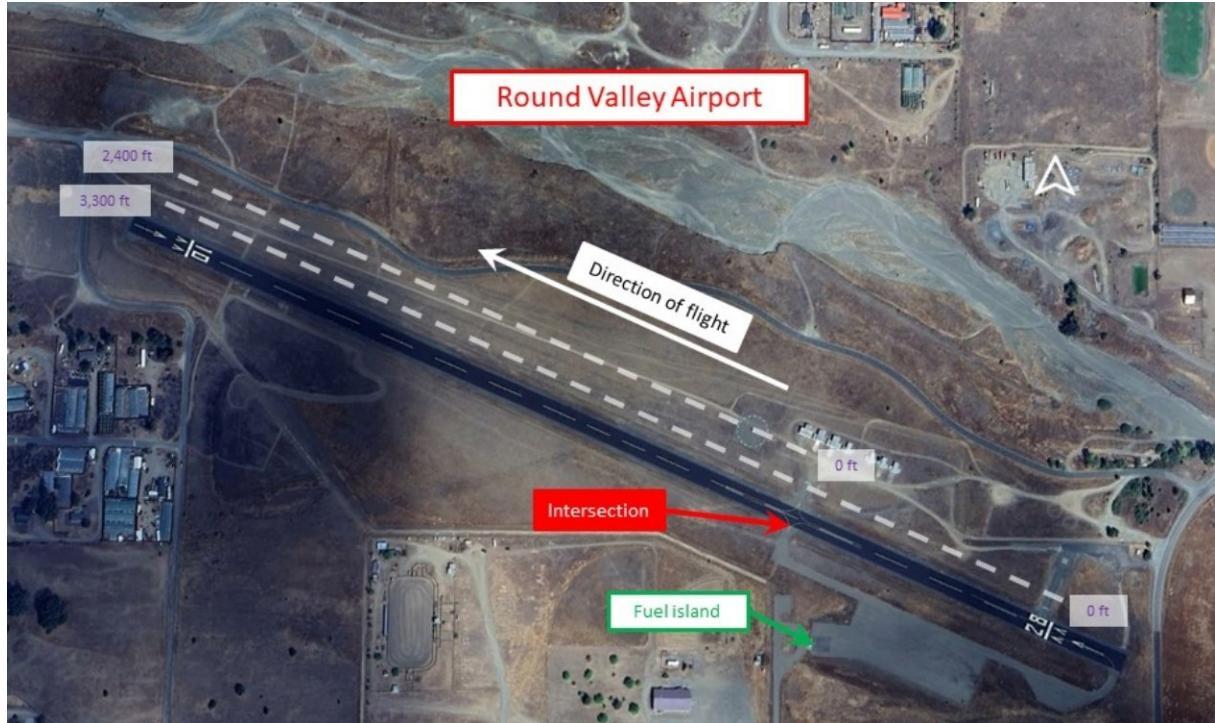
Figure 1: Airport fuel island and runway entrance

A taxiway and self-service fuel pump was located near the approach end to runway 28. (See Figure 1.) The distance from the taxiway intersection to the departure end of runway 28 was about 2,400 ft.

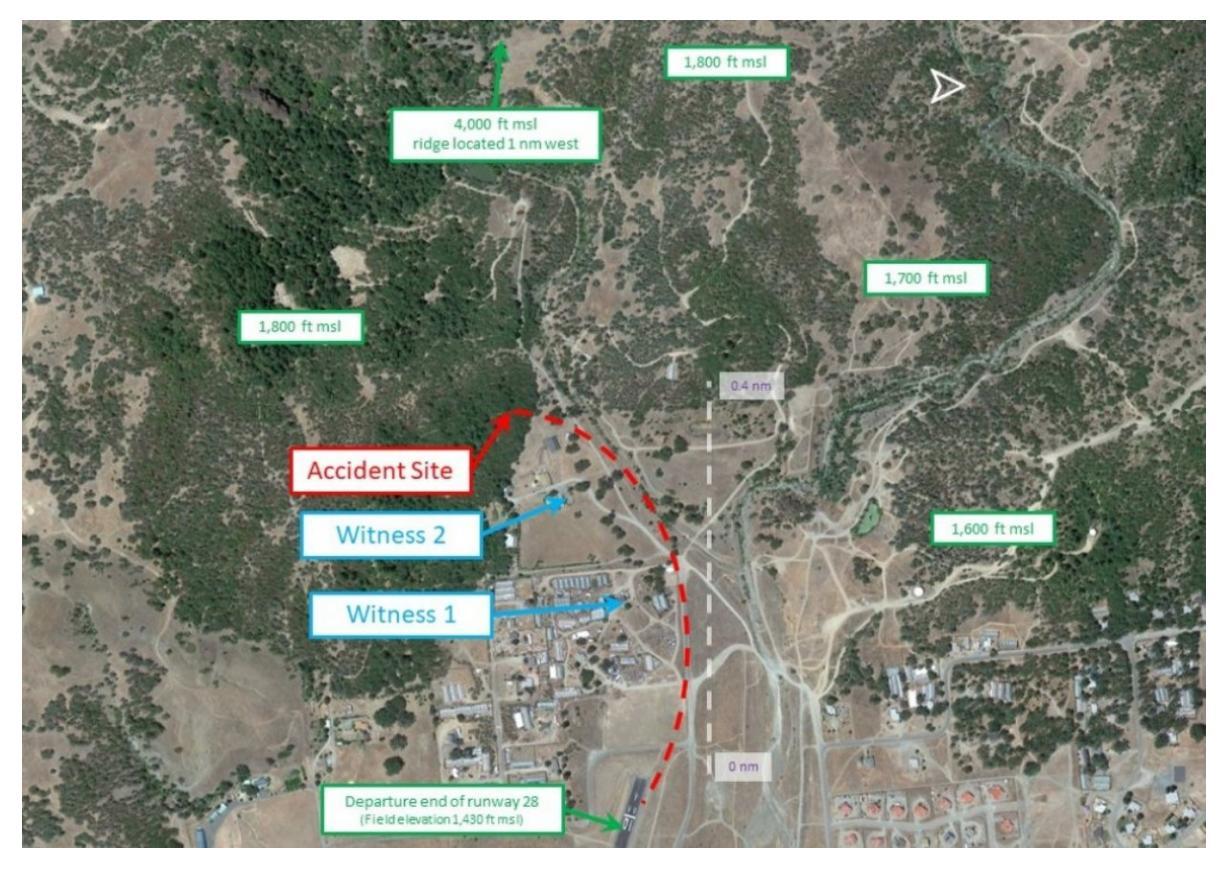
Figure 2: Flight path, accident site, and surrounding terrain

The airport was surrounded by mountainous terrain. (See Figure 2.) A review of the surrounding terrain showed 200 to 400-ft peaks between valleys immediately off the departure end of runway 28. In addition, there was an approximate 4,000-ft-tall mountain peak about 1 nm west of the runway 28 departure end. A resident who lived near the departure end of runway 28 reported that airplanes normally departed the other direction (using runway 10). The topography off the departure end of runway 10 was mostly flat and at the same field elevation as 009 for 2-4 nm depending on the direction of flight.

The Federal Aviation Administration chart did not describe the topography off the departure end of runway 28 including the peaks and valleys immediately off the end of the runway or the presence of a 4,000 foot-tall mountain peak about 1 nm west of the runway end.

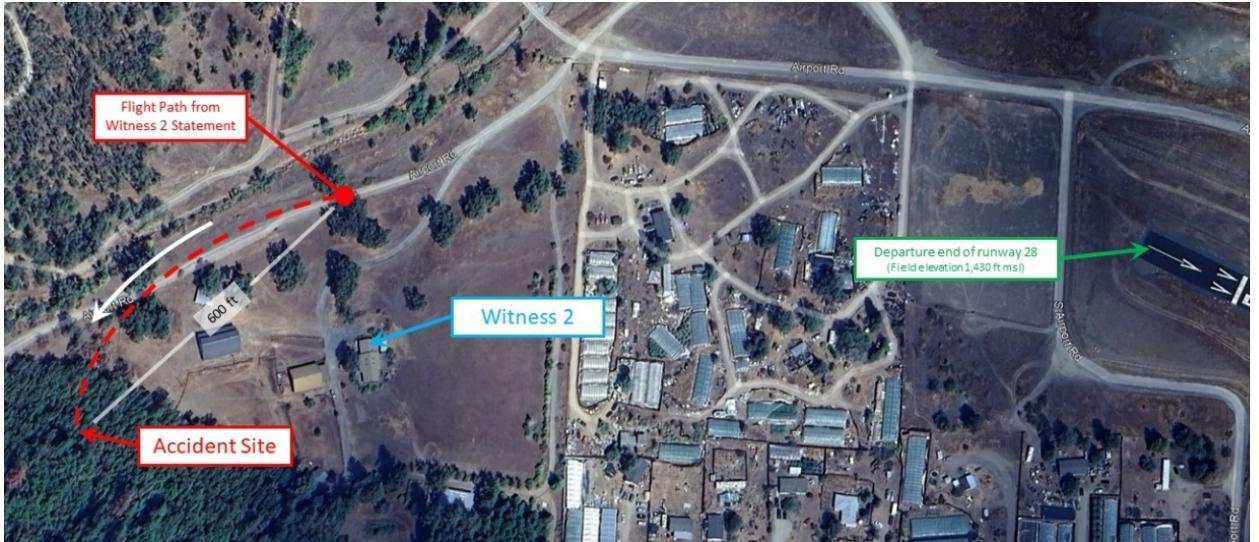
Figure 3: Start of turn and estimated distance

An analysis of the airplane's turning performance was completed using Figure 2.29 contained in the publication Aerodynamics for Naval Aviators (NAVWEPS 00-80T-80), based on a witness statement regarding where the turn began and the location of the wreckage. According to the chart, the bank angle required to maintain a turn radius of about 600 ft at an estimated true airspeed (TAS) of about 90 kts (84 kts KIAS) was about 51° given a constant altitude.
