Aviation Investigation Preliminary Report

Location:	Corona, CA	Accident Number:	WPR24FA056
Date & Time:	December 16, 2023, 11:50 Local	Registration:	N6948L
Aircraft:	DAVID B LUNN VANS RV8	Injuries:	1 Fatal
Flight Conducted Under:	Part 91: General aviation - Personal

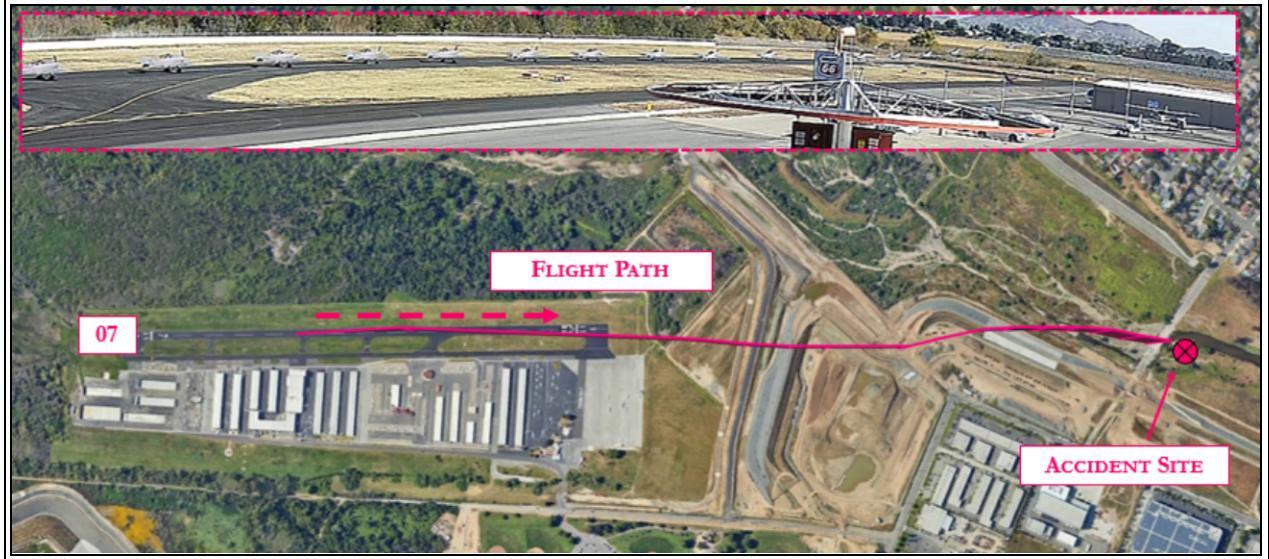
Figure 1: Showing the Flight Path with Video Excerpts Showing Takeoff

Witnesses reported hearing the airplane during the takeoff and remarked that the engine sounded as if was "missing" and producing partial power.

A review of the recorded security camera footage at the airport revealed that the airplane came into the frame at 11:49:23 when it was midway down runway 07, (passing by the fuel tanks) showing the wheels had not yet lifted from the surface. The airplane continued down the runway and rotated about 4 seconds later. Based on the distance and time, the airplane's speed was calculated to be 71 kts at the time of rotation and a sound spectrum analysis revealed that the engine rpm was about 2,500 at that time. The airplane climbed slightly, just passing over a berm at the airport's perimeter reaching a maximum altitude of about 95 ft above the runway. The estimated ground speed was 58 kts. Thereafter, the airplane descended and made a left turn, disappearing from the frame (see Figure 1 below).

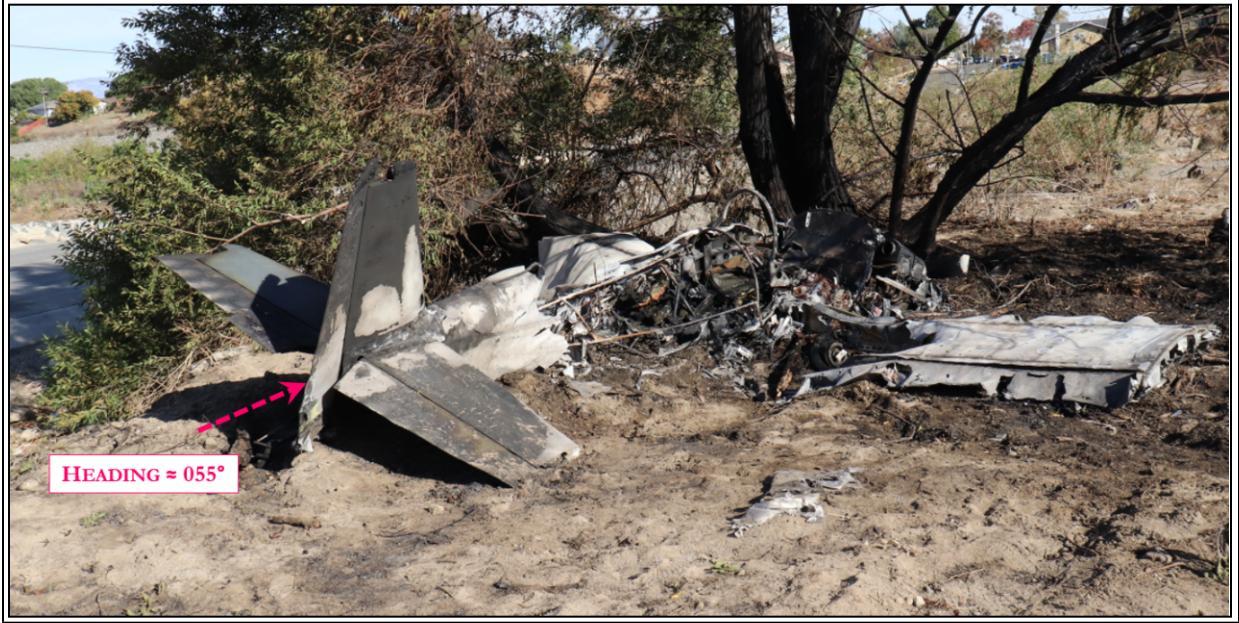
Figure 2: Main Wreckage

The accident site was located in soft dirt about 3,650 feet from the departure end of runway 25. In character, the terrain was located in a water-runoff and populated with large bushes, trees, tumbleweeds, and discarded trash. The main wreckage, consisting of the engine and remains of the fuselage, came to rest upright under a tree and had burned the terrain in the surrounding 5 to 10 feet.

The wreckage was consumed by post-impact fire and a majority of the fuselage, wings and skin panels were charred, with areas of ash and resolidified puddled aluminum. The directional path of the airplanes fuselage was on a magnetic bearing of about 055 degrees (see Figure 2 below). The entire airplane was located at the accident site with the exception of portions of the wheel pants and outboard left wing, which was all found in the debris path.

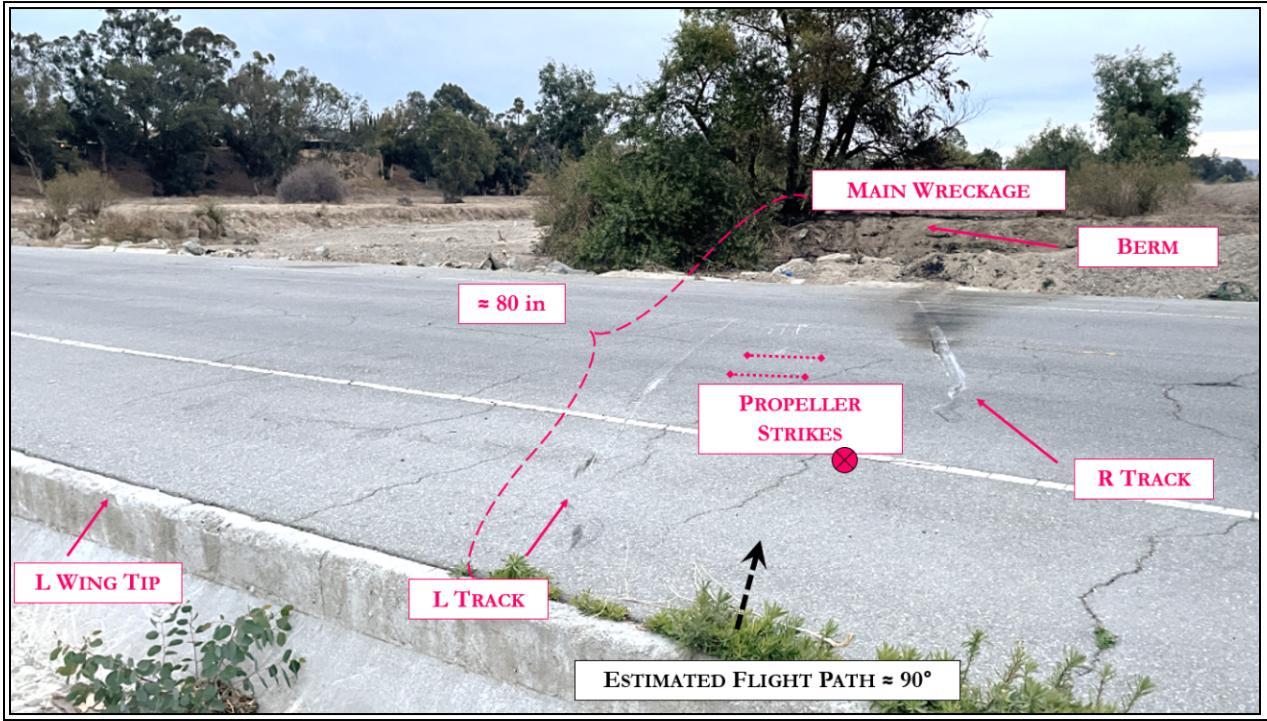
Figure 3: Debris Field Prior to Main Wreckage

The first identified points of contact consisted of disrupted concrete and paint transfers on the west side of the flat paved road, making up the far west end of the debris field. The initial impact mark was located between to powerline poles spaced 275 ft apart with numerous powerlines strung between about 30 ft above the ground. The first impact was a groove in the edge of the concreate wall making the lip of the road. There was paint transfers and a pile of paint chips adjacent to the divot, consistent with the left-wing tip (see Figure 3 below). Pieces of grey and white paint chips were scattered in the area as well as large portions of curved plexiglass that were similar in convex and hardware pattern to that of the wingtip-light housing.

About 85 inches south of the divot was a black smudge transfer on the road's surface, which continued toward the wreckage and made a left track. The debris path continued with grooves and indentations on the road making a parallel right track. There was a black residue over the right track as it continued toward the main wreckage. About 12 feet from the road's western lip were two 18 in gouges in the concrete that was oriented perpendicular and in between the two parallel tracks, consistent with propeller slashes.

The dimensions and orientation of the witness marks were consistent with the left wing impacting the road first followed by the left wheel and then the right wheel (see Figure 4 below).

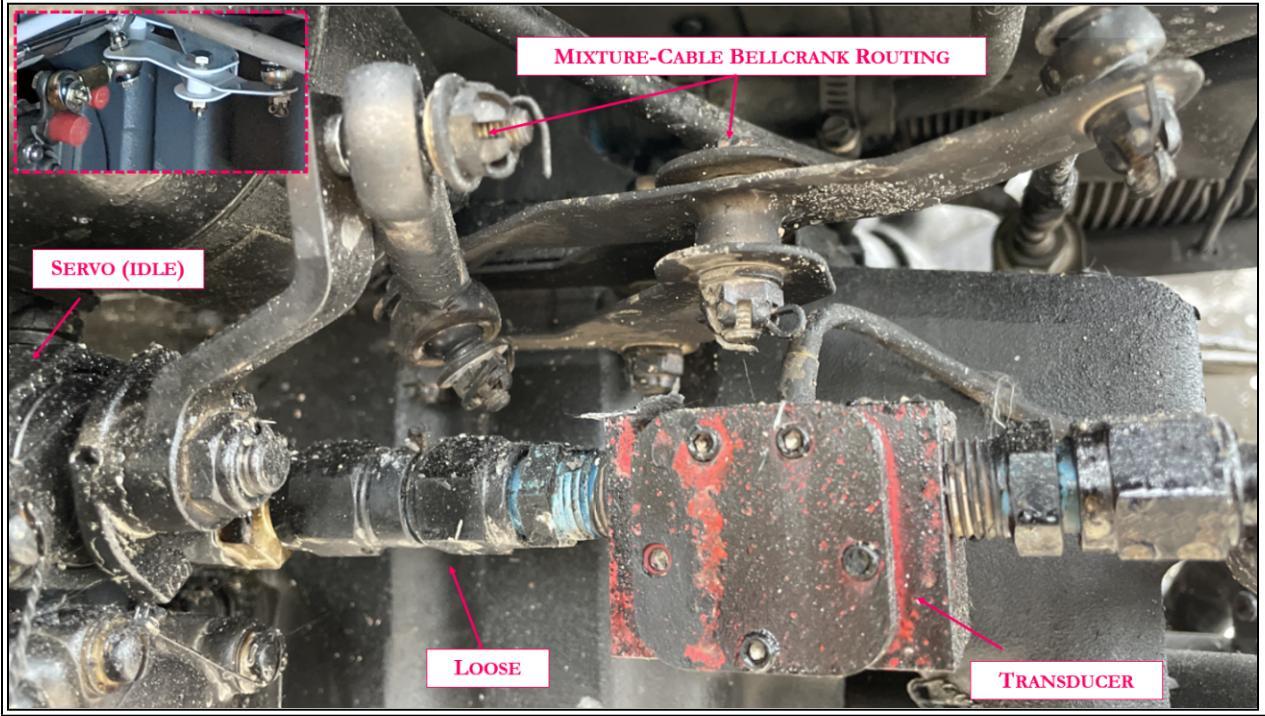
Figure 5: Transducer

The fuel line continued to the engine-drive fuel pump and then was routed forward under cylinder Nos. 4 and 2. After passing under the cylinders, there was an elbow inward where the line connected to a transducer. The transducer was not mounted, nor were the surrounding fuel lines (see Figure 5 below). The transducer and surrounding fittings lightly burned with their distinctive red and blue coloration predominant. There was evidence of a white material on the inboard threads of the fittings. The inboard fitting on the union from the transducer to the servo (throttle body) was loose and could be manipulated by hand. The mixture arm was in the idle position. The fuel distributor (spider) was disassembled revealing the diaphragm seal was present; there was no liquid contained in the body.
