# **Aviation Investigation Preliminary Report**

Location:	Concord, CA	Accident Number:	WPR24FA080
Date & Time:	January 30, 2024, 10:29 Local	Registration:	N30AK
Aircraft:	SWANSON R/SWANSON S RV-6	Injuries:	1 Fatal
Flight Conducted Under:	Part 91: General aviation - Personal

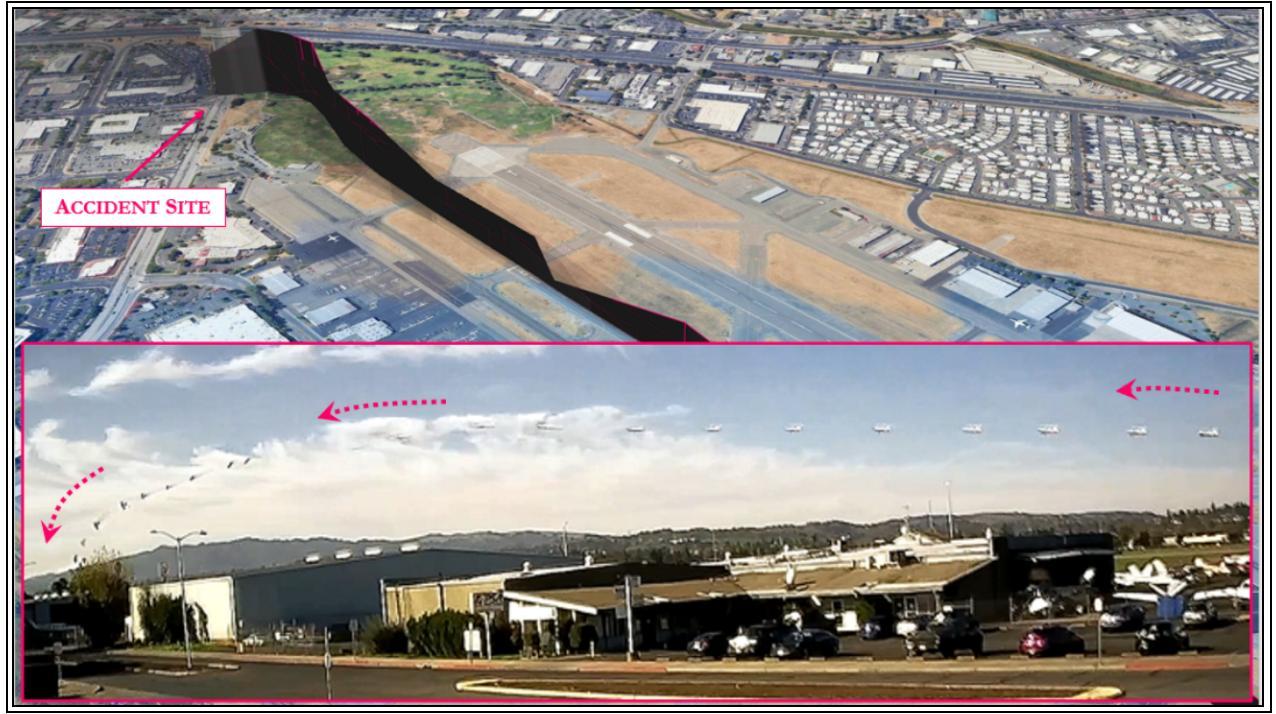
A review of preliminary Automatic Dependent Surveillance Broadcast (ADS-B) data provided by the Federal Aviation Administration disclosed that the pilot departed from runway 19L at Buchanan Field Airport (CCR), Concord, California, at 1019. The data showed that the airplane remained within the airport traffic patten for a series of five touch-and-go take-offs and landings. During the sixth take-off, the airplane climbed to approximately 300 ft mean sea level (msl) and began a descending left turn (see Figure 1). The last ADS-B target was at 1028:06, about 100 ft east of the main wreckage.

A review of security camera footage revealed that after the final take-off, the airplane entered a nearvertical nose-down descent. Numerous witnesses reported that they observed the airplane climbing and then heard the engine suddenly quit. The engine sound momentarily resumed, and the airplane started a brief climb. Seconds later, the engine noise stopped again, and the airplane banked left. As the airplane descended, the left bank increased.

Figure 1: ADS-B data with a composite image from a security camera recording. (Video courtesy of Contra Costa County Concord Airport Authority)
