Aviation Investigation Final Report

Location:	Farmington, Pennsylvania	Accident Number:	ERA16FA064
Date & Time:	December 11, 2015, 14:22 Local	Registration:	N72054
Aircraft:	Beech A36	Aircraft Damage:	Destroyed
Defining Event:	Loss of control in flight	Injuries:	3 Fatal
Flight Conducted Under:	Part 91: General aviation - Personal

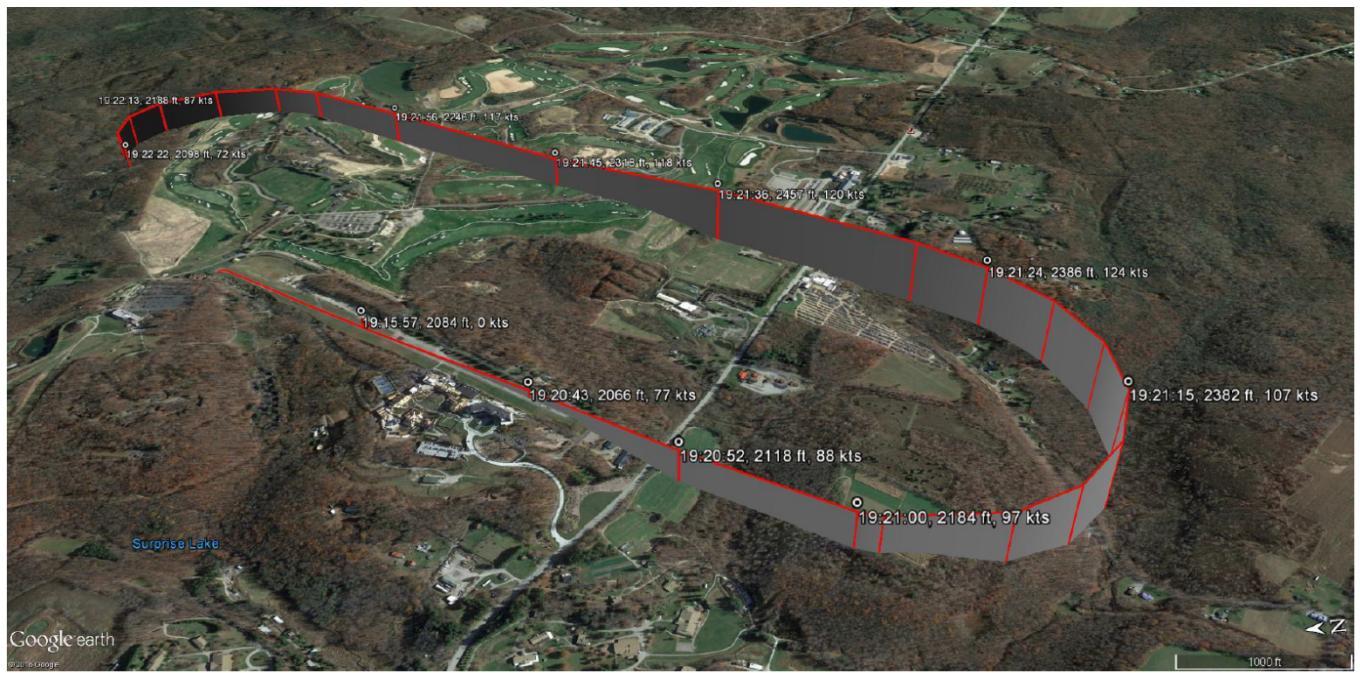
Figure 1. Plotted GPS Data - Complete Accident Flight.

An onboard GPS recorded data for the accident flight. The recording began at 1415:57 near the airport parking area. The airplane subsequently taxied to the end of runway 23 for takeoff. Recorded GPS altitude at this time was about 1,975 ft. The takeoff roll began at 1420:18. At 1421:00, at a GPS altitude of 2,184 ft and about 2,500 ft from the departure end of the runway, the airplane began a left, climbing turn. The turn continued, and the airplane reached a maximum recorded altitude of 2,457 ft at 1421:36. At this time, its position was consistent with a left downwind for runway 23. The airplane descended as it continued the downwind leg, then began a left turn about 1422. Shortly thereafter, the airplane descended through 2,150 ft at 69 knots groundspeed. The last recorded data point was at 1422:22.

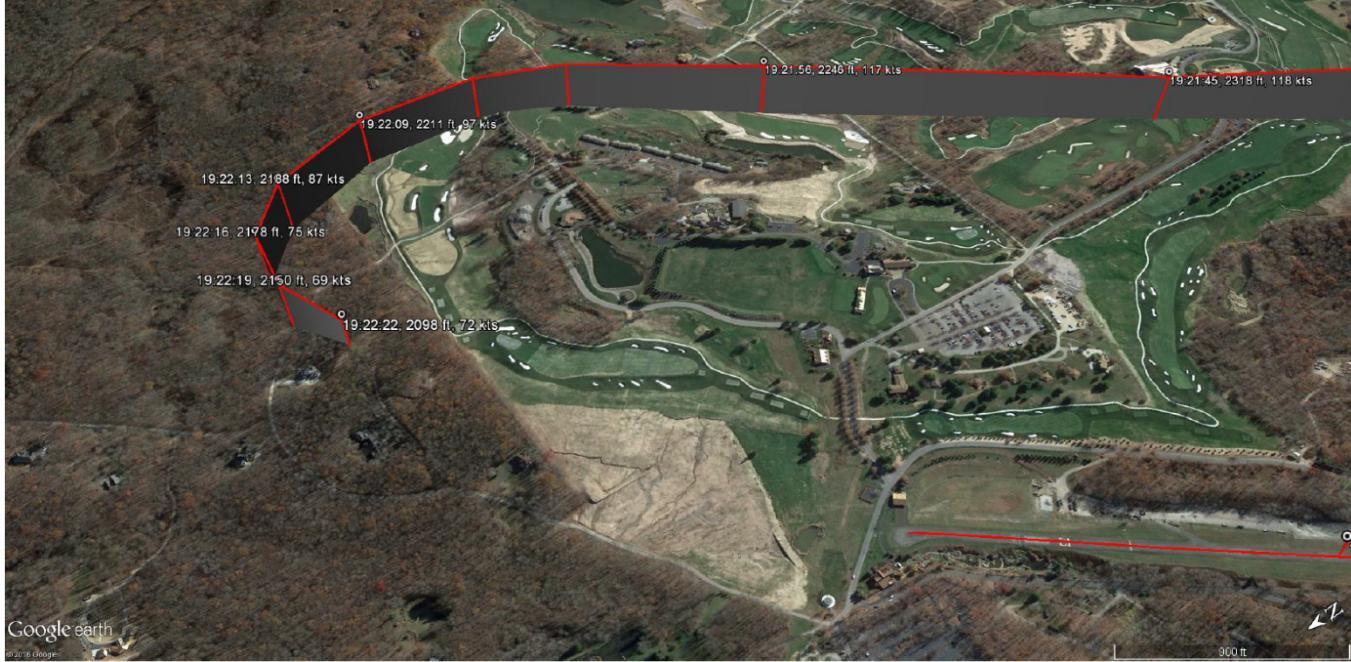
Figure 2. Plotted GPS Data – End of Accident Flight.

Review of the GPS data showed that the airplane's groundspeed dropped to 69 knots prior to its rapid descent. Calculations using the wind vector solutions function of an E6-B flight computer indicated that the true airspeed of the airplane at that point, would have been about 79 knots, which was below the published stall speed in the Beechcraft Bonanza Pilot's Operating Handbook (POH) for banked turns in excess of about 45°.
