Aviation Investigation Final Report

Location:	Gilmer, Texas	Accident Number:	CEN16FA083
Date & Time:	January 12, 2016, 19:54 Local	Registration:	N737EZ
Aircraft:	Cessna 172N	Aircraft Damage:	Substantial
Defining Event:	Fuel exhaustion	Injuries:	1 Fatal, 1 None
Flight Conducted Under:	Part 91: General aviation - Personal

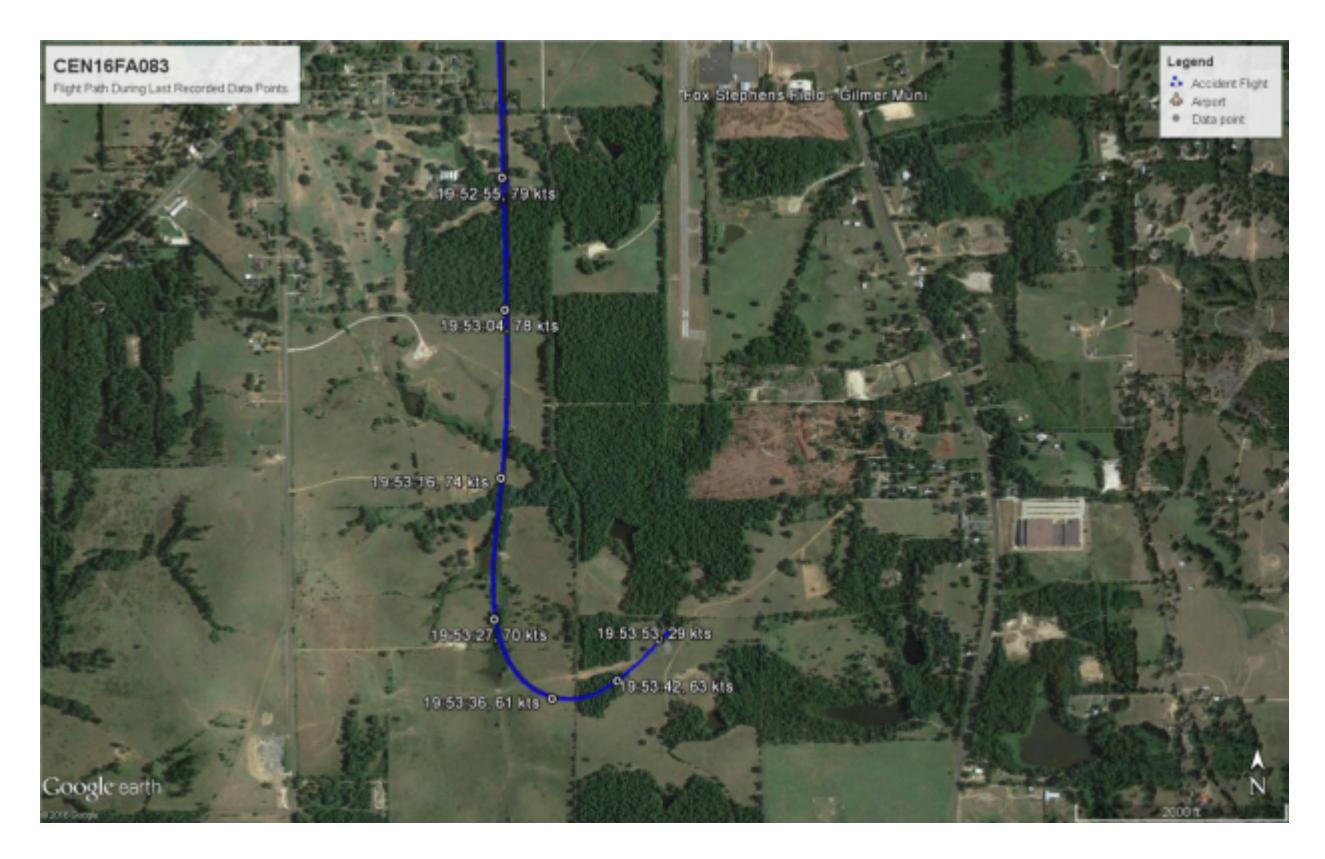
Recorded GPS data showed that the pilot flew the traffic pattern 400-600 ft lower than the recommended 1,000-ft above airport elevation and turned to the base leg of the traffic pattern farther from the runway than recommended. Had the pilot flown the traffic pattern at the recommended altitude and distance from the runway, it may have been possible for the airplane to glide to the runway following the loss of engine power.

During the last minute of flight, the airplane's speed steadily decreased from 79 knots to the last recorded speed of 29 knots. The GPS altitude also steadily decreased from 832 ft to 425 ft. At 19:53:16 the airplane was at 649 ft GPS altitude, 74 kts, and about 35 degrees past and .43 miles from the approach end of runway 36 at JXL. At 19:53:27 the airplane was at 583 ft GPS altitude, 70 kts, and about 55 degrees past and .62 miles from the approach end of runway 36.

Figure 1 shows the flight track the airplane followed, which is consistent with a left downwind and a left base leg for runway 36 at JXI, which had an airport elevation of 415 feet. The GPS track indicated the airplane began a turn for the left base when the airplane reached about 55 degrees past abeam the approach end of runway 36, as depicted in Figure 1.

Plot of recorded data points for the accident flight showing the accident location near JXI.

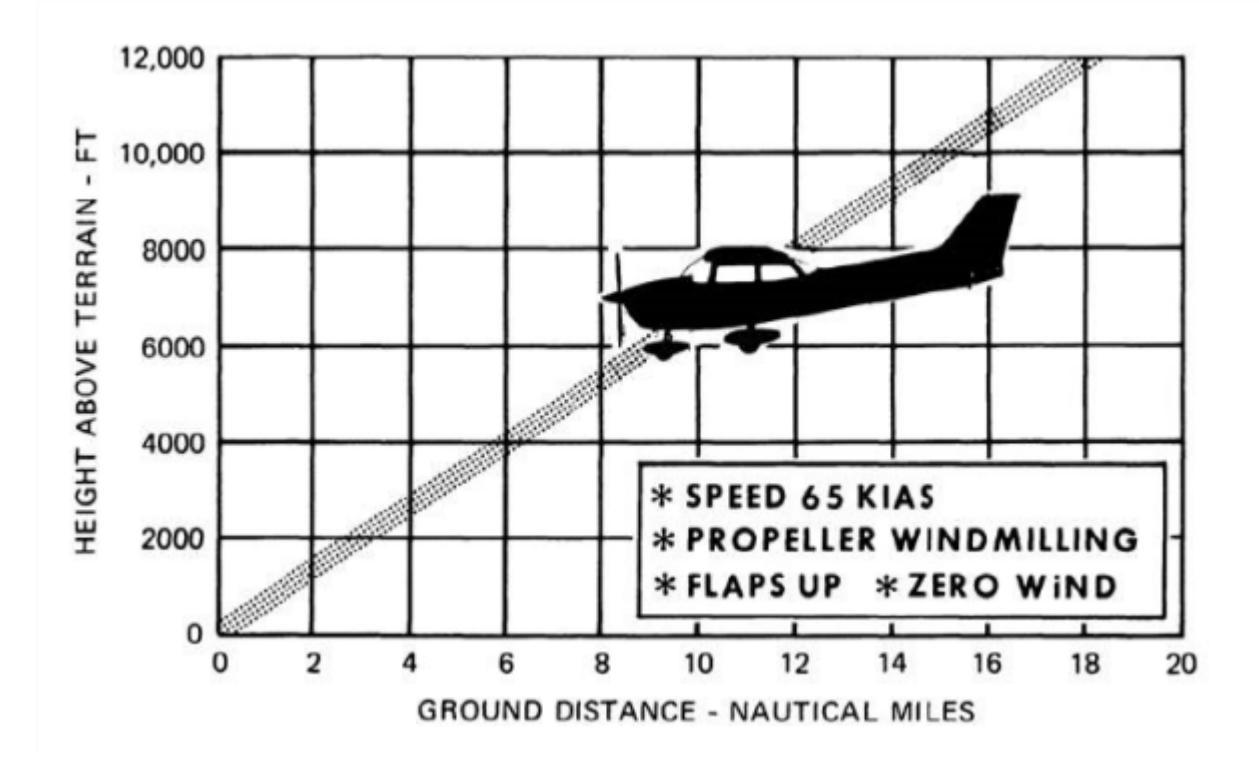
Figure 2.

The Cessna 172N flight manual chart for maximum glide distance shows an approximate glide distance of 1 nautical mile at an altitude of 500 ft above ground level with a speed of 65 knots indicated airspeed, propeller windmilling, flaps up, and zero wind.
