## **Aviation Investigation Final Report**

Location:	Rome, Georgia	Accident Number:	ERA16LA131
Date & Time:	March 14, 2016, 15:08 Local	Registration:	N465FL
Aircraft:	RAYTHEON AIRCRAFT COMPANY 400A	Aircraft Damage:	Substantial
Defining Event:	Runway excursion	Injuries:	1 Minor, 1 None
Flight Conducted Under:	Part 91: General aviation - Positioning

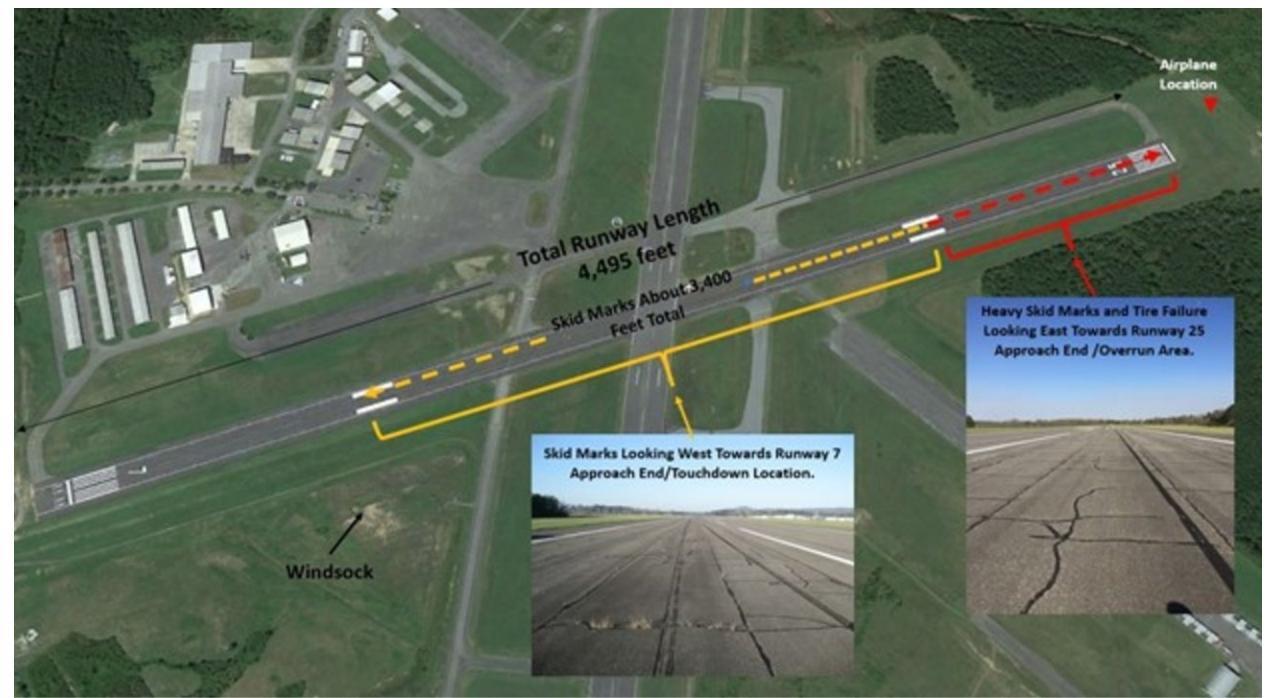
Tire skid marks were found beginning about 1,000 feet from the approach end of runway 7. The PF stated that the airplane touched down "abruptly at Vref+5 and he applied the brakes while the PM applied the speed brakes. Neither pilot felt the airplane decelerating, so the PF applied harder pressure to the brakes with no effect and subsequently applied full braking pressure. When it was evident that the airplane was going to depart the end of the runway, the PM applied the emergency brakes, at which point he felt some deceleration; however, the airplane overran the end of the runway and travelled through grass and mud for about 370 feet before stopping.

During a postaccident examination of the runway, tire skid marks were found beginning about 1,000 ft from the approach end of the runway 7. The tire marks swerved slightly toward the right about 20 ft right of the centerline and then slightly left toward the centerline and extended to the runway end. Further down the runway, the tire marks became increasingly more pronounced, flattened out, and widened. The tire marks continued and veered left through grass and mud for another 370 ft past the departure end of the runway, where the airplane came to rest (see figure 1).

Figure 1 - Overhead view of runway layout showing the approximate measurements of the skid marks and the airplane's final resting location.
