# **Aviation Investigation Final Report**

Location:	Reedsville, Wisconsin	Accident Number:	CEN16FA171
Date & Time:	May 4, 2016, 10:02 Local	Registration:	N629JK
Aircraft:	McDonnell Douglas Helicopter 369E	Aircraft Damage:	Substantial
Defining Event:	Loss of engine power (total)	Injuries:	1 Fatal
Flight Conducted Under:	Part 133: Rotorcraft ext. load

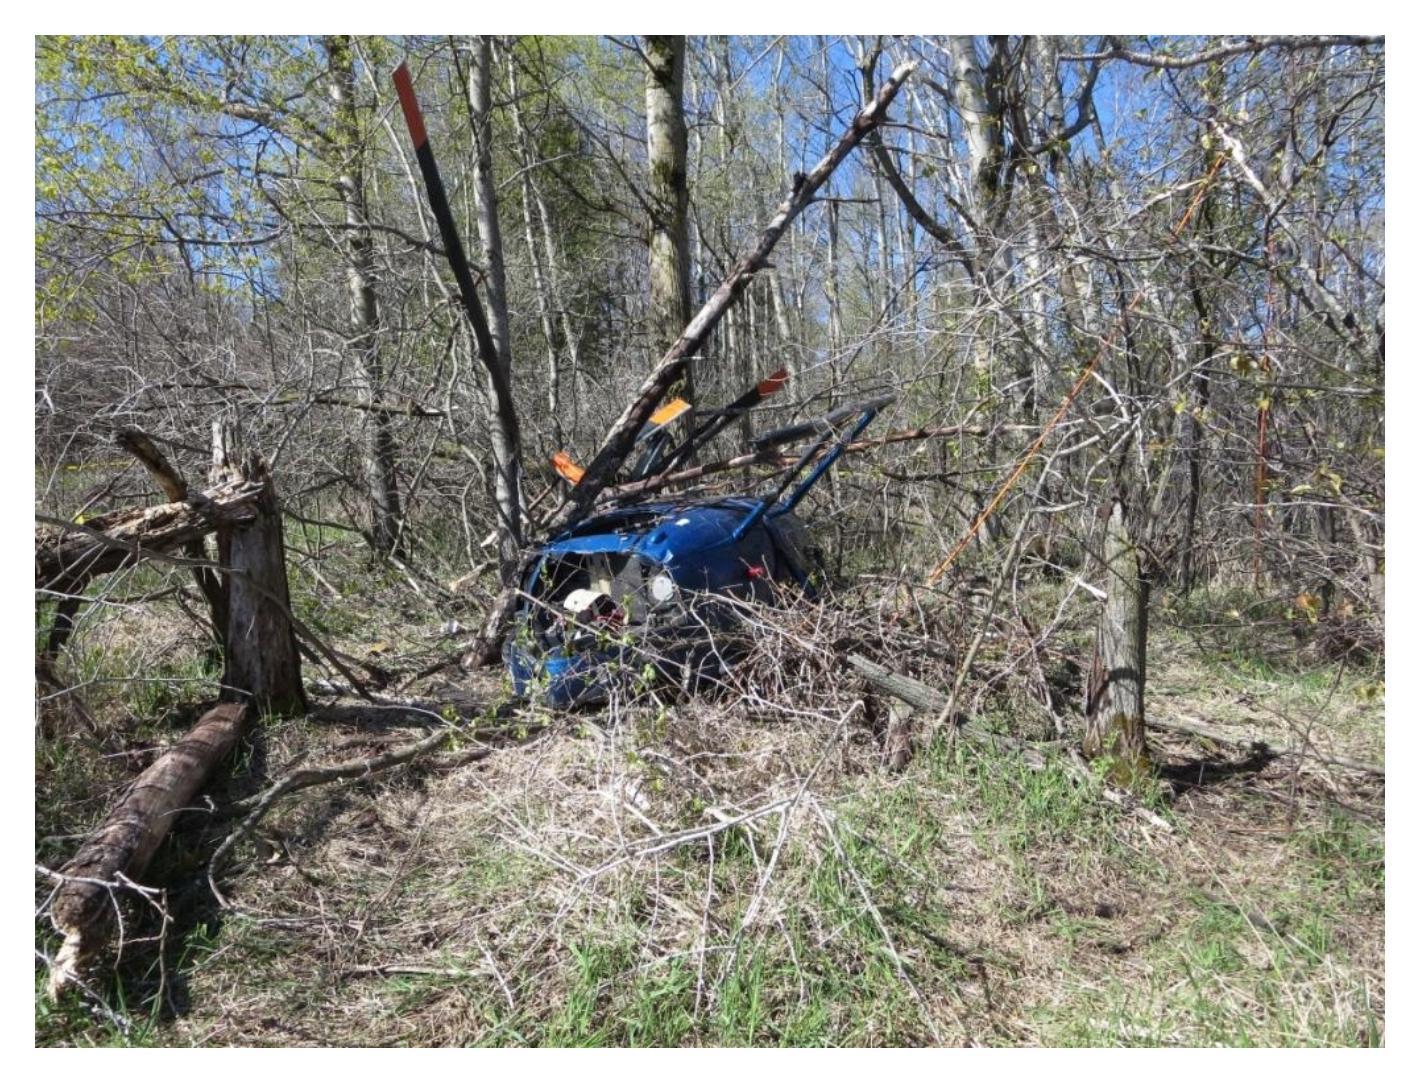
The helicopter came to rest in a wooded area about 125 ft south of tower 9904 (figure 4/5). The surrounding trees were 50 to 75 ft tall, and several of them were broken or showed signs of recent scaring and damage, consistent with the helicopter's impact sequence. All of the major components of the helicopter were found at the accident site. The long line remained attached to the cargo hook and trailed north toward the tower. There was an odor of Jet-A fuel around the main wreckage, and fuel was observed leaking from the helicopter. On-scene documentation was completed, and the wreckage was recovered to a secure examination facility.

#### Figure 4 – The accident helicopter surrounded by trees

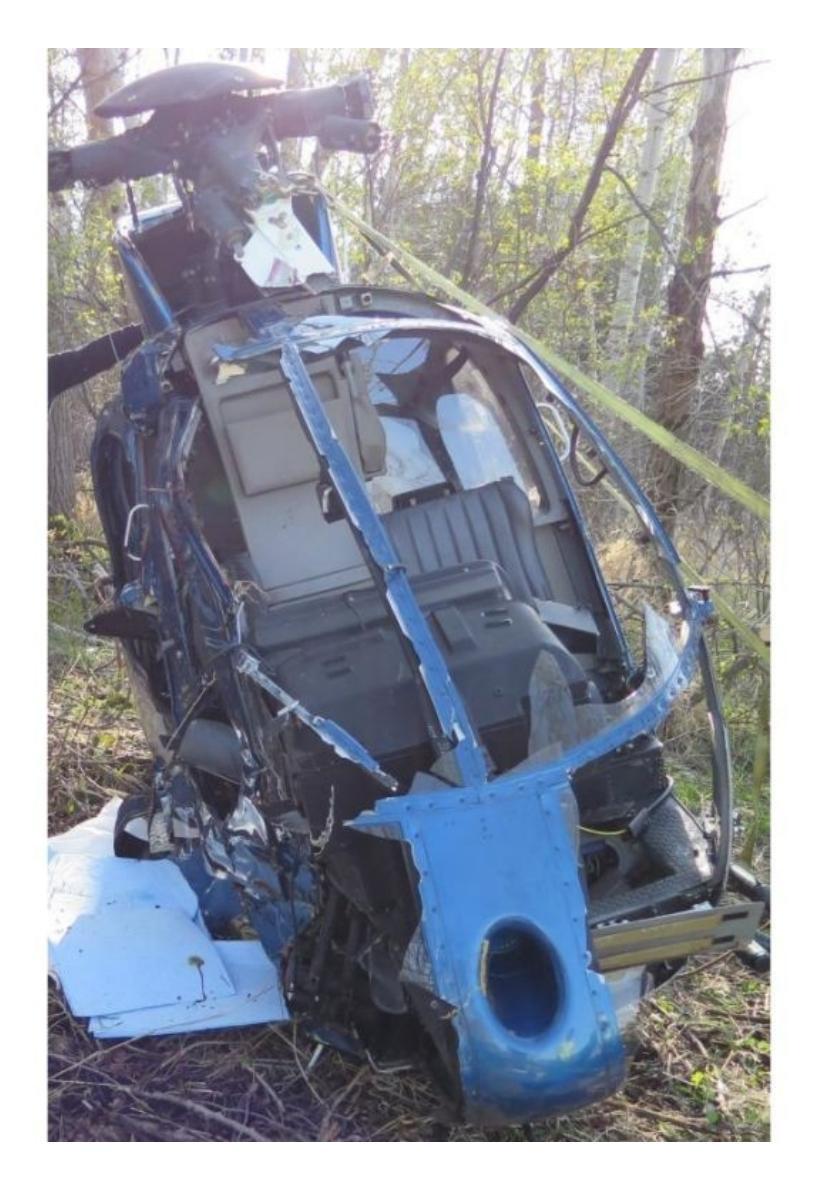
Figure 5 – Front view of accident helicopter damage

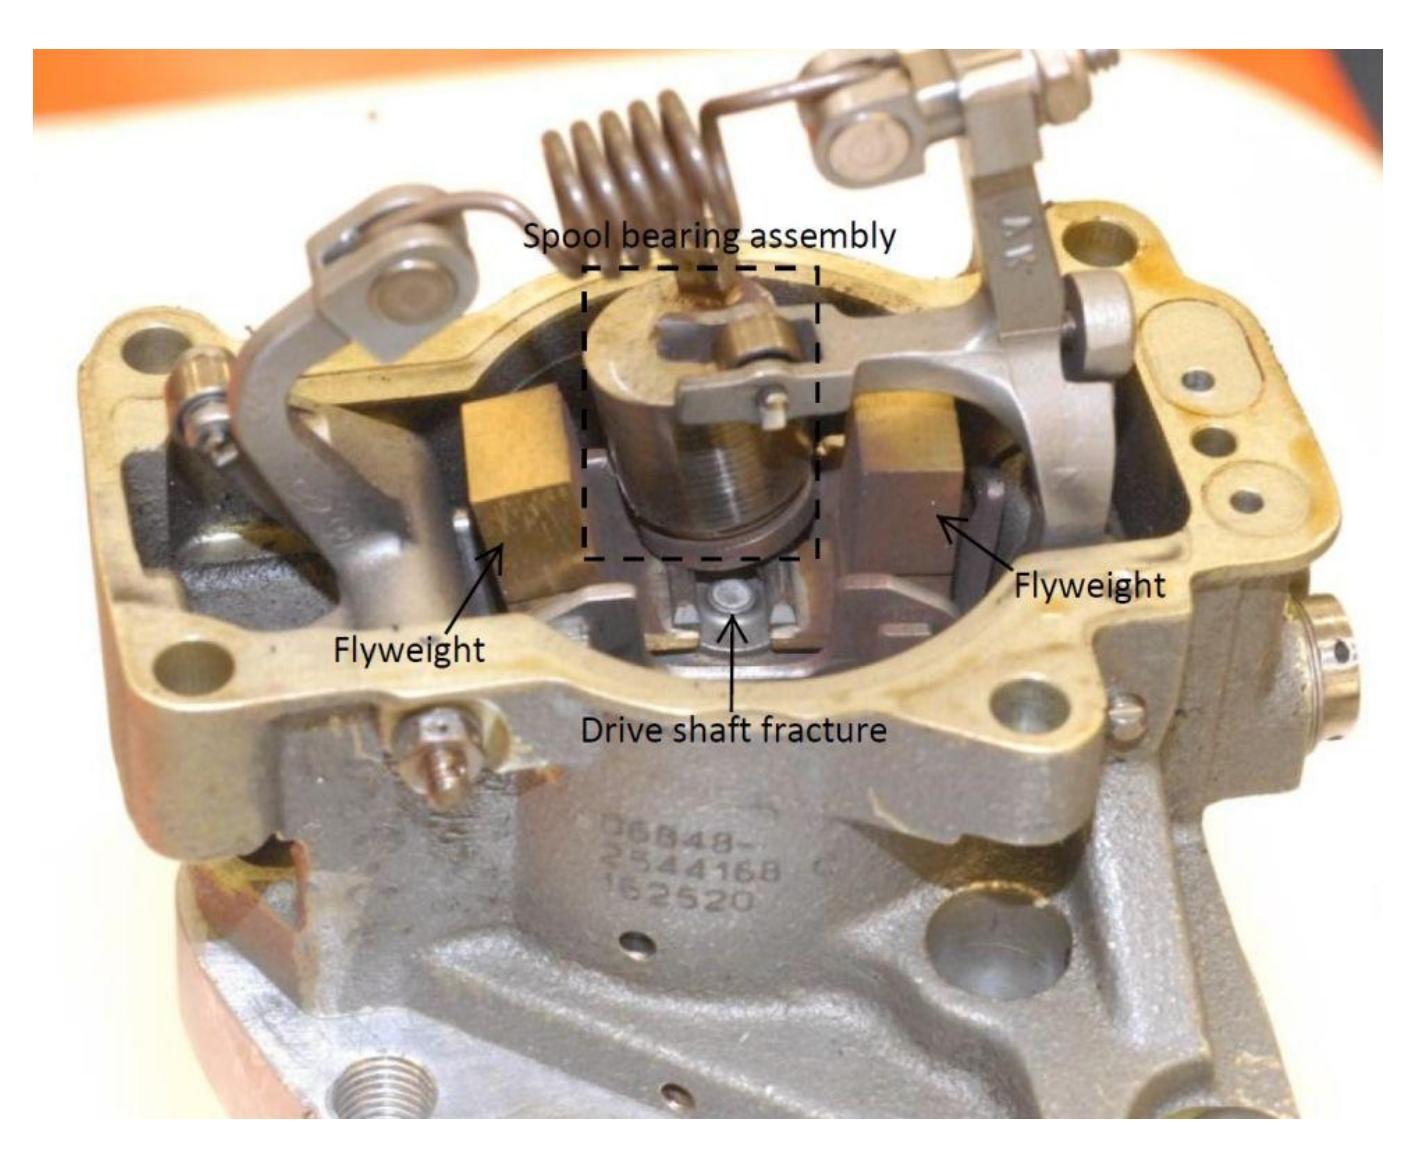
On August 9, 2016, the PTG, which was designed and manufactured by Honeywell, was disassembled and examined at a Honeywell facility under the auspices of the NTSB. A functional performance test could not be performed due to the internal damage. The examination revealed that the governor pressure (Pg) lever clevis fork was bent, and the spool bearing assembly was loose within the drive body cavity (figure 6). The drive shaft guide post was fractured and trapped within the spool bearing bushing. Metallic debris was found within the interior of both the drive body and the drive body cover. The internal bearing elements of the spool bearing assembly were seized and would not rotate. One flyweight was bent and did not pivot freely. The drive shaft was found fractured at the guide post and at the drive spline. The PTG was sent to the NTSB Materials Laboratory, Washington, DC, for further examination.

Figure 6 – Internal view of the PTG
