Aviation Investigation Final Report

Location:	Hickory, Kentucky	Accident Number:	ERA16FA248
Date & Time:	July 11, 2016, 11:23 Local	Registration:	N427TV
Aircraft:	BELL HELICOPTER TEXTRON CANADA 407	Aircraft Damage:	Substantial
Defining Event:	Flight control sys malf/fail	Injuries:	1 Fatal
Flight Conducted Under:	Part 91: General aviation

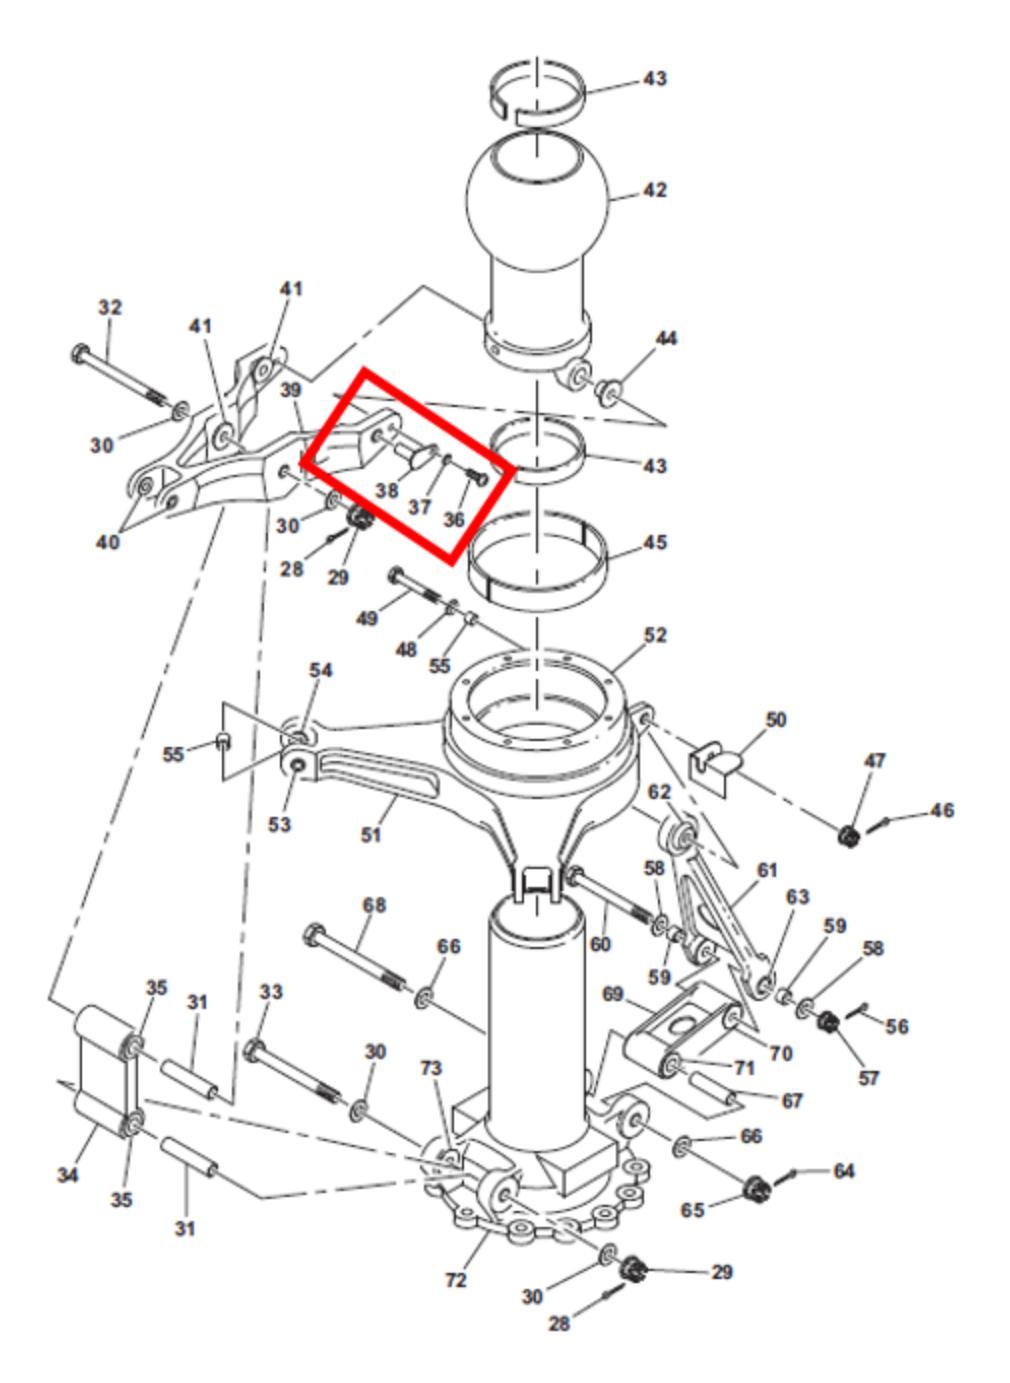
Company maintenance personnel's inappropriate removal without replacement of the safety wires on the collective lever pin screws during a recent maintenance inspection, which resulted in the screws backing out and led to a loss of collective control in flight.

The collective lever was located at the front and bottom of the swashplate support. The collective lever and collective control link were designed to move the pivot sleeve vertically on the swashplate support to change the pitch on all the main rotor blades simultaneously. The collective lever was attached to the pivot sleeve with screws, washers, and pivot pins (see figure 1). Once attached, the and the specified torque was applied, locking wire would typically be affixed to the screw.

Figure 1 - Swashplate support assembly, with collective pitch lever attaching hardware outlined in red.

The left collective control was not installed. Collective control continuity was confirmed through the right collective and up through the servo actuators to the disconnected collective lever. The two collective lever pivot pins and screws that attached the collective lever to the pivot sleeve were not installed. The pivot pins and screws were found on the transmission deck and on the ground underneath the right side of the helicopter. The flat washers and lockwire were missing; the washers were later found during a subsequent examination of the wreckage.

The collective lever and attachment hardware were sent to the NTSB Materials Laboratory for further examination. The collective lever, collective lever pins, collective lever pin screws, and washers were examined visually and by optical microscopy. All components were intact. Threads on the collective lever pin screws and the mating threaded holes in the collective lever were intact with no evidence of stripping. Holes for attaching lockwire were present in the

heads of the screws and at an adjacent area on the collective lever, but no lockwire was observed attached at either location. Deformation at the edges of the lockwire holes was noted. Circumferential scoring was present across the entire face on one side of one of the washers. On one of the screws, thread peaks were flattened near the middle of the shank on one side of the screw consistent with contact with the collective lever pin hole bore with the screw partially threaded into place.
