Aviation Investigation Final Report

Location:	Camilla, Georgia	Accident Number:	ERA17FA066
Date & Time:	December 5, 2016, 22:22 Local	Registration:	N765FA
Aircraft:	Fairchild SA227	Aircraft Damage:	Destroyed
Defining Event:	Loss of control in flight	Injuries:	1 Fatal
Flight Conducted Under:	Part 135: Air taxi & commuter - Non-scheduled

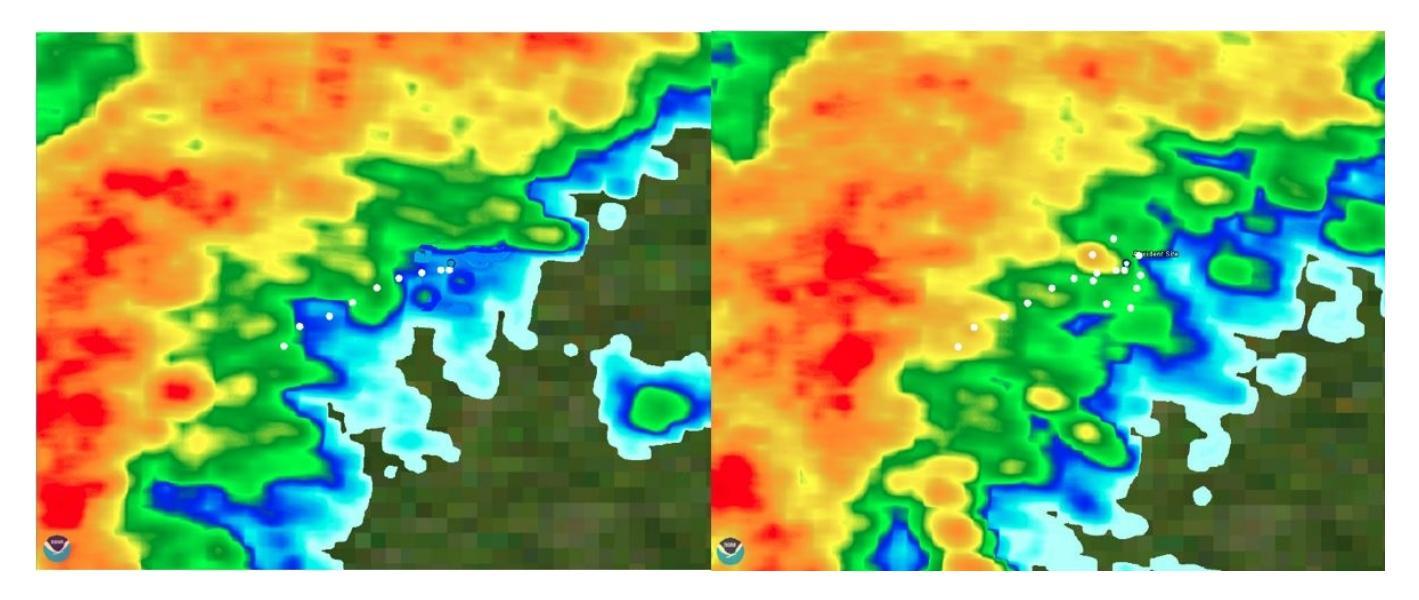
The KTLH WSR-88D base reflectivity image for the 0.5° elevation scan at 2221:47 (see Figure 1) showed the accident flight as it tracked along the leading edge of a line of heavy-intensity echoes, and operating in echoes of 5 to 20 dBZ, or light intensity precipitation. The next base reflectivity image for the 0.5° elevation scan at 2228:12 showed rapidly-developing echoes over the preceding flight track (which ended at 2222:24 in the vicinity of the accident site), with intensities of up to 43.5 dBZ or heavy-intensity precipitation.

Figure 1 - WSR-88D 0.5° base reflectivity image at 2221:47 (left) and 2228:12 (right) with radarderived flight track overlaid (white dots).

The base reflectivity image for the 0.5° elevation scan at 2234:39 continued to show echoes increasing in intensity over the accident site with reflectivity values between 40 and 52 dBZ, or heavy to extreme intensity. Several small bowing segments were also indicated to the southwest.
