Aviation Investigation Final Report

Location:	Port Orange, Florida	Accident Number:	ERA17FA074
Date & Time:	December 27, 2016, 17:56 Local	Registration:	N669WR
Aircraft:	INDEPENDENT TECHNOLOGIES INC EPIC LT	Aircraft Damage:	Substantial
Defining Event:	Loss of control in flight	Injuries:	2 Fatal
Flight Conducted Under:	Part 91: General aviation - Personal

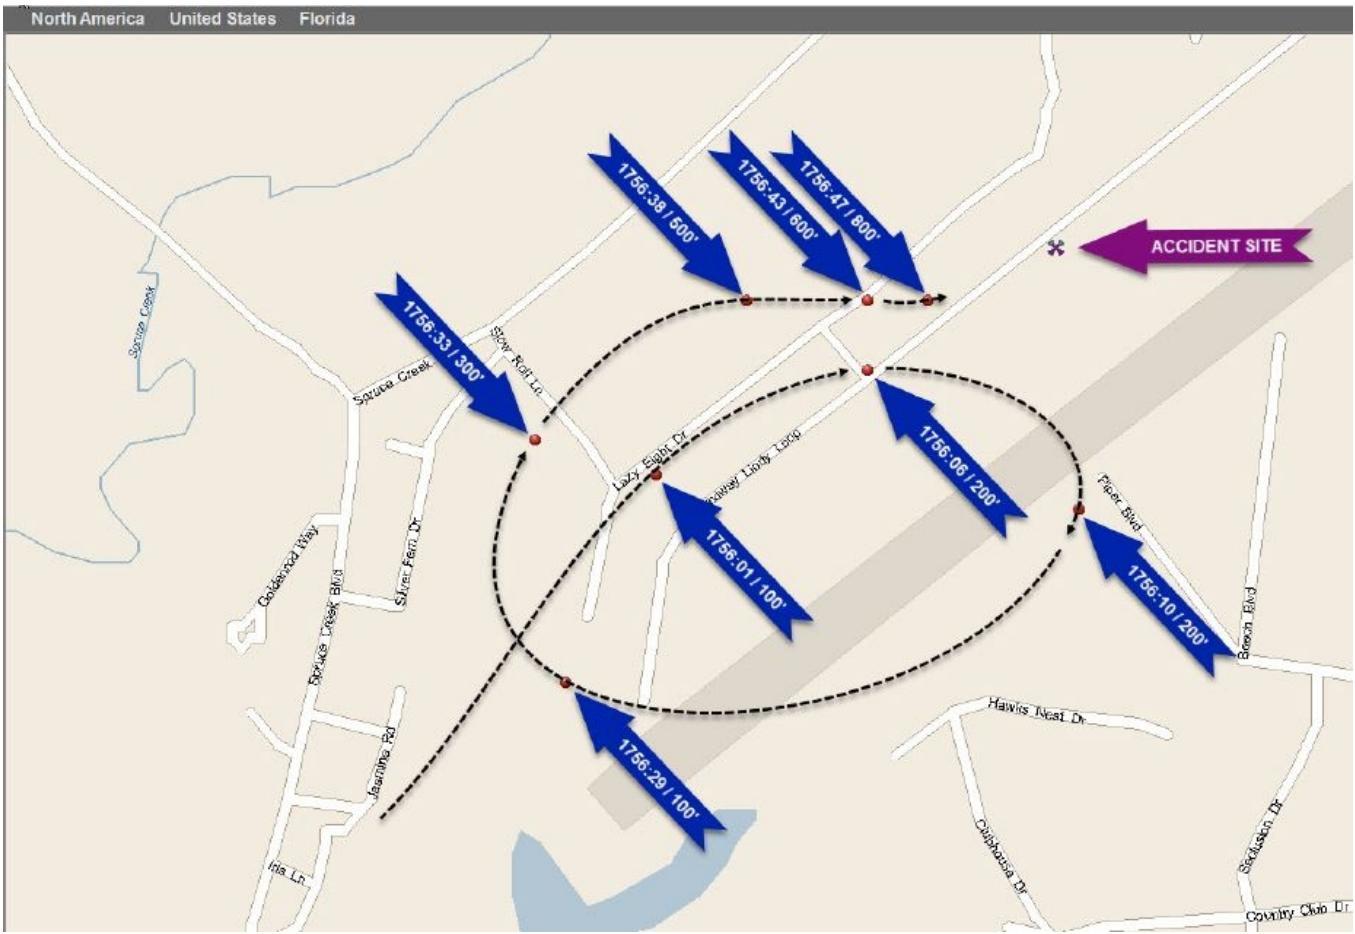
Figure 1. Radar Flight Track of Attempted Landing at 7FL6.

A review of radar data revealed that, during the final 46 seconds of flight, the airplane approached the airport on a northeasterly heading just north of the final approach course. At 1756:01, the airplane was abeam the runway numbers at an altitude of 100 ft mean sea level (msl) (76 ft above ground level) before it initiated a climbing right turn. During the turn, the airplane initially climbed to 200 ft msl then descended to 100 ft msl before climbing up to 300 ft. After completing a 360° turn, the airplane began to climb on a northeasterly heading. Over the next 14 seconds, the airplane climbed to 800 ft, while making a shallow turn to the right followed by a turn to the left before the data ended at 1756:47. The last radar return was near-coincident with the location of the accident site (See figure 1).
