# **Aviation Investigation Final Report**

Location:	Micanopy, Florida	Accident Number:	ERA17FA145
Date & Time:	April 4, 2017, 09:08 Local	Registration:	N155CL
Aircraft:	Pipistrel Virus SW	Aircraft Damage:	Destroyed
Defining Event:	Windshear or thunderstorm	Injuries:	1 Fatal
Flight Conducted Under:	Part 91: General aviation - Personal

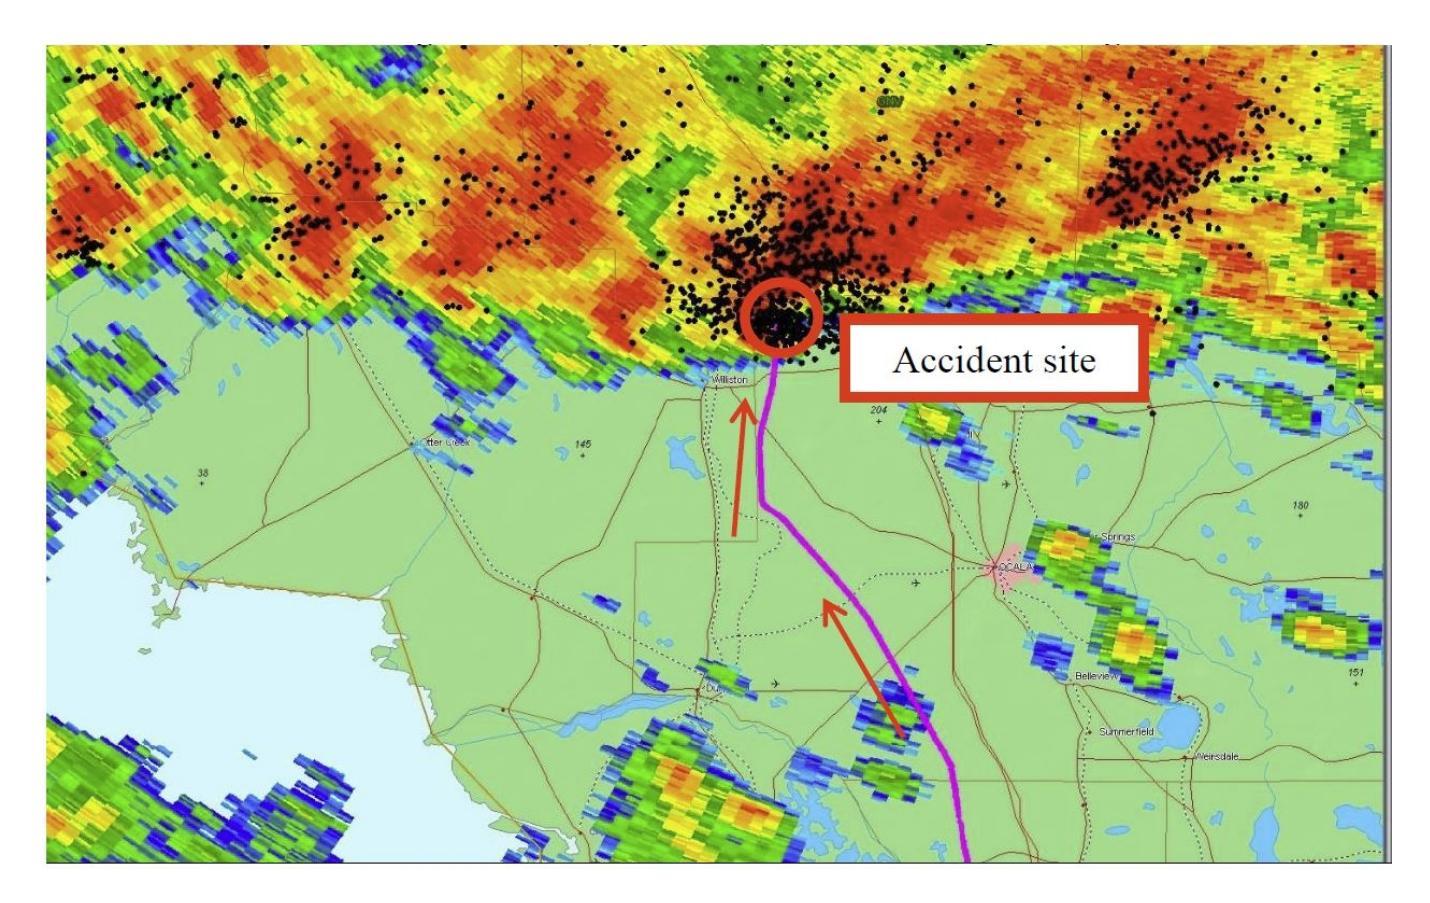
Figure 1 - KJAX WSR-88D reflectivity for the 0.5° elevation scan initiated at 0911 EDT

Radar returns from the motorglider ended at the edge of an east-west oriented line of severe thunderstorms, rain showers, and lightning that extended about 100 nautical miles to either side of the motorglider's radar flight track, according to National Weather Service (NWS) weather radar data. (See figure 1.)

Weather radar imagery and lightning data depicted heavy to extreme echoes (precipitation) at the accident location with convective cells and lightning. The echoes were consistent with the possibility of hail, extreme turbulence, and strong surface wind gusts. Radar velocity data indicated winds conducive to rotation above the accident site at the time of the accident, with the potential for tornadic activity at the surface. The area of heavy to extreme precipitation stretched across the entire width of northern Florida between 0845 and 0915.
