Aviation Investigation Final Report

Location:	Amarillo, Texas	Accident Number:	CEN17FA168
Date & Time:	April 28, 2017, 23:48 Local	Registration:	N933DC
Aircraft:	PILATUS AIRCRAFT LTD PC 12	Aircraft Damage:	Destroyed
Defining Event:	Loss of control in flight	Injuries:	3 Fatal
Flight Conducted Under:	Part 135: Air taxi & commuter - Non-s	scheduled - Air Medical	(Medical emergency)

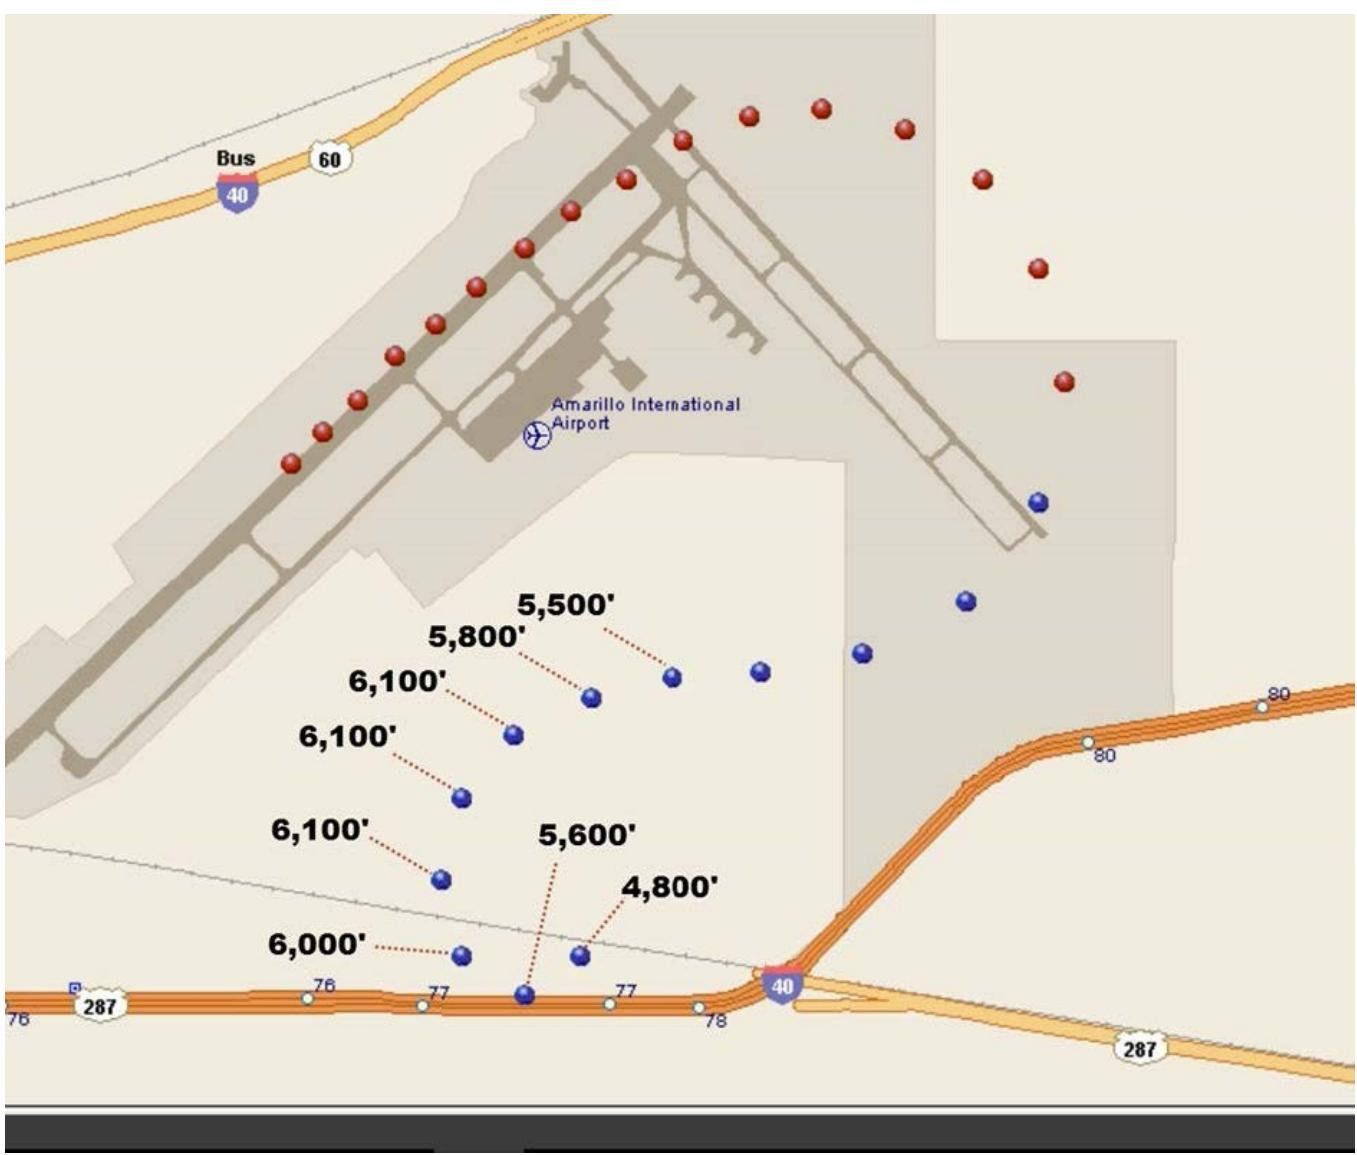
Figure 1 – Plotted radar data illustrating the accident flight path

After departing runway 4, the local controller observed a primary target with an associated transponder code of 4254, which was the code that had been assigned to the airplane on its previous flight. The local controller observed the 4254 target climb through 4,400 ft msl and instructed the pilot to reset the transponder to 4261. The pilot reset the transponder code to 4261. The local controller observed the beacon code change from 4254 to 4261, then advised the pilot "I've got you now," and instructed him to contact AMA departure control.

Figure 1 shows the plotted AMA radar data illustrating the accident flight path. The red targets are from transponder code 4254, and the blue targets are from transponder code 4261. The last eight recorded targets are labeled with their mode C reported altitudes.

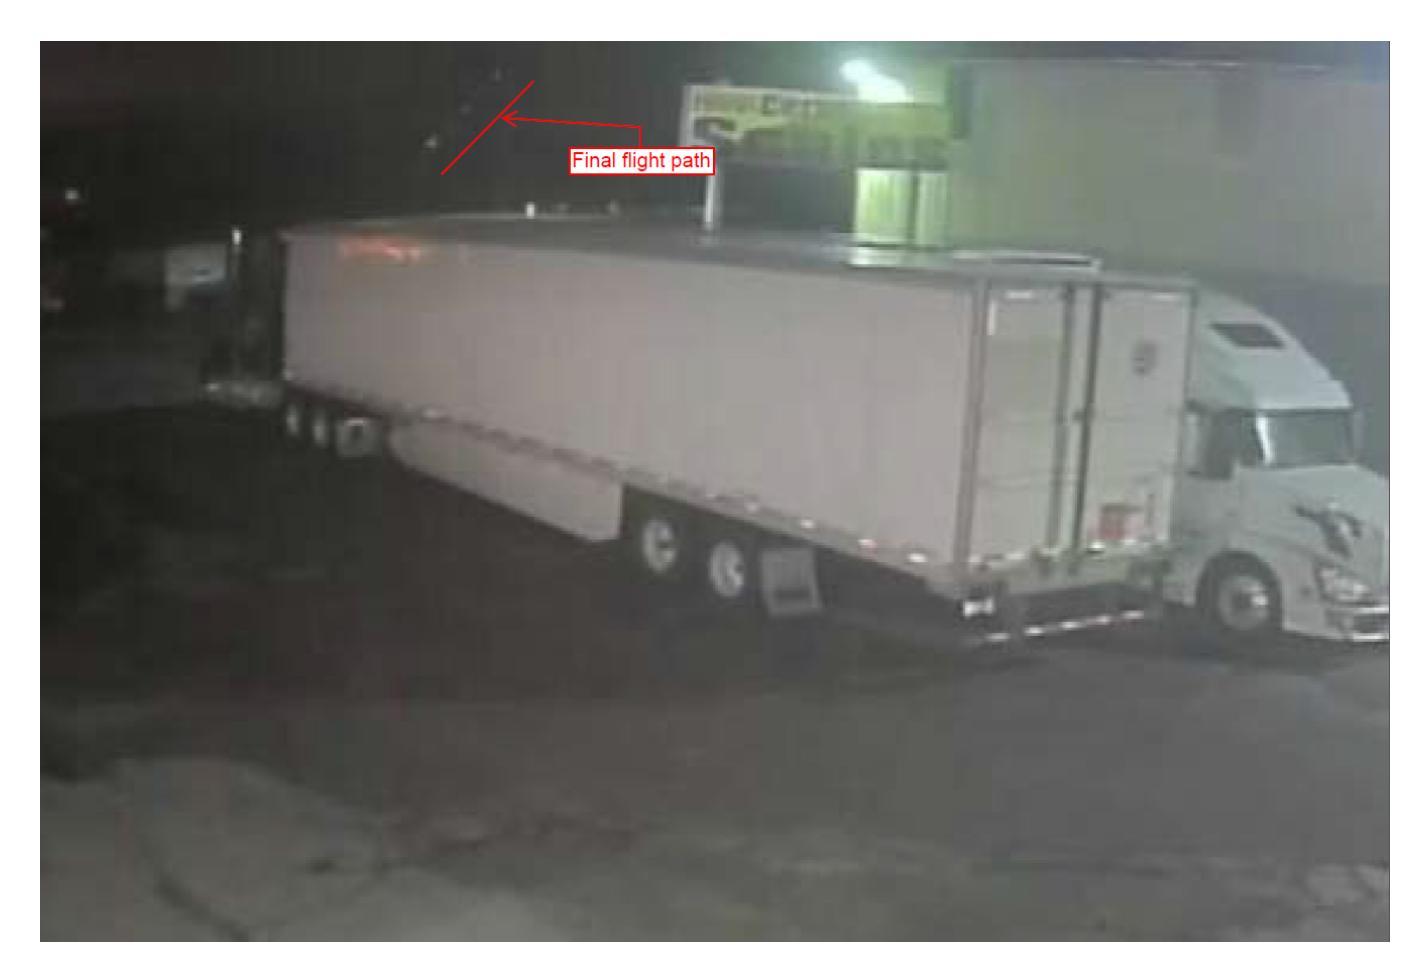
Figure 2 – Accident airplane's final flight path

Surveillance video from a nearby truck stop, located about 400 yards southwest of the accident site, recorded lights from the airplane followed by an explosion. Still images were taken from the video and

layered to produce figure 2, which depicts the airplane's final flight path. The images show the airplane descending about a 45° angle to ground impact.

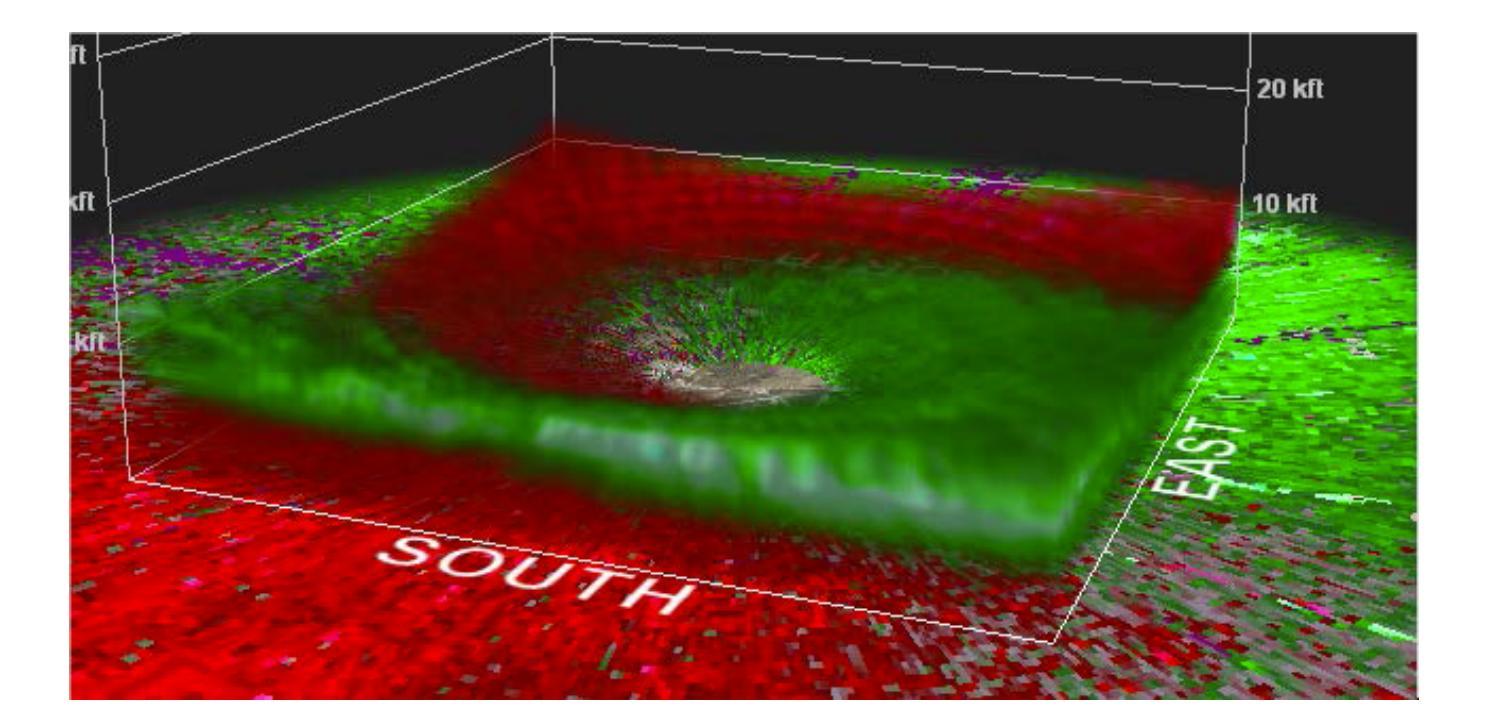
Figure 3 – Wind profile, 3D view

The warning coordination meteorologist for the National Weather Service (NWS) Weather Forecast Office (WFO) in Amarillo, Texas, provided a 3D image (figure 3, which shows AMA at the center of the 3D box) that showed a wind shear zone between 2,500 and 3,500 ft msl as seen from the AMA weather radar about 2355. The red area indicates wind away from the radar, and the green area indicates wind toward the radar. The image shows a northerly wind near the surface and a 40 to 60 knot southerly wind above 4,000 ft msl.

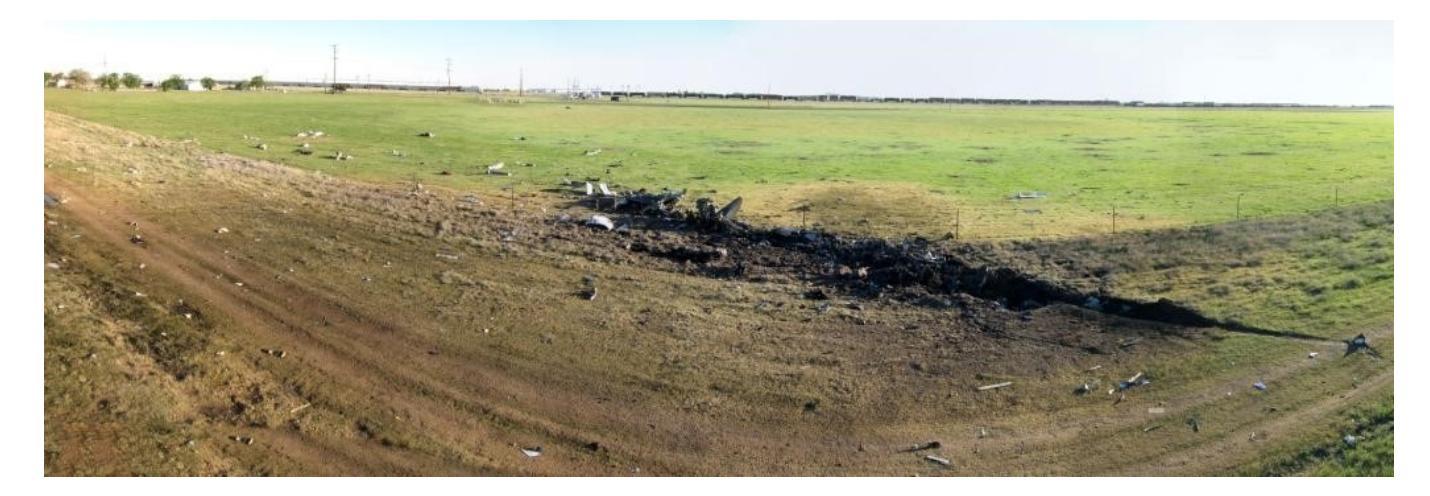
Figure 4 – Accident site viewed from the south

The airplane impacted a pasture (figure 4) adjacent to several stationary train cars about 1.5 nautical miles south of AMA, and a postimpact fire ensued. The wreckage debris path was generally oriented along a northeast-southwest line, and the airplane impacted the ground facing southwest. All major structural components of the airplane were located within the debris field.

Ground scars at the accident site and damage to the airplane were consistent with the airplane impacting in a steep, nose-low and wings-level attitude. The top soil was dark and relatively soft extending 3 to 4 ft deep, and the subsoil was a relatively hard clay. The impact crater was about 5 ft deep. A section of the left winglet, the left pitot tube, and the angle of attack sensor from the left wing were found embedded in the ground; the winglet is noticeable on the far right side of figure 4. The vertical stabilizer remained attached to the fuselage and sustained relatively minor damage compared to the rest of the airplane structure. The horizontal stabilizer separated near mid-span, and both sides were identified. The left side was severely crushed from the leading edge aft; a corresponding impact mark was observed in the ground near the center and in front of the impact crater.

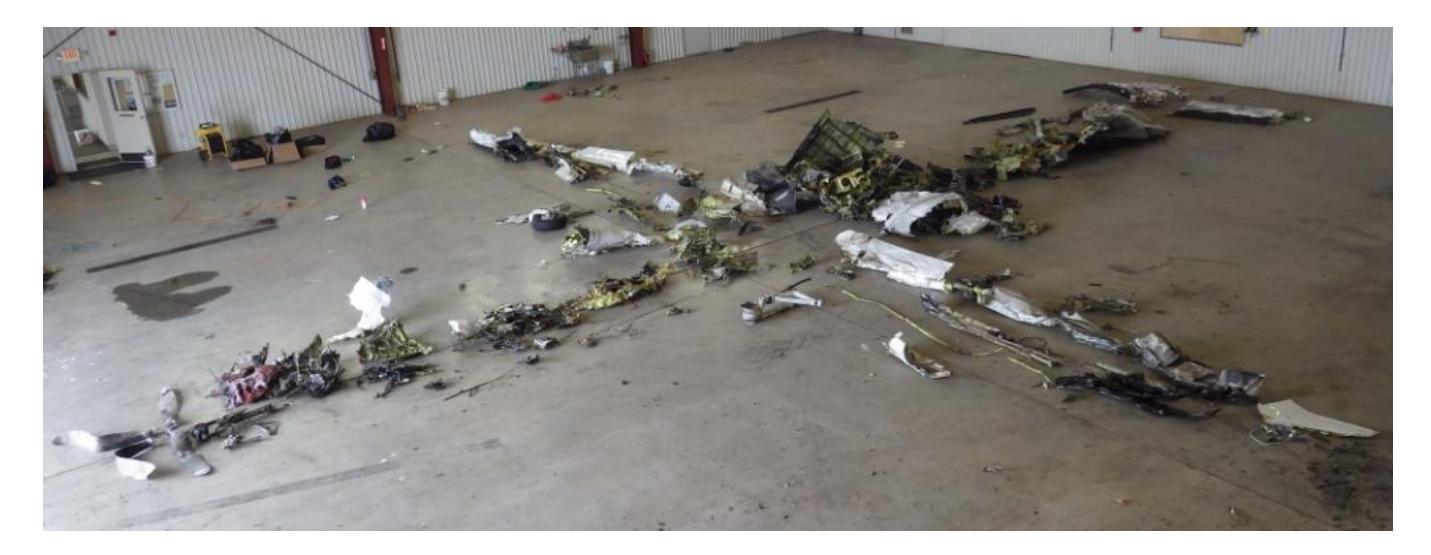
Figure 5 – Wreckage organized in hangar

The wreckage was documented at the accident site and then relocated to a secure hangar at AMA for a full layout and detailed examination. The airplane was heavily fragmented (figure 5).

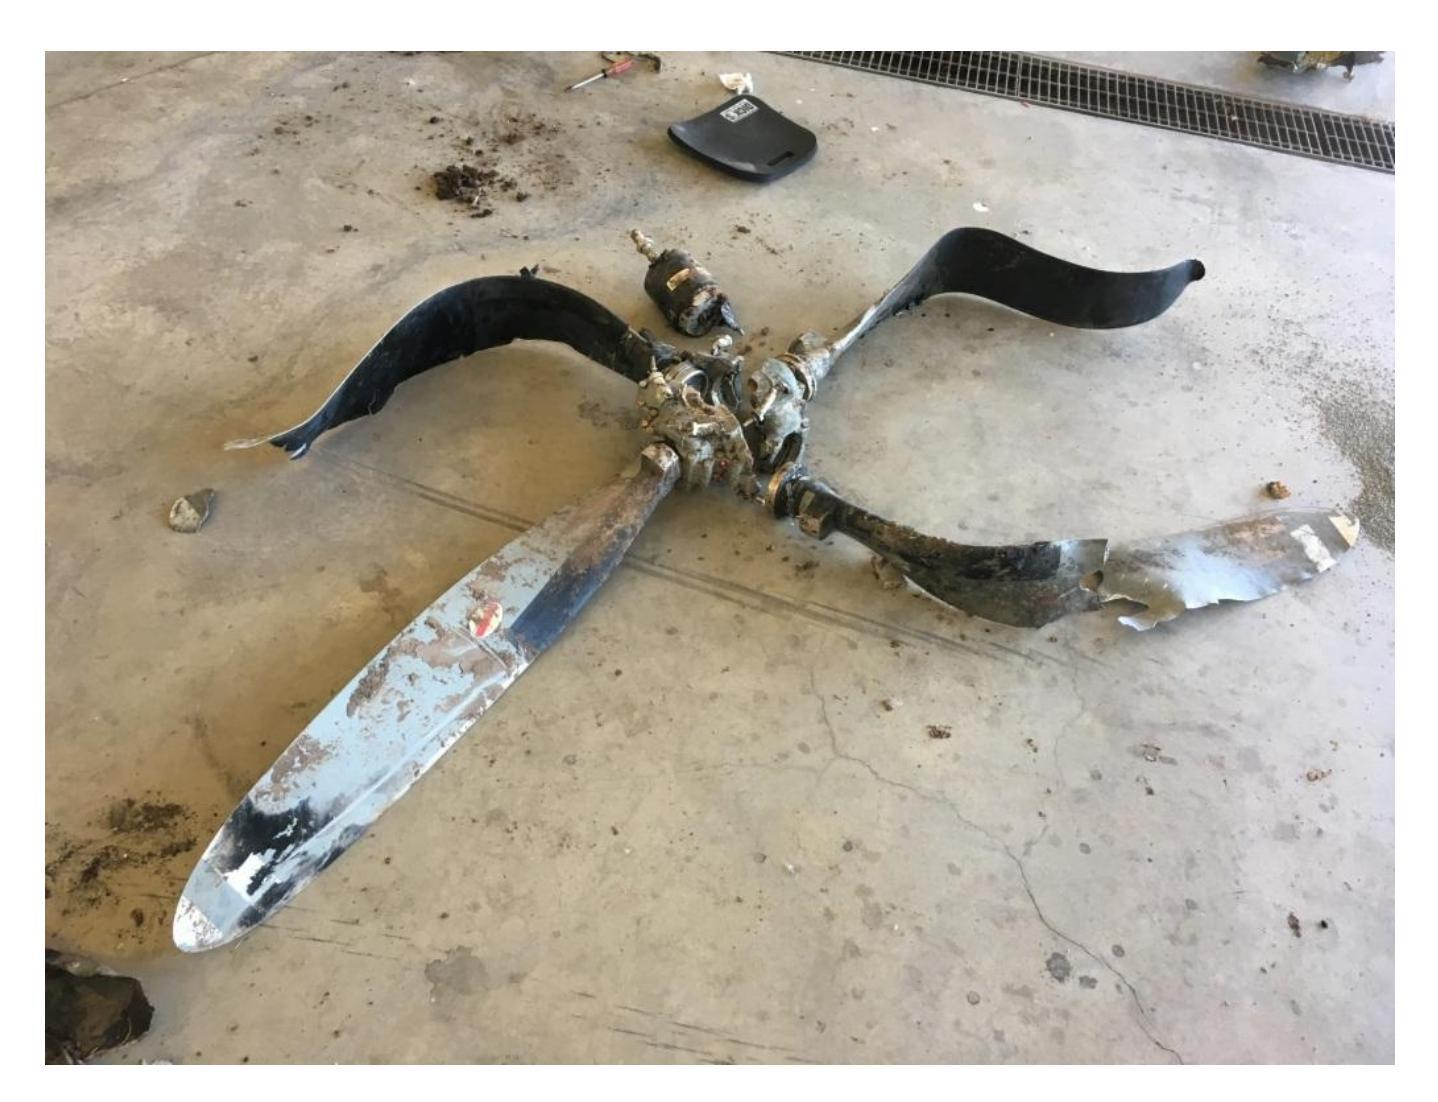
Figure 6 – Propeller

The propeller blades (figure 6) exhibited damage consistent with engine operation during impact.

There were no preimpact anomalies found that would have prevented or degraded normal propeller operation.

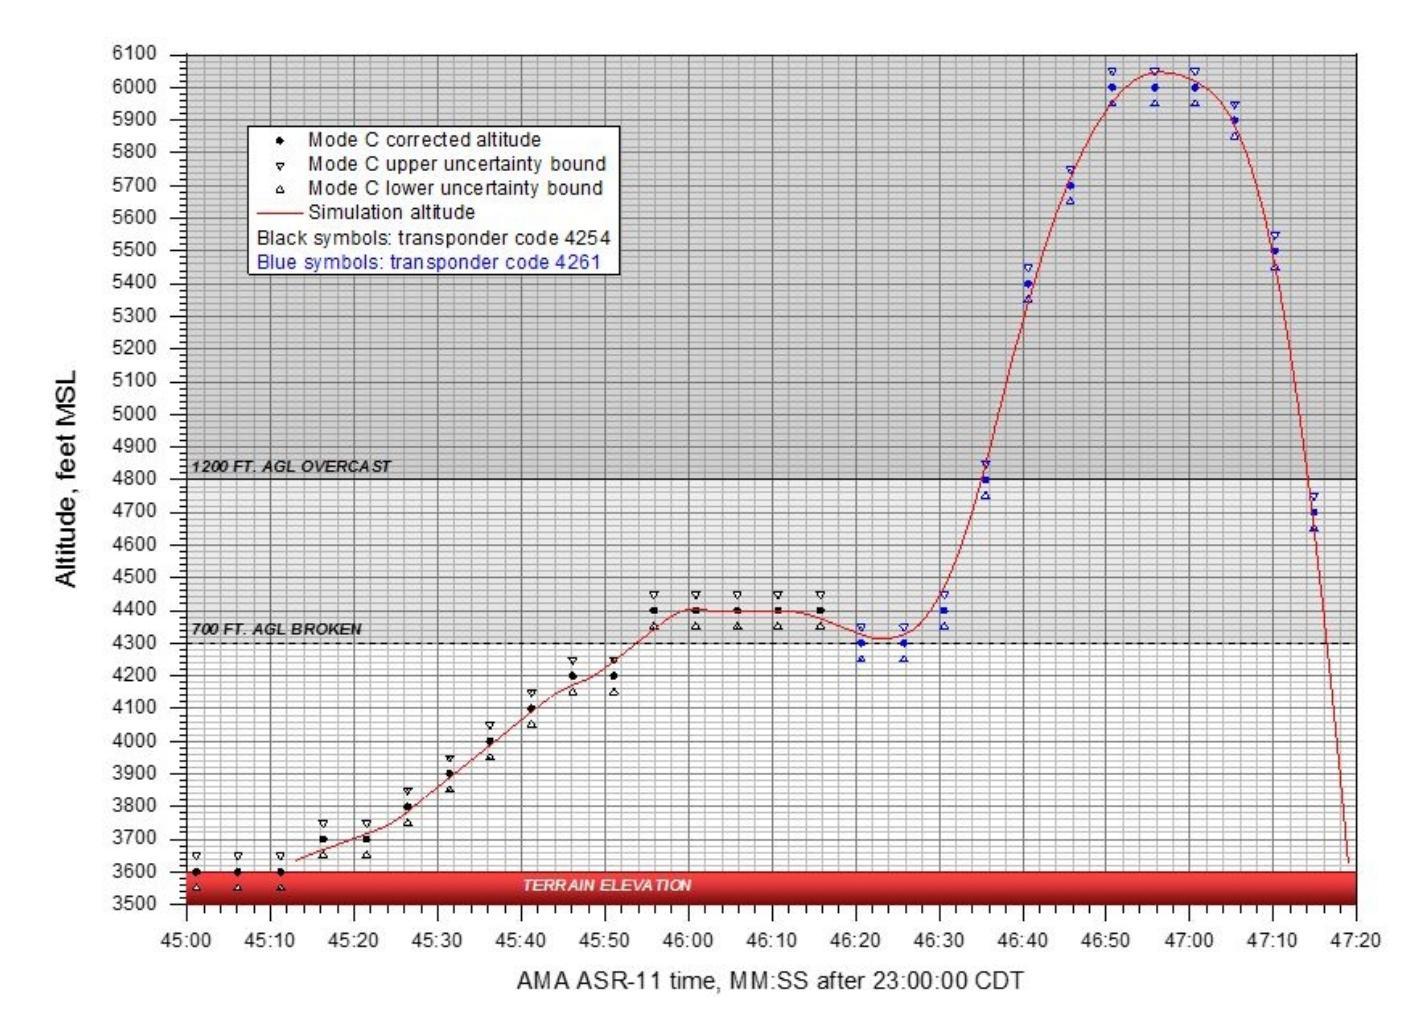
Figure 7 – Simulation of accident flight, altitude vs time graph

The simulation indicated that, after lifting off from AMA runway 4, the airplane accelerated to about 193 knots calibrated airspeed (KCAS) while climbing between 600 and 1,200 ft per minute (fpm) to an altitude of about 4,400 ft msl, or about 800 ft agl (figure 7). The airplane leveled about 4,300 to 4,400 ft msl for about 30 seconds; at 23:46:30, it resumed climbing, reaching 6,000 ft msl (2,400 ft agl) at 23:46:52. During this climb, the airplane decelerated from 193 KCAS to 122 KCAS. At 23:47:02, the airplane started an increasingly rapid descent from 6,000 ft msl to the ground (elevation 3,600 ft msl). Based on the simulation, the estimated rate of descent and airspeed at impact were about 17,000 fpm and 220 KCAS, respectively. The estimated time of impact was 23:47:19.

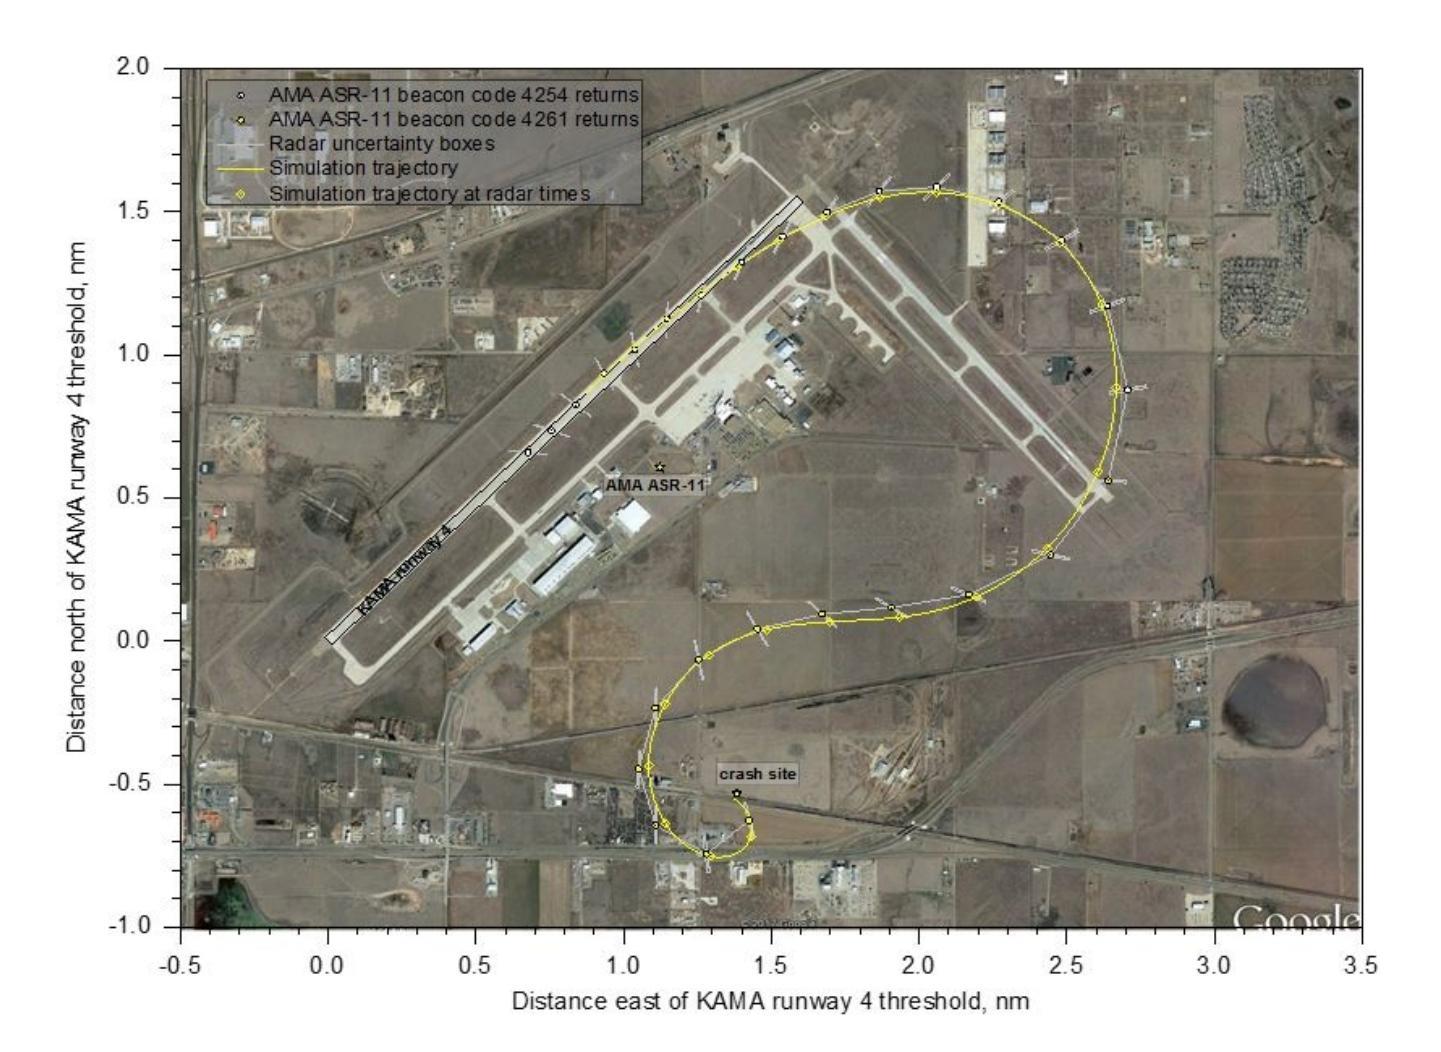
Figure 8 – Google Earth view of radar data and simulation trajectory

At 23:45:42, while climbing through 4,100 ft msl (500 ft agl), the airplane started a slow right roll

(figure 8), reaching a roll angle of about 42° at 23:46:10. At 23:46:24, the roll angle had decreased to 36°, and the pitch angle started to increase steadily, which was consistent with the climb to 6,000 ft msl. At 23:46:32, when the roll angle was 30°, the airplane started rolling more quickly to the left, rolling through wings level at 23:46:40, then on a ground track of 267° true.

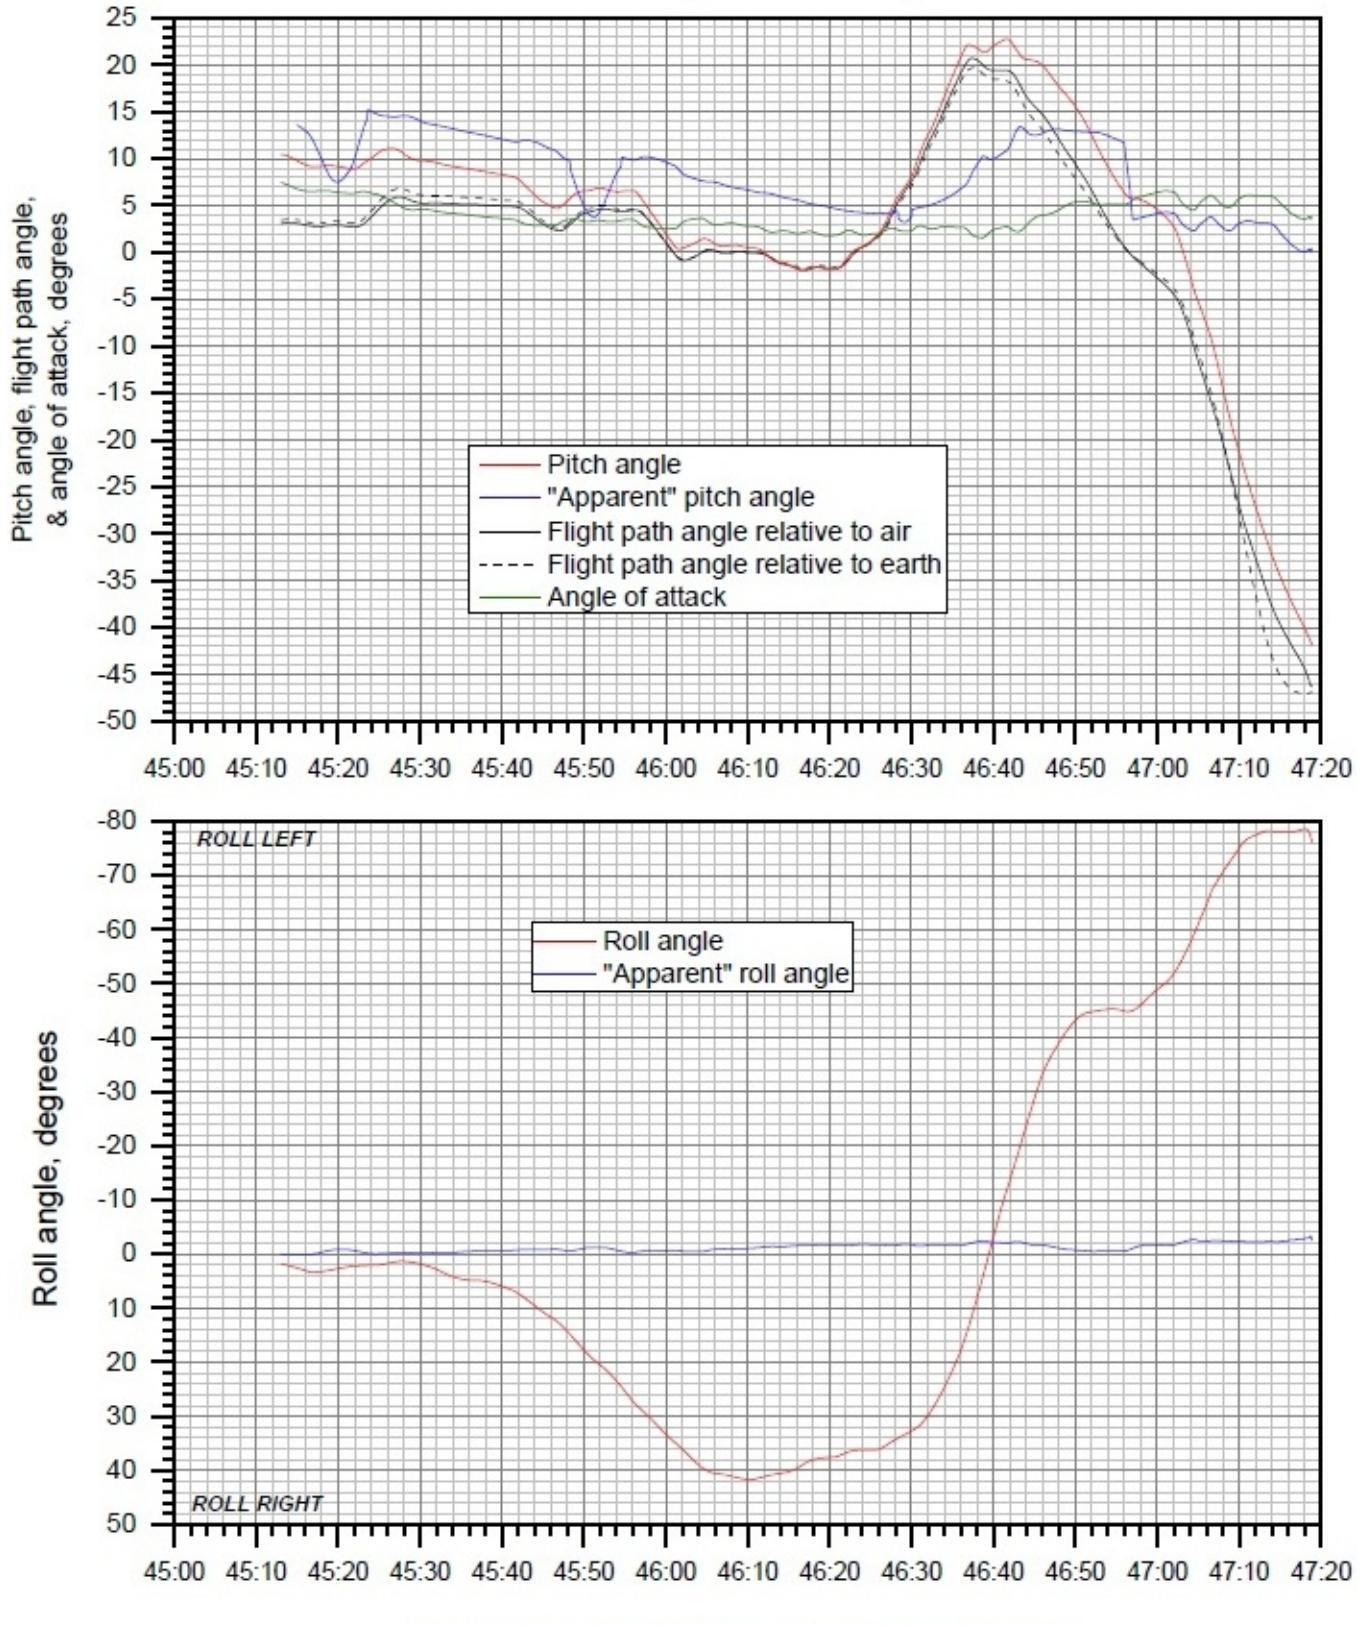
Figure 9 – Simulation apparent pitch and roll angles

The airplane achieved a peak pitch angle of about 23° at 23:46:42 (figure 9), after which the pitch angle decreased steadily to an estimated -42° at impact. As the pitch angle decreased, the roll angle increased steadily to the left, reaching an estimated -76° at impact.

An estimate of the "apparent" pitch and roll angles, which represent the attitude a pilot would "feel" the airplane to be in based on his vestibular/kinesthetic perception of the components of the load factor vector in his own body coordinate system, was made based on the simulation load factors. The "apparent" pitch angle ranged between 0° and 15° , and the "apparent" roll angle ranged between 0° and -4° (figure 9).
