Aviation Investigation Final Report

Location:	New Castle, Delaware	Accident Number:	ERA17FA190
Date & Time:	May 25, 2017, 11:53 Local	Registration:	N62UP
Aircraft:	EUROCOPTER DEUTSCHLAND GMBH EC 135	Aircraft Damage:	Destroyed
Defining Event:	Loss of control in flight	Injuries:	1 Fatal
Flight Conducted Under:	Part 91: General aviation - Personal

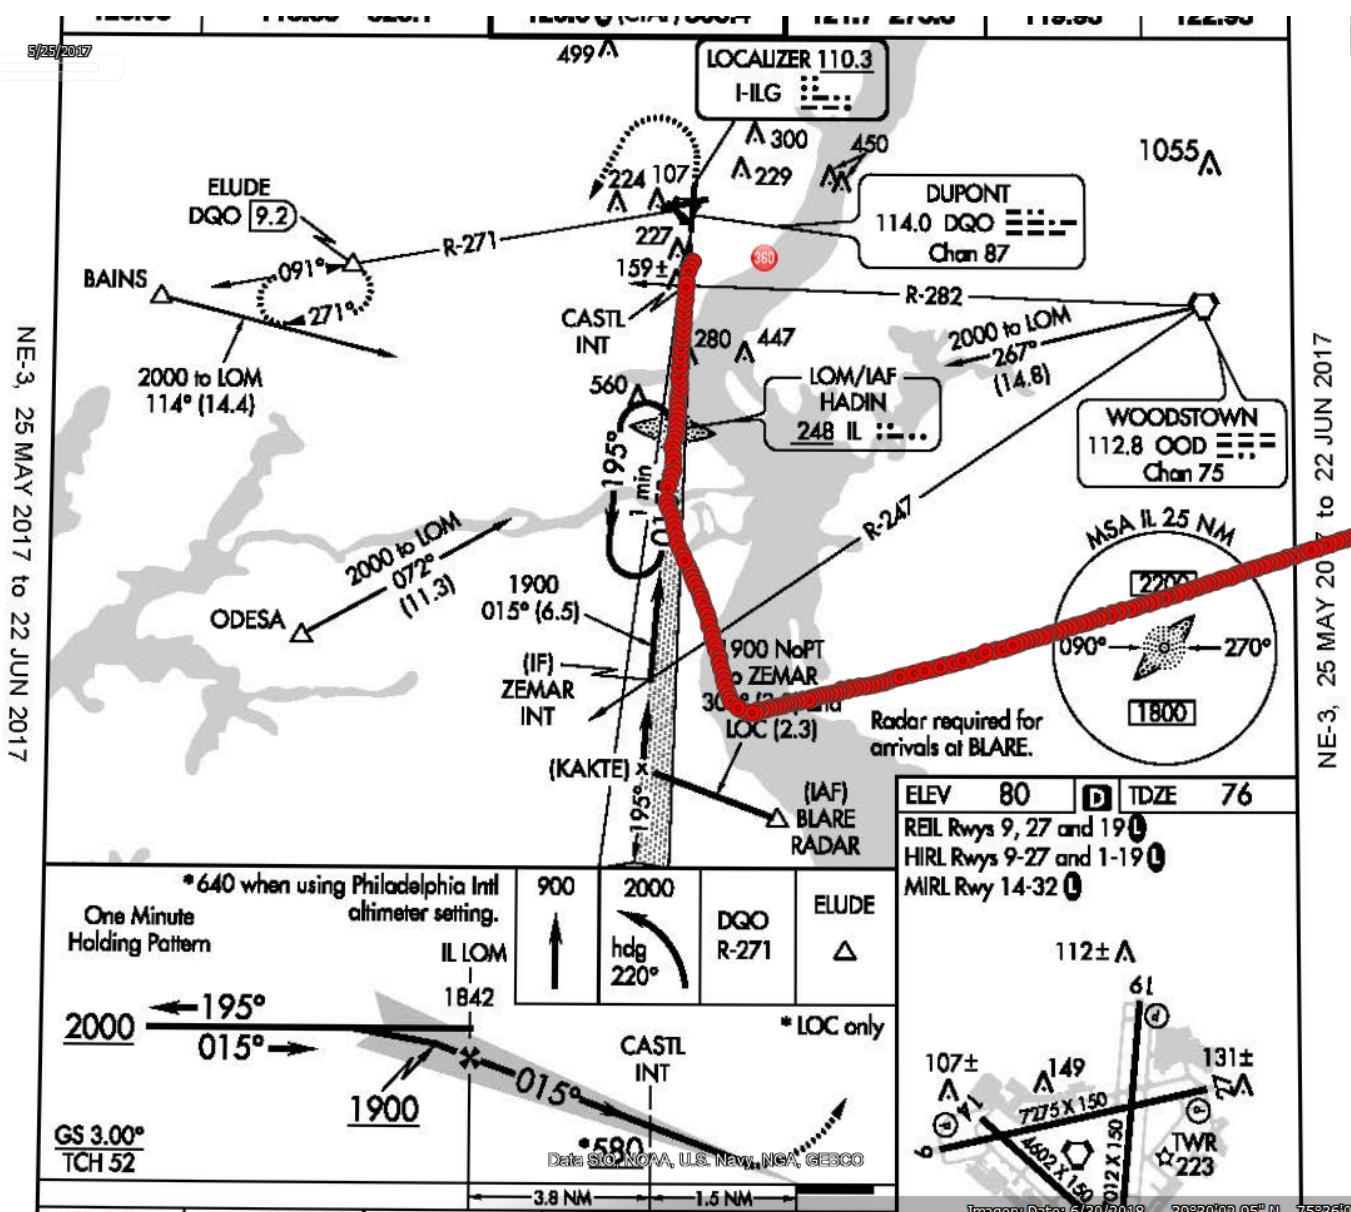
As the helicopter reached a point about 3 nm inside the outer marker, while flying at an altitude about 2,000 ft msl, the pilot declared a missed approach, telling the controller that he had received "some bad vectors at the very end" and that he wanted to "just line up and come back around again." The controller

Although the radar vectors provided by the controller during the approach were contrary to the FAA's guidance to air traffic controllers, which required aircraft to be vectored to intercept an ILS localizer course 2 nm outside the approach gate given the weather conditions that prevailed at that time, radar data confirmed that the helicopter successfully tracked inbound toward the airport on the localizer course. Although the radar vectors did not directly contribute to the accident, they likely increased the pilot's task load during the accident sequence.

Figure 1. Overhead view of helicopter's radar ground track (red) overlaid onto the ILS Rwy 1 instrument approach procedure plan view.

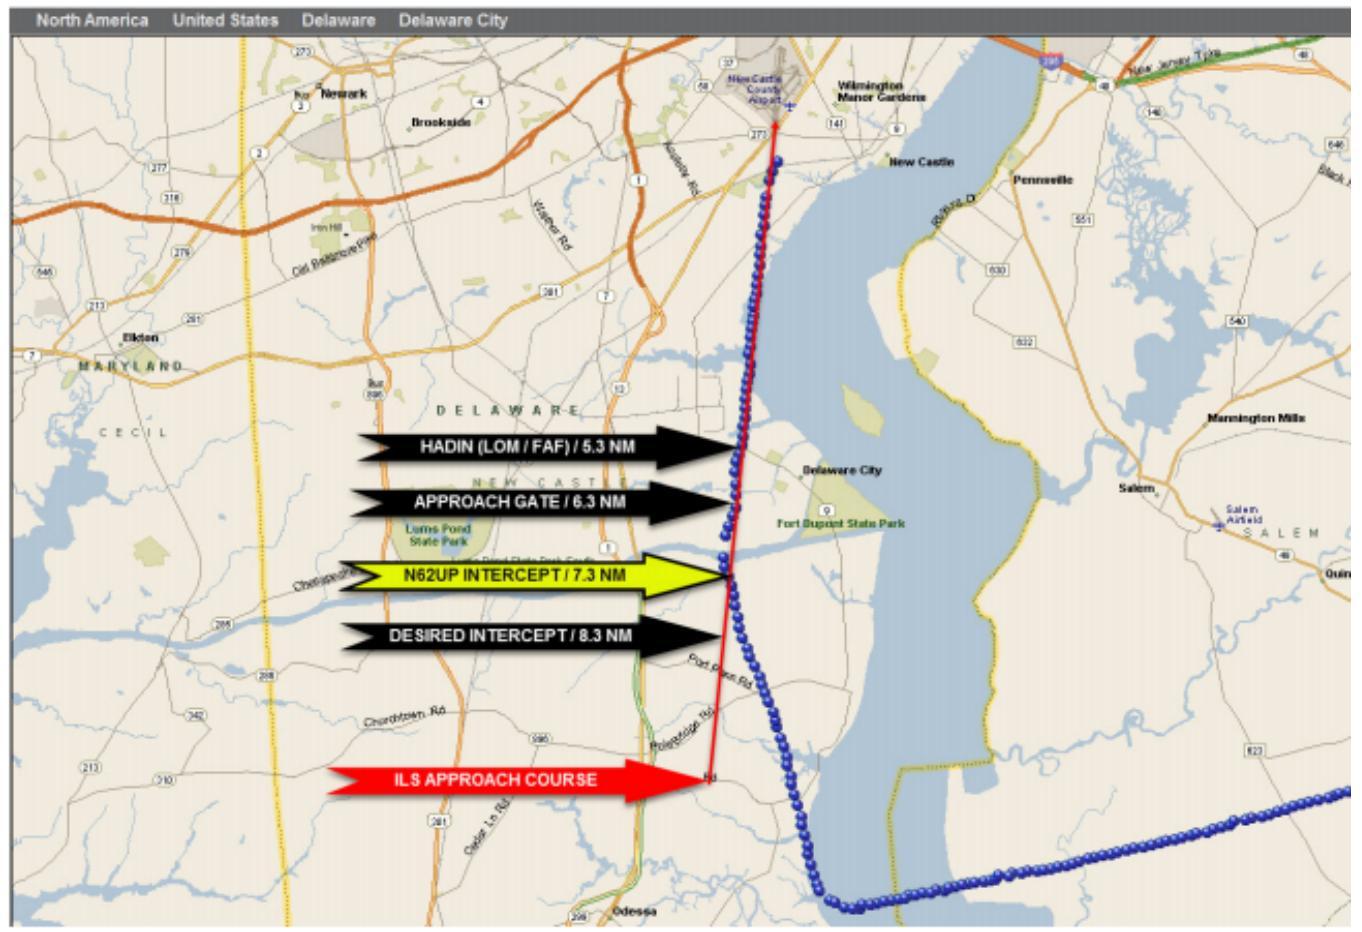
Figure 2. Radar flight track of the final segment of the accident flight. Key points along the route of flight have been depicted in order to illustrate the final approach intercept with relation to the final approach fix and approach gate.

According to FAA Order 7110.65W, "Air Traffic Control," chapter 5, section 9, paragraph 5-9-2, for final approach course interception, the controller was to assign headings that would permit final approach course intercept on a track that does not exceed a 20° angle if an aircraft intercepts the approach course less than 2 miles from the approach gate, or a 30° angle if an aircraft intercepts the approach course 2 miles or more from the approach gate.

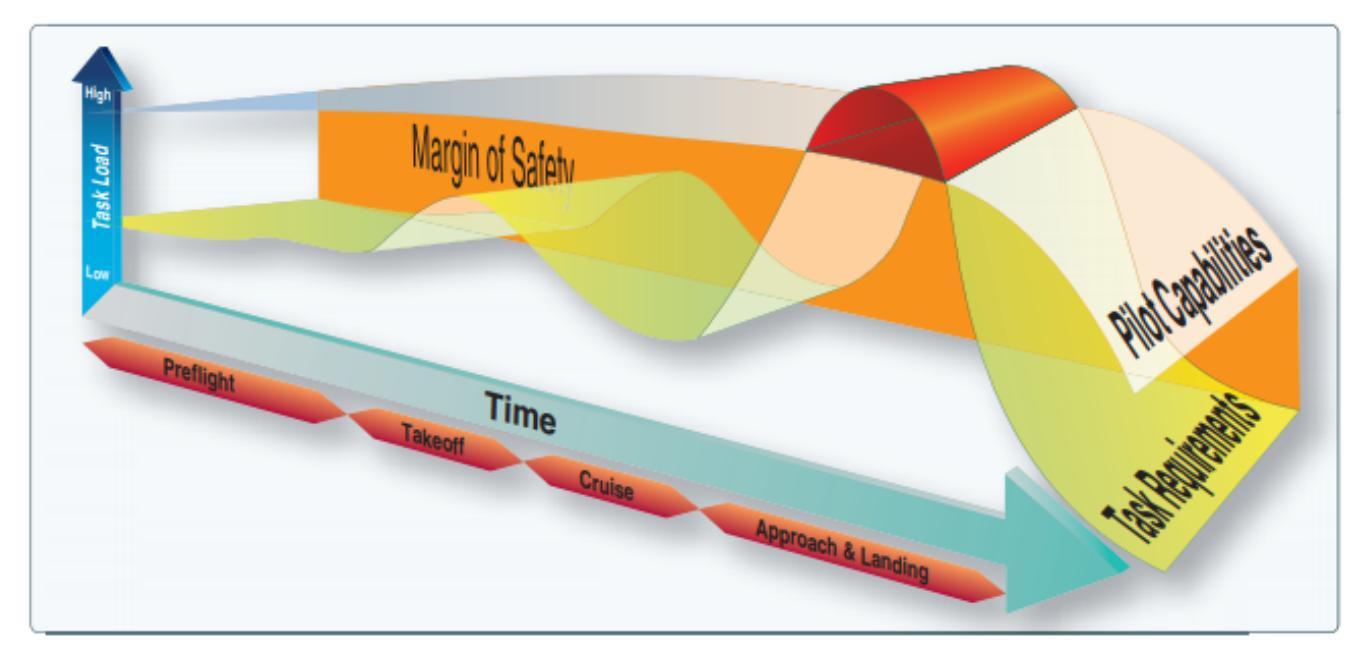
Figure 3. A depiction of task requirements and pilot capabilities in reference to a margin of safety.

Several factors indicated that the pilot was task-saturated when the accident sequence occurred: he was performing an instrument approach that he had not previously performed; he was provided radar vectors close to the approach gate, which accelerated the timeline of the approach procedure; and he was likely already planning the return flight to the departure airport, which he previously indicated to the controller that he would conduct following the approach. That the pilot did not descend the helicopter after intercepting the glideslope or passing the final approach fix and did not fly the published missed approach procedure are indicative that he had likely become task-saturated during the final moments of the flight.

Figure 14-1. The pilot has a limited capacity of doing work and handling tasks, meaning there is a point at which the tasking exceeds the pilot's capability. When this happens, either tasks are not done properly or some are not done at all.
