Aviation Investigation Final Report

Location:	Haines, Alaska	Accident Number:	WPR17FA108
Date & Time:	May 27, 2017, 11:01 Local	Registration:	N7376Y
Aircraft:	Piper PA 30	Aircraft Damage:	Substantial
Defining Event:	Loss of control in flight	Injuries:	2 Fatal, 1 Serious
Flight Conducted Under:	Part 91: General aviation - Personal

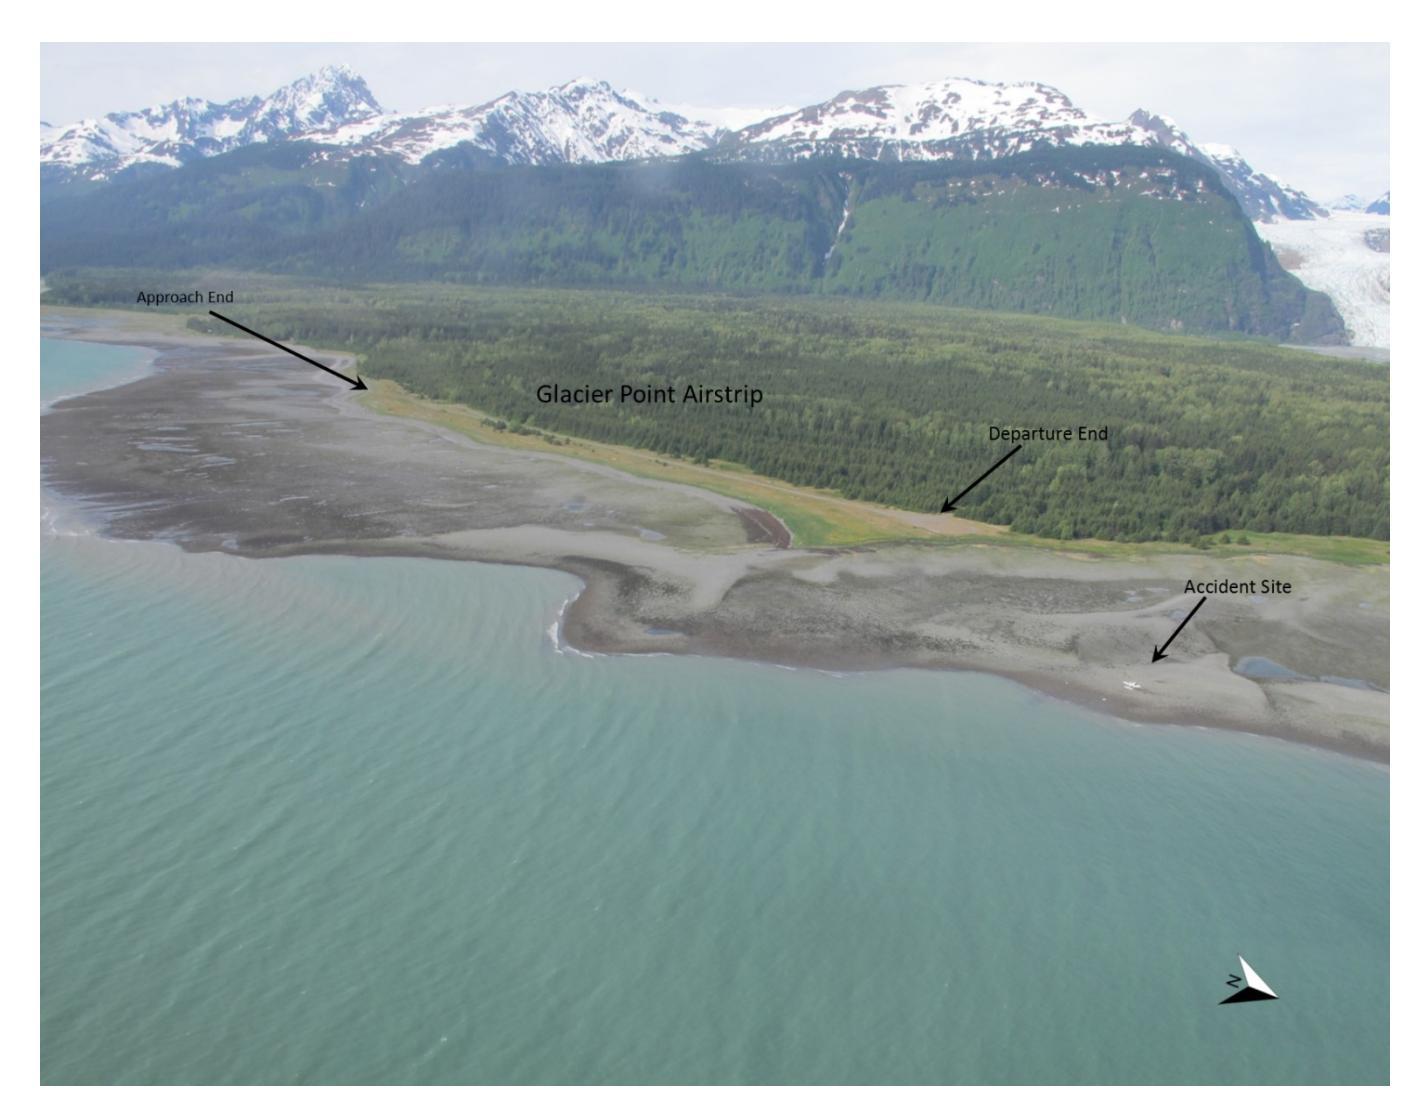
Figure 1-Aerial Image of the Accident Site

The impact site was located on the western tidal flats of the Chilkat Inlet, about 1/4-mile northeast of the north end of the airstrip at Glacier Point.

The initial on-scene examination of the airplane by the NTSB-IIC and a Federal Aviation Administration inspector revealed impact damage consistent with a right-wing-down, nose-down attitude during ground impact. The airplane remained intact, all flight control surfaces were accounted for, and cable control continuity was confirmed. The landing gear was in the down position, and the landing gear position switch was in the down position. The landing gear extension motor release arm was found in the disengaged position. The emergency landing gear extension handle was removed from its stowed position and installed in a socket on the emergency disengage control. The flaps were in the up position and the flap lever was in the down position.

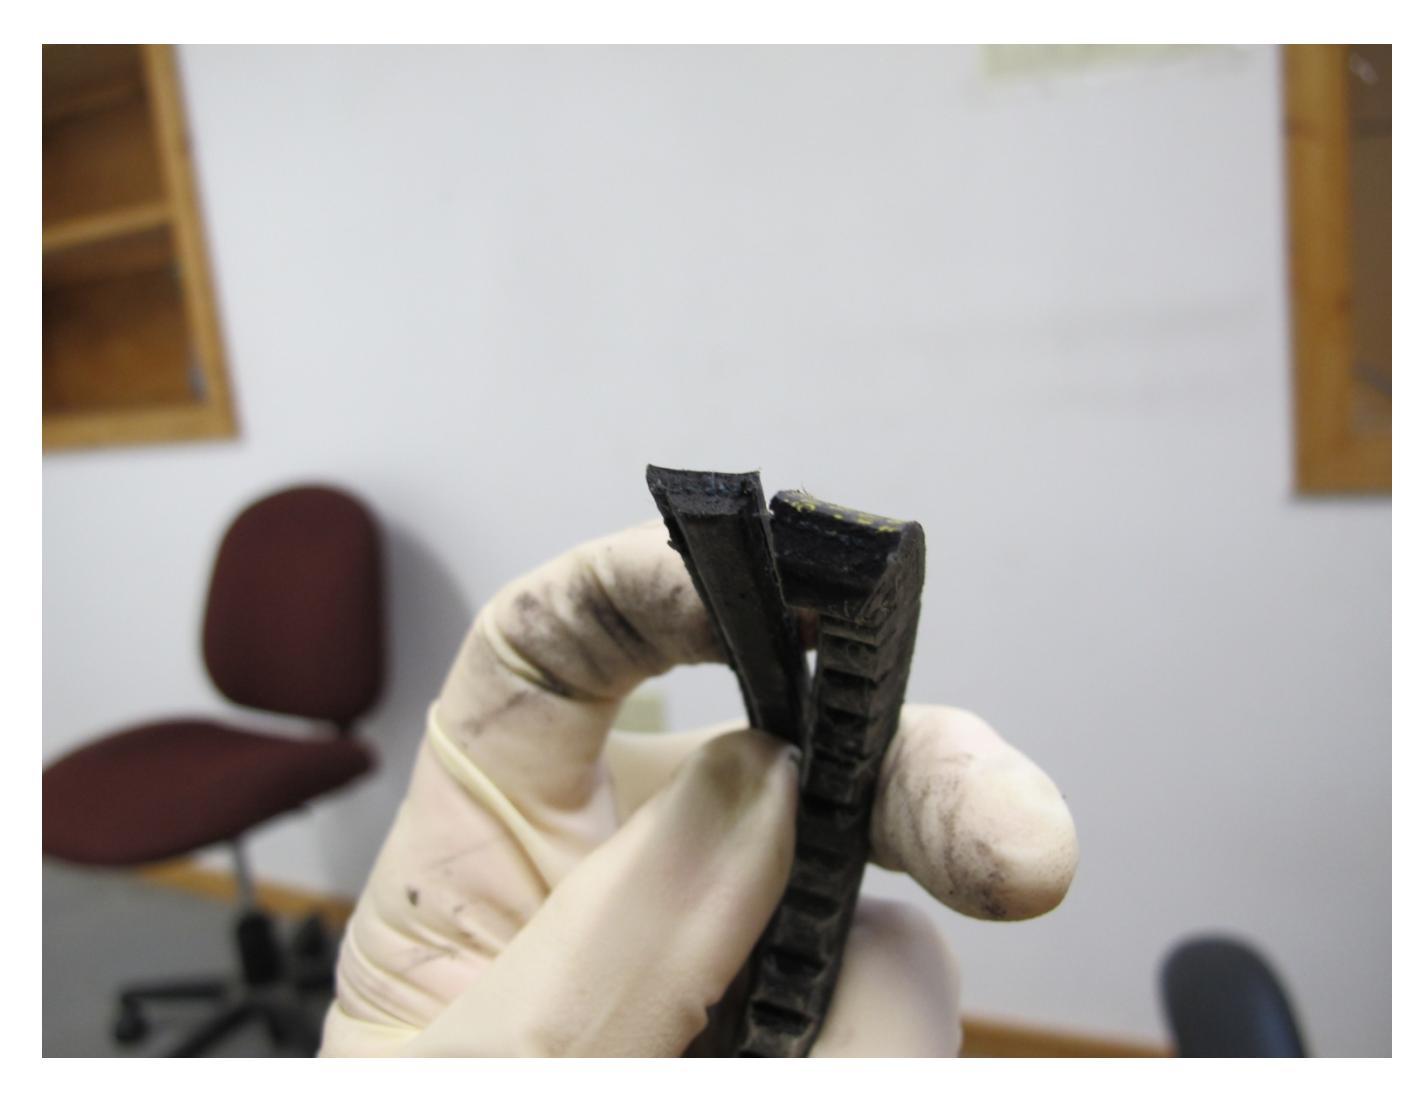
Figure 2-Right Engine Alternator Belt

The right engine alternator drive shaft rotated freely by hand, but the drive belt remained stationary with the crankshaft. The alternator drive belt was loose and excessively worn on the pulley contact area. The right engine inlet cowling section had rubber filings in the forward right interior surface. Rubber filings were also found on the back side of the starter ring gear and surrounding areas. The rubber filings were likely due to the loose fit of the belt on the pulley during engine operation. Given this evidence, the right engine alternator was probably intermittent with a loose belt.

The wreckage was relocated to a hangar at PAGS, and examination of the wreckage showed that the right engine crankshaft propeller flange was bent to one side and that the rocker covers had impact damage. The right engine's exterior surfaces had a dark oily residue. Oil residue was observed in the area of the alternator pulley and belt. The right engine alternator was undamaged and secure, and no signatures suggested that the alternator was repositioned during the accident sequence. The alternator electrical wiring remained secure at the terminals. The alternator drive pulley rotated freely by hand, and the drive belt remained stationary with the crankshaft. The right engine alternator drive belt was loose when examined and was subsequently removed from the engine. The belt was excessively worn on the pulley contact area as shown in Figure 2. A spare alternator drive belt was found stowed to the engine; the stowed belt shared the same part numbers as the worn belt (Napa Premium XL 25-7365). According to the alternator STC installation instructions, a Franklin (P/N 14883) or a Goodyear 5L380 belts should be used.

The right engine inlet cowling section had rubber filings in the forward right interior surface. Rubber filings were also found on the back side of the starter ring gear and surrounding areas.
