Aviation Investigation Final Report

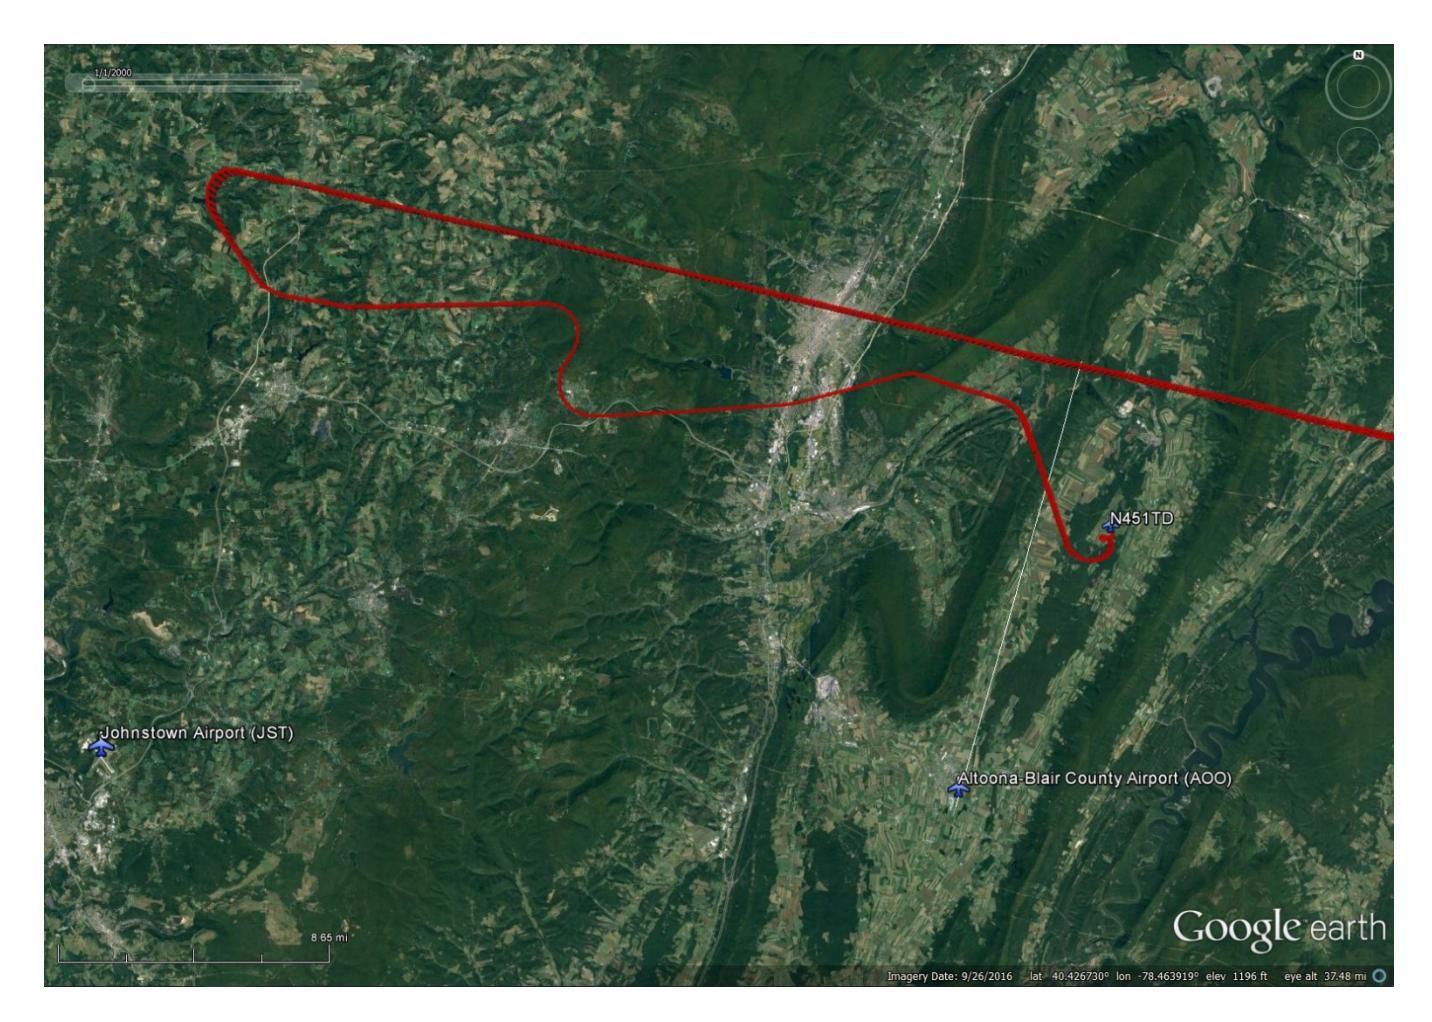
Figure 1. Radar track and accident location (Google Earth overlay)

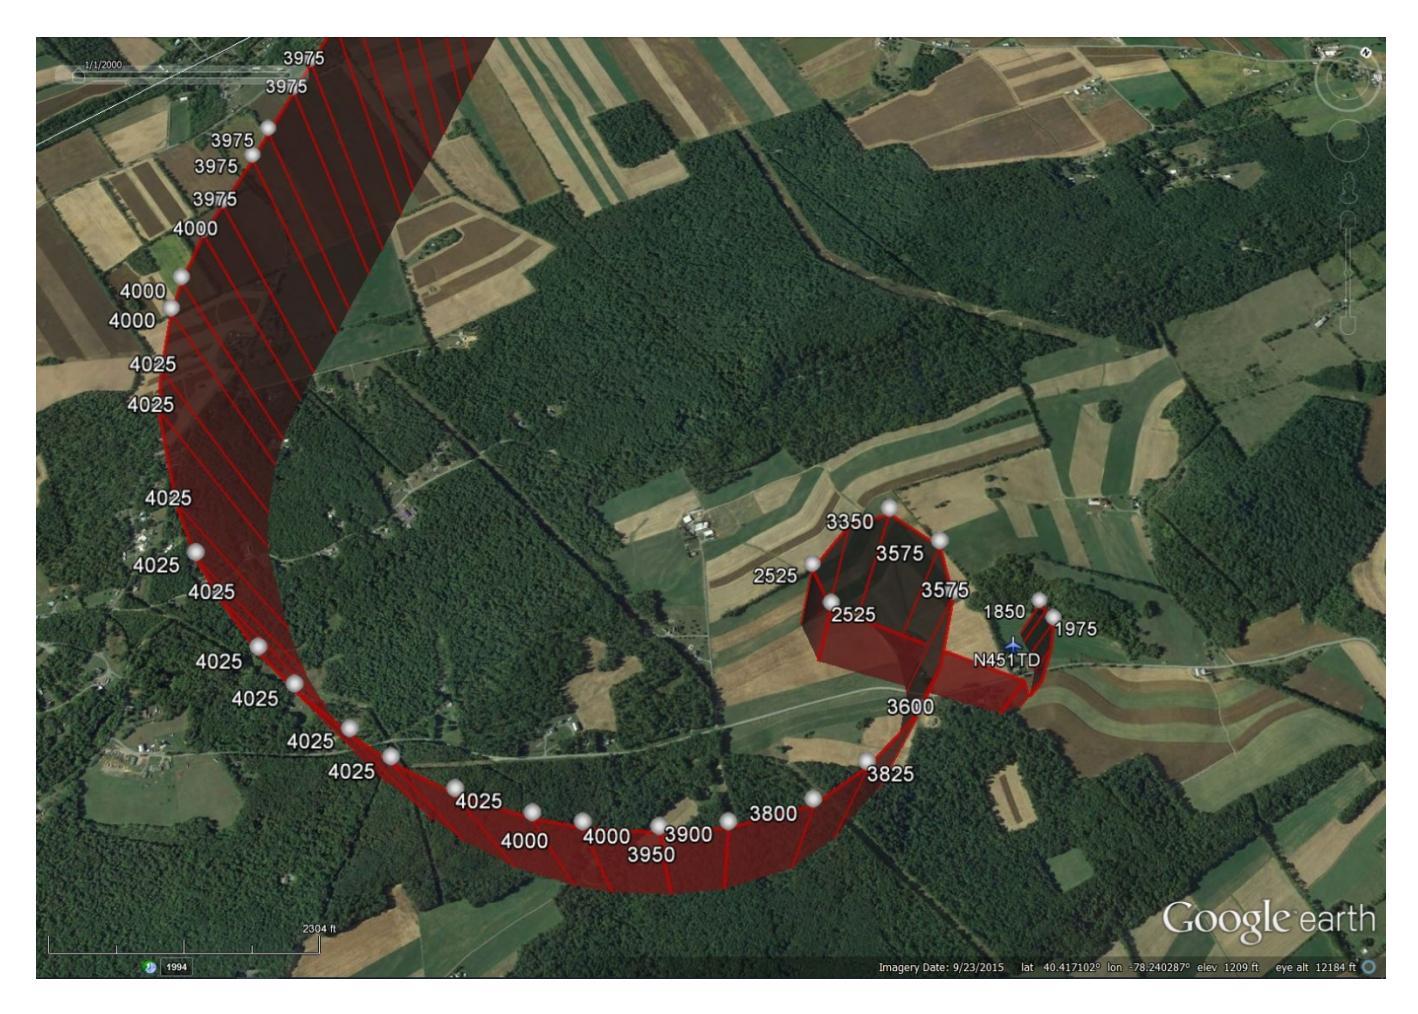
Figure 2. Radar track showing the spiraling left turns (Google Earth overlay)

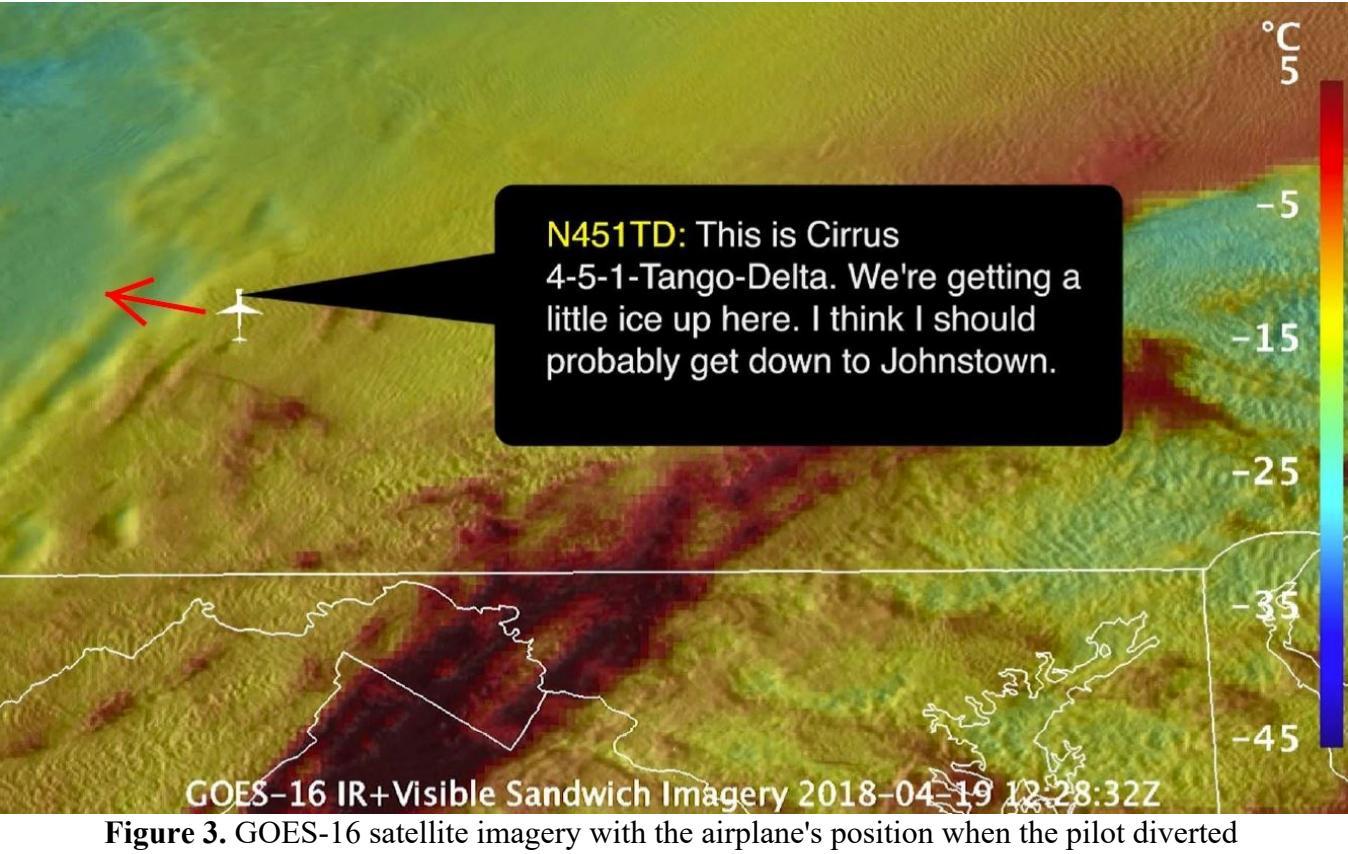
Figure 3 shows the compiled Geostationary Operational Environmental Satellite 16 (GOES-16) infrared and visible data and the pilot's communication with ATC at the time he requested to divert with the direction of travel indicated with a red arrow. This imagery indicated that the airplane was in areas of abundant cloud cover with cloud top temperatures between -5° and -15°C throughout the flight. The airplane turned back toward the east before reaching an area of cloud top temperatures between -15° and -25°C. The cloud-top heights above the accident site at around the time of the accident were about 10,400 ft msl. The IMC and icing conditions would have ended above the cloud layer.

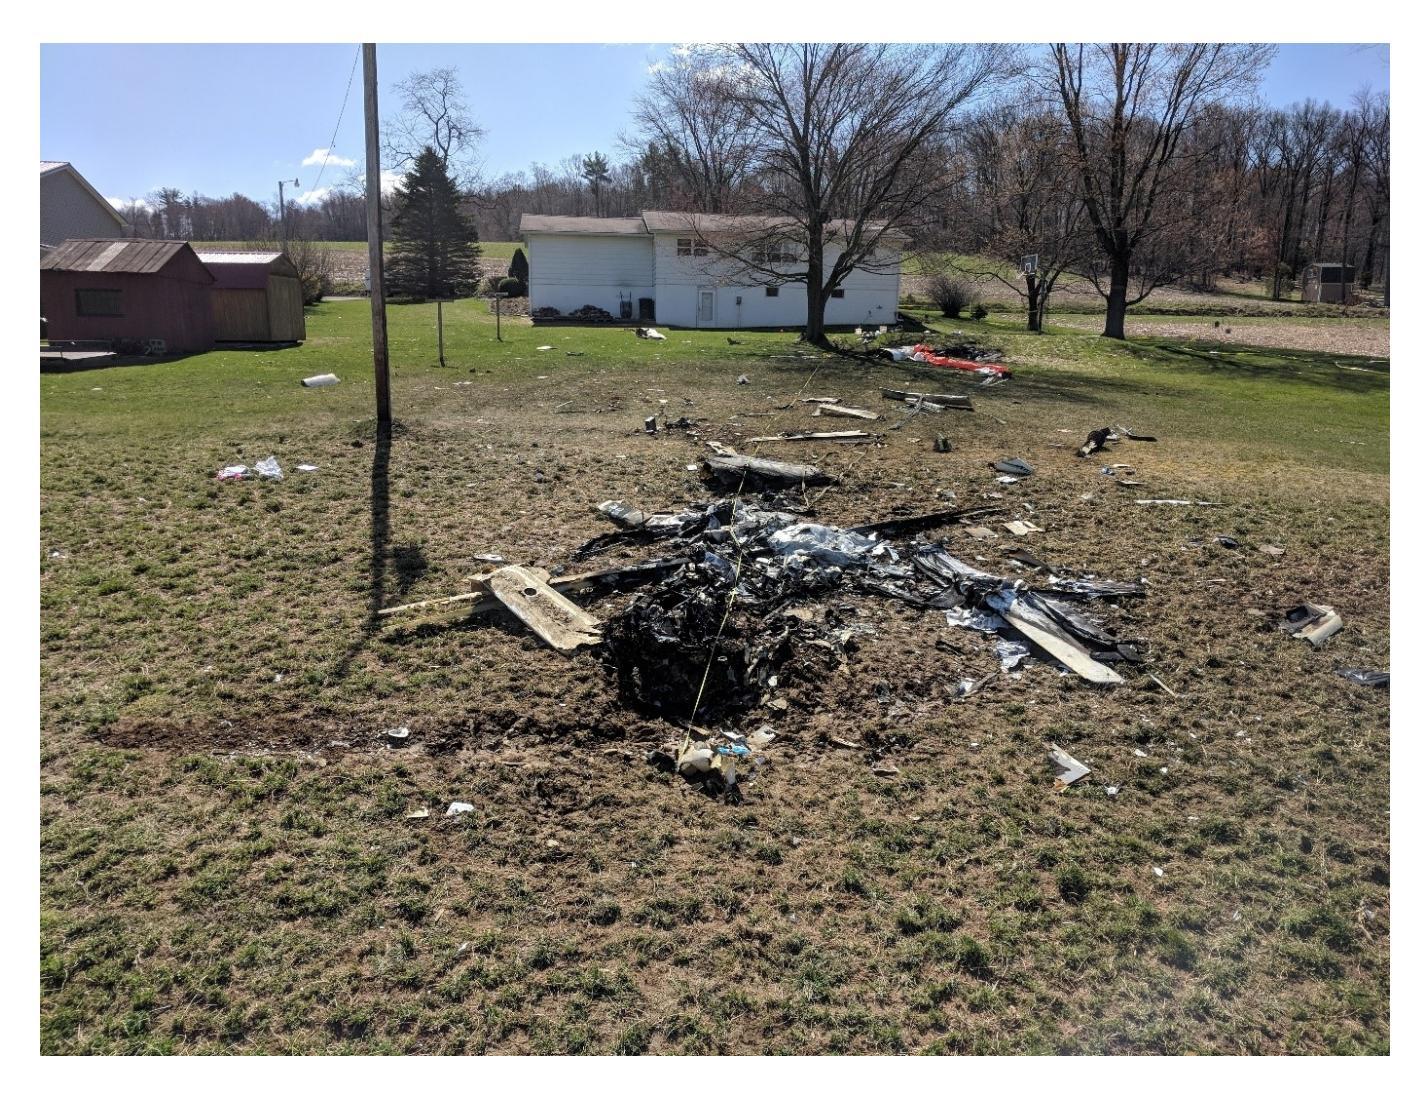
Figure 4. Initial impact point and airplane wreckage

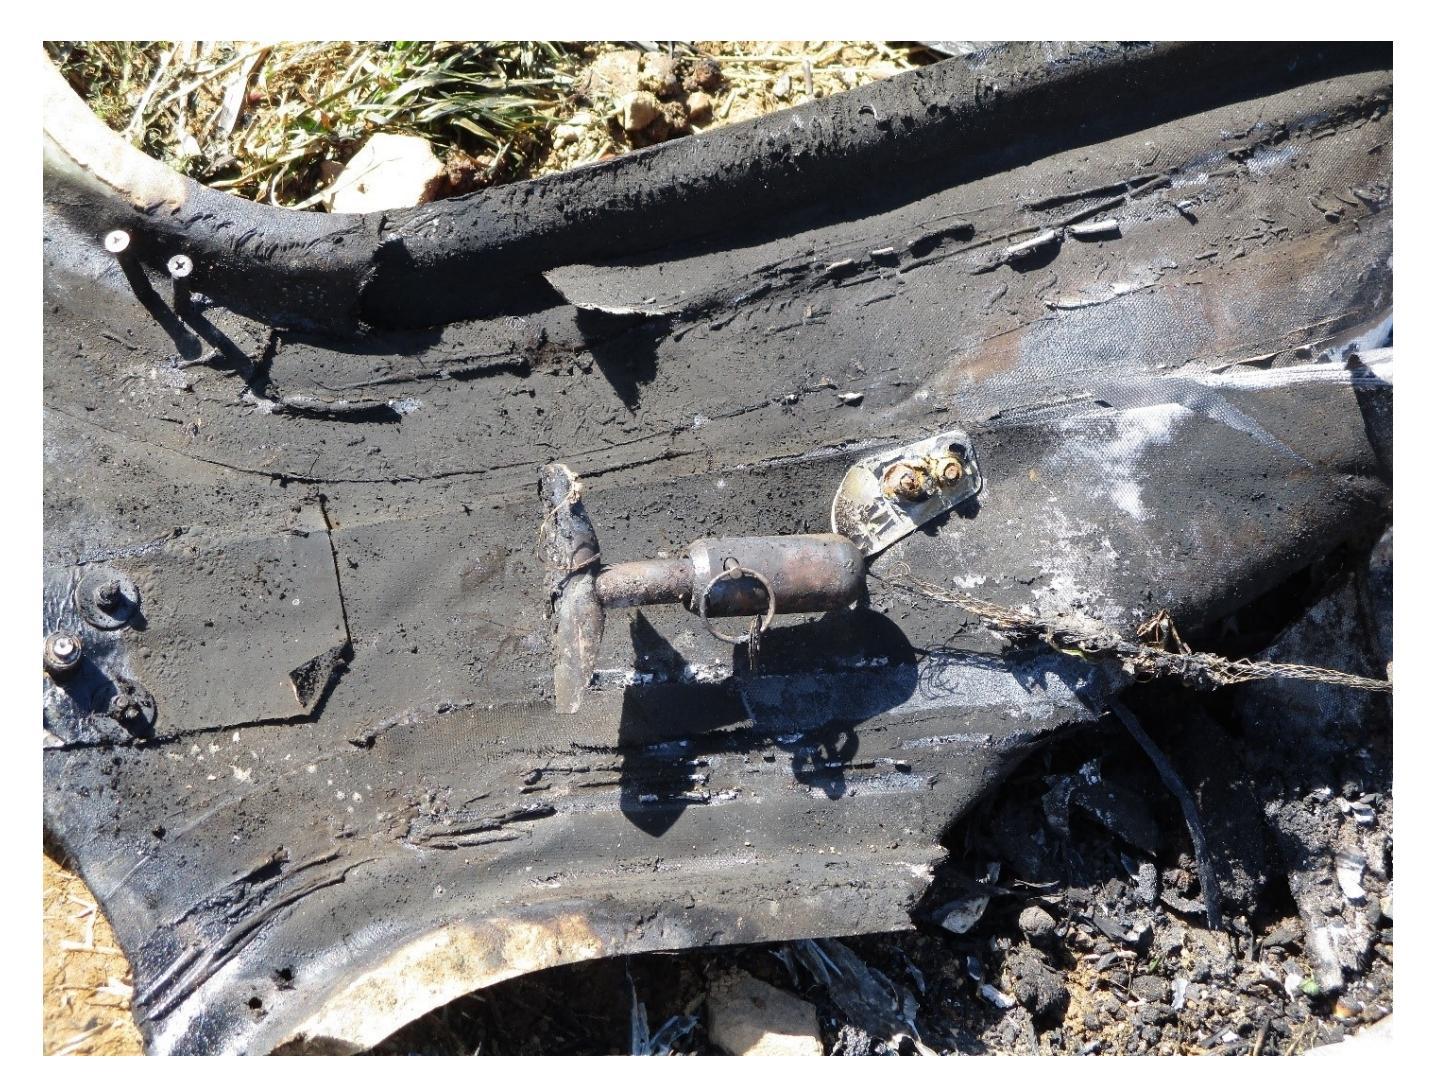
Figure 5. Safety pin installed in the CAPS activation handle
