Aviation Investigation Final Report

Location:	Galliano, Louisiana	Accident Number:	CEN16LA401
Date & Time:	April 7, 2016,	Registration:	N639NA
Aircraft:	AGUSTAWESTLAND PHILADELPHIA AW139	Aircraft Damage:	Substantial
Defining Event:	Part(s) separation from AC	Injuries:	9 None
Flight Conducted Under:	Part 91: General aviation - Other work use

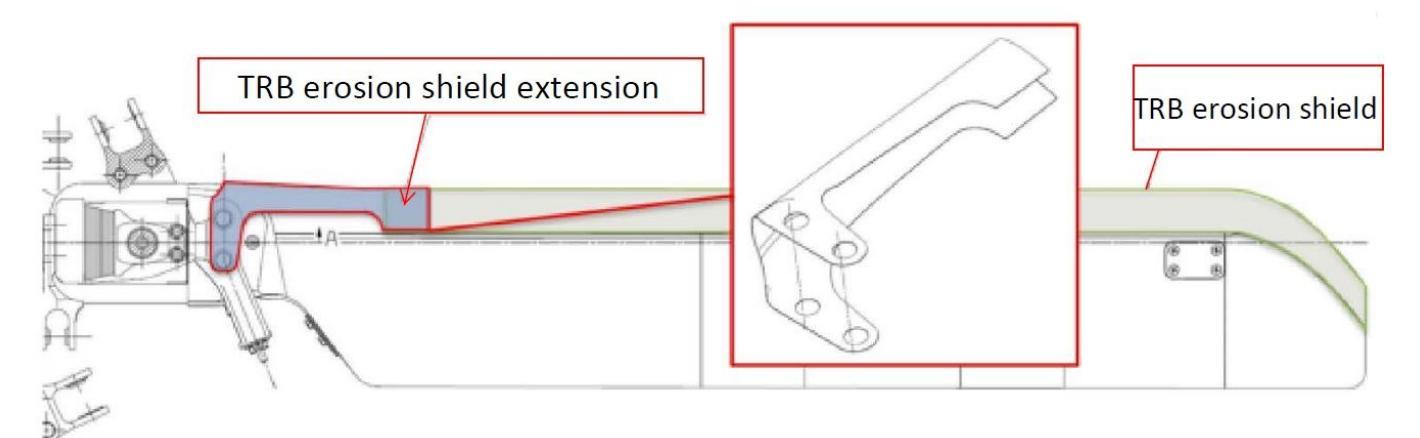
On May 9, 2018, the Chevron aviation department reported the accident to the NTSB and stated that during the flight the crew felt a slight vibration of the tail rotor. After landing at GAO during a post flight inspection, one of the tail rotor blade (TRB) erosion shield extensions (figure 1) commonly known as a lightning strip (LS) was missing and only its side tabs remained attached to the blade. Additionally, a main rotor blade (MRB) tip was damaged.

Figure 1 – TRB erosion shield extension diagram with notations (Courtesy of Leonardo)

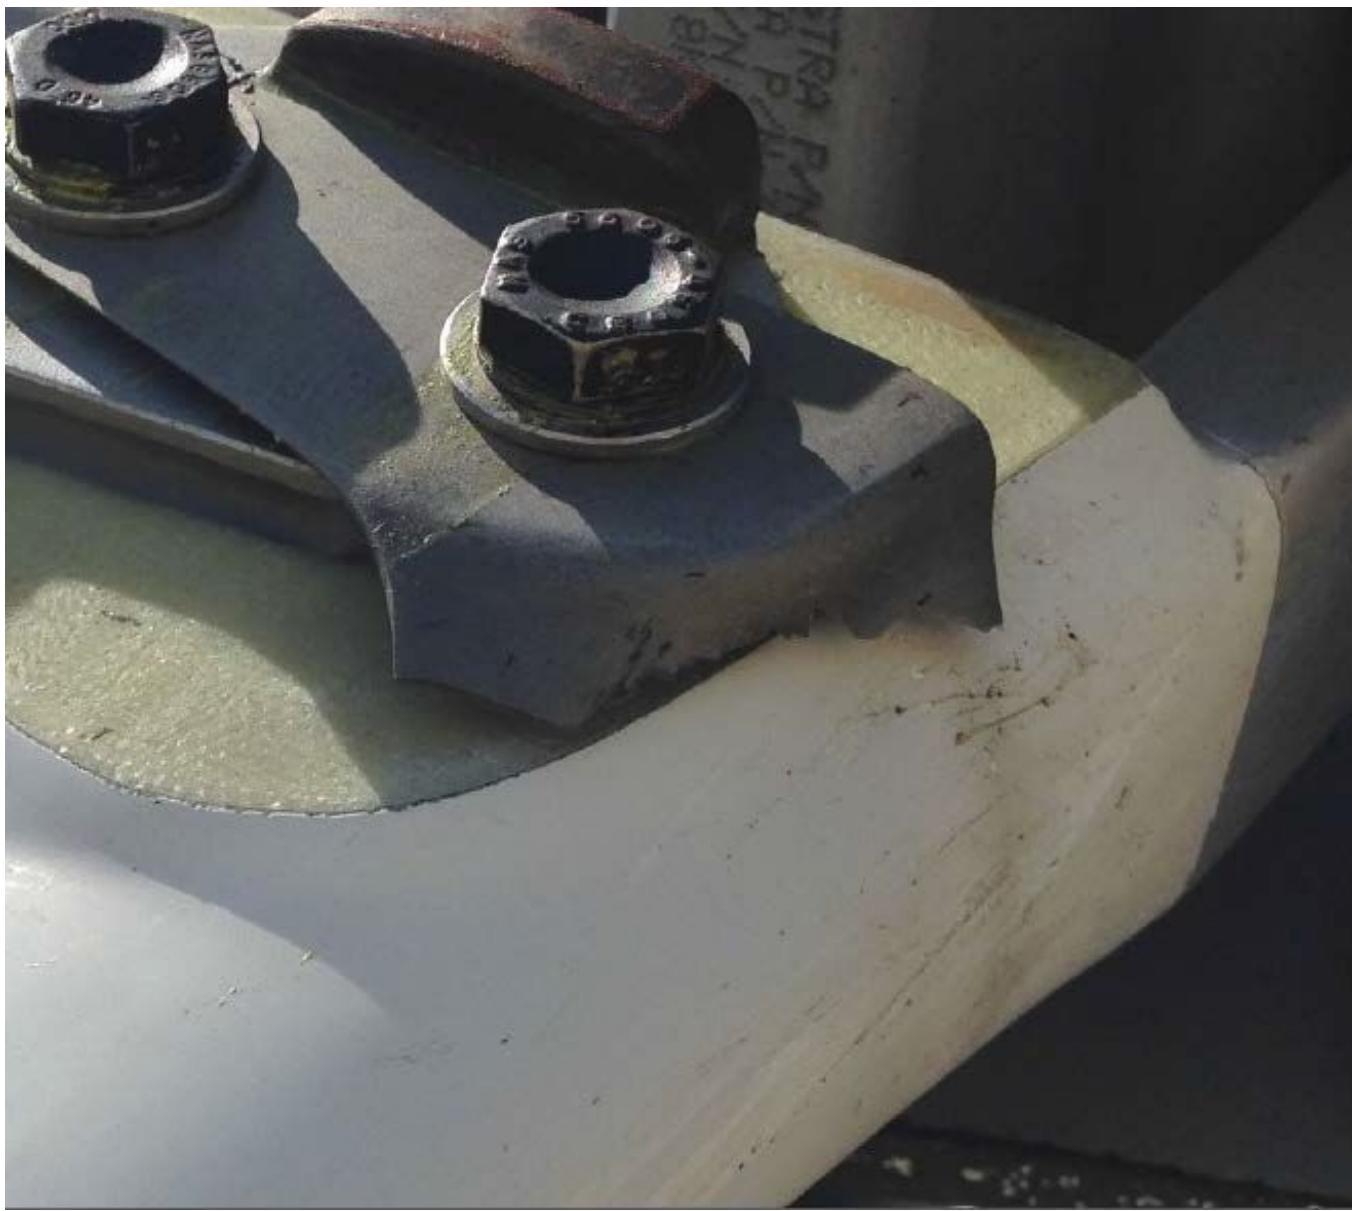
A Chevron post flight inspection of the helicopter revealed that the LS on the white TRB was fractured and most of the component was missing. Only the side tabs, where the tail rotor damper bracket bushings pass through, remained attached (figure 2).

Figure 2 – Damaged Tail Rotor Erosion Shield Extension (Courtesy of Chevron)

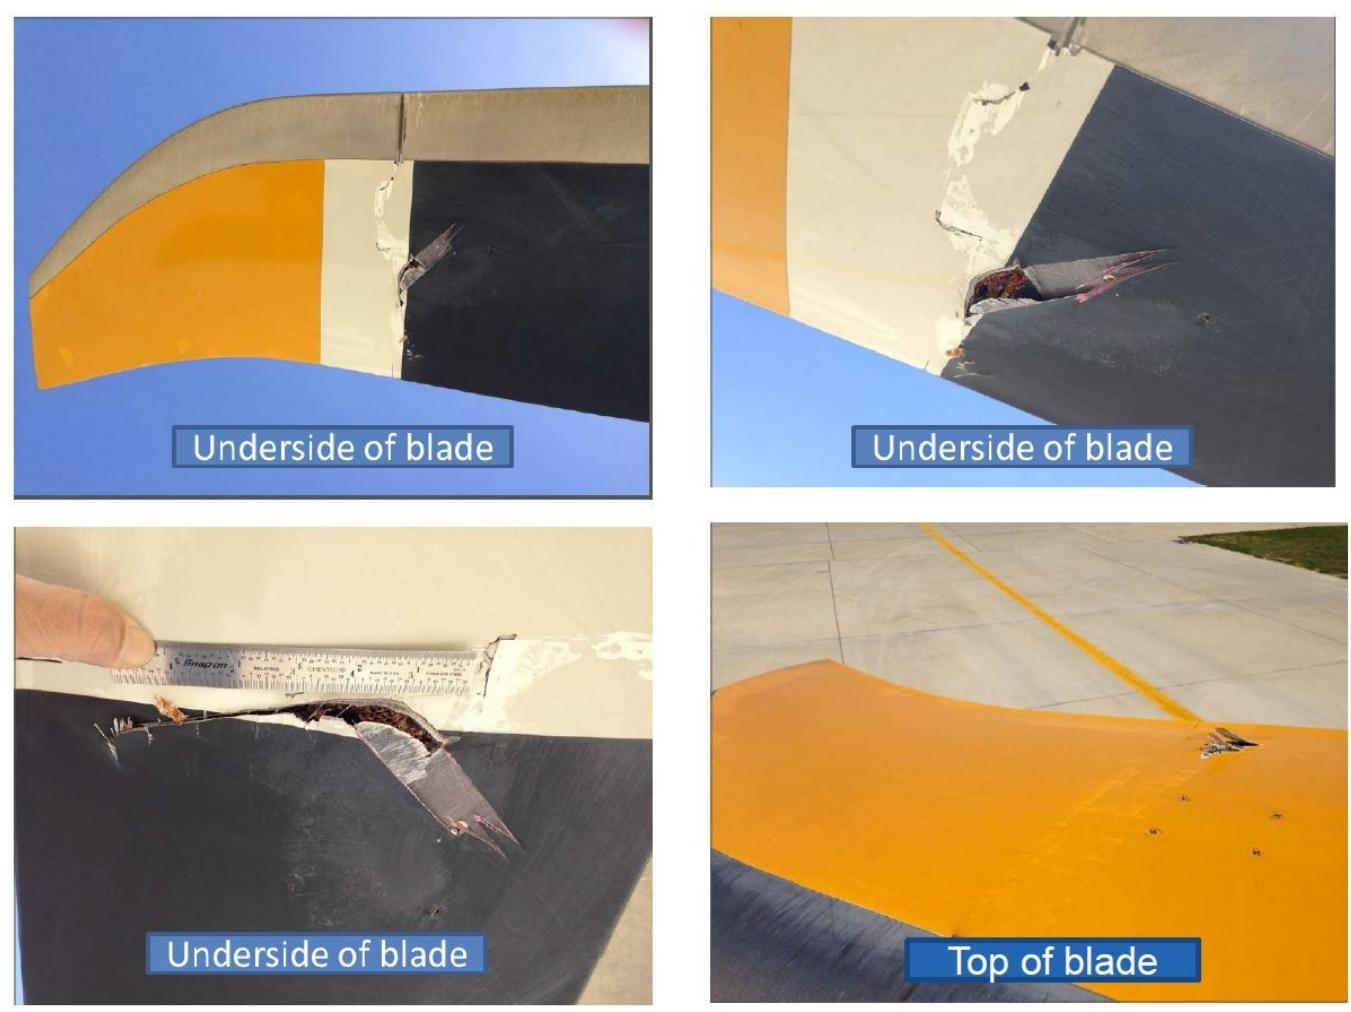
The inspection also found damage to one of the main rotor blades; the blue MRB tip sustained damage mostly on the under side of the blade (figure 3). No additional damage was observed on the remainder of the helicopter.

Figure 3 – Damaged Main Rotor Blade (Courtesy of Chevron)

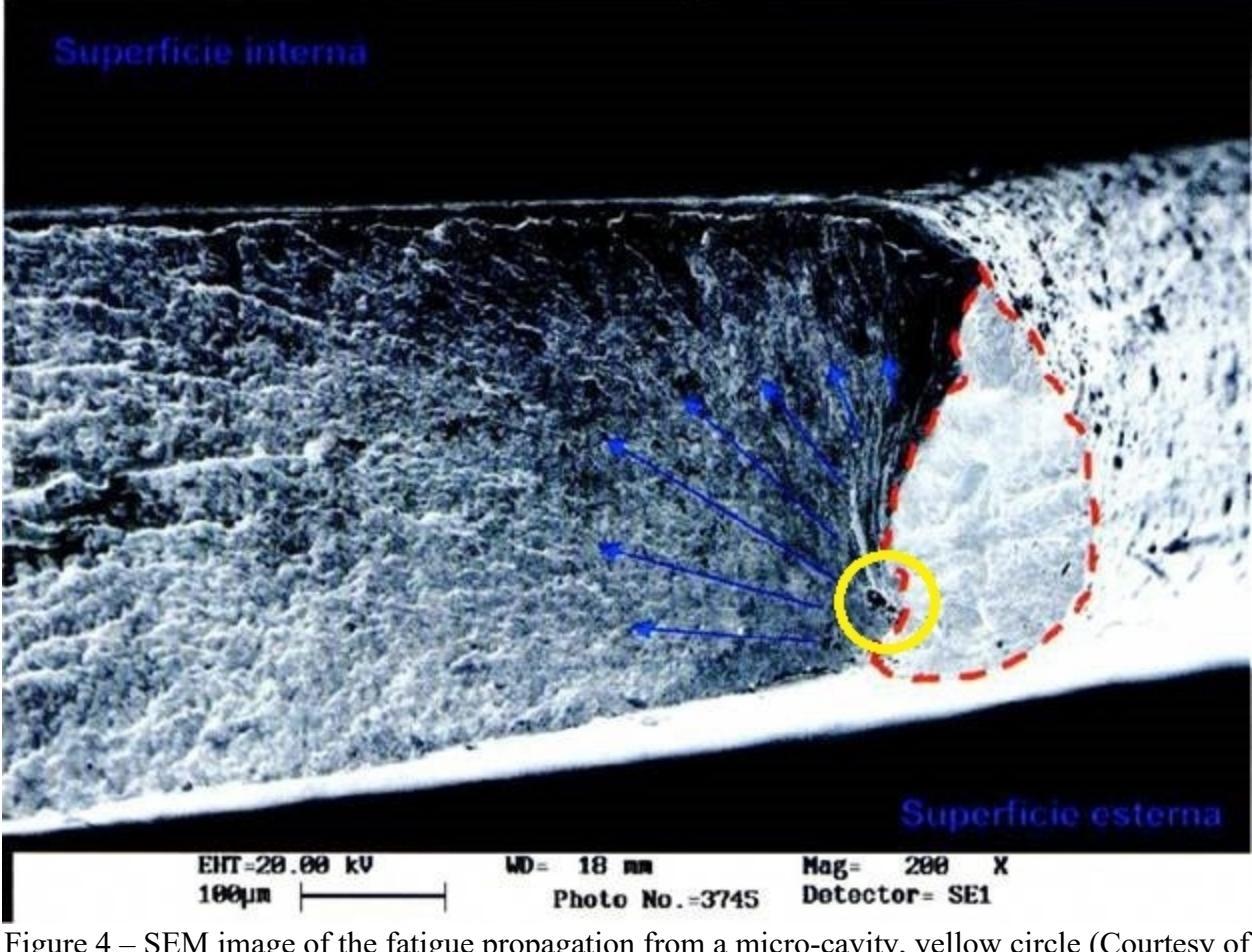
Leonardo, the current AW139 helicopter manufacturer, performed a failure analysis on the remaining portion of the LS, using a scanning electron microscope (SEM), which revealed the presence of microcavity spots or porosity on the surface of the fractured section. Leonardo concluded that the microcavities were a direct result of the electroplating manufacturing process. In figure 4, the area circled in yellow is the microcavity, the red dashes indicate the crack initiation, and the blue arrows indicate the direction of the fatigue crack propagation.

Figure 4 – SEM image of the fatigue propagation from a micro-cavity, yellow circle (Courtesy of Leonardo)

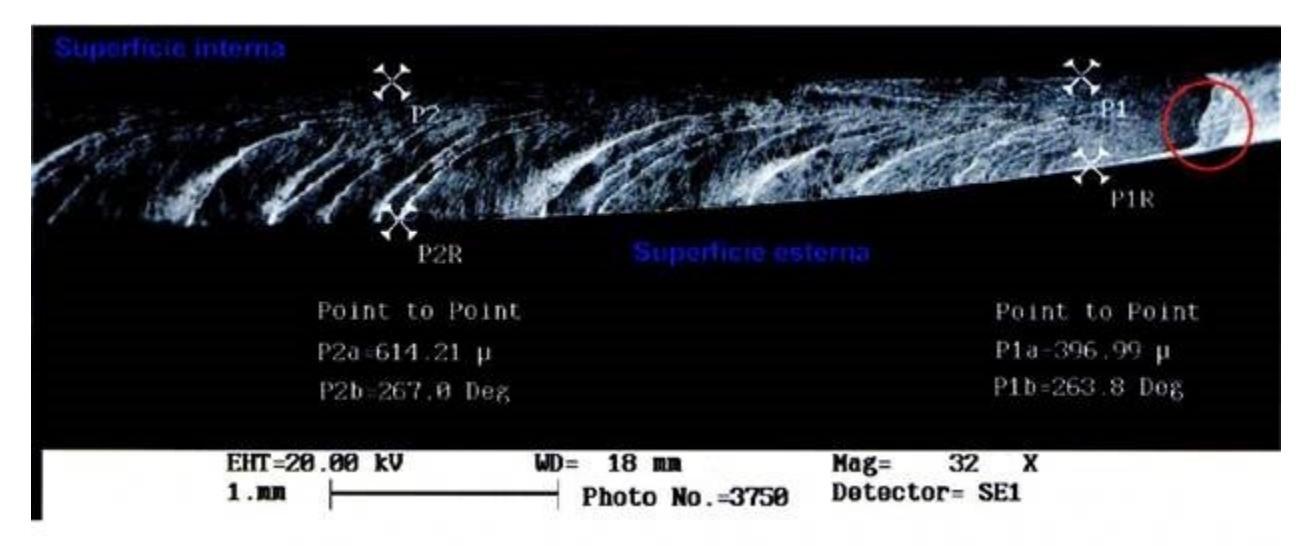
Figure 5 shows a wide view of the fracture surface with the crack origination circled in red.

Figure 5 – SEM image, wide view of fracture surface (Courtesy of Leonardo)
