Aviation Investigation Final Report

Location:	Lincolnton, North Carolina	Accident Number:	ERA18FA197
Date & Time:	July 24, 2018, 05:21 Local	Registration:	N38523
Aircraft:	Piper PA32R	Aircraft Damage:	Substantial
Defining Event:	VFR encounter with IMC	Injuries:	2 Fatal
Flight Conducted Under:	Part 91: General aviation - Personal

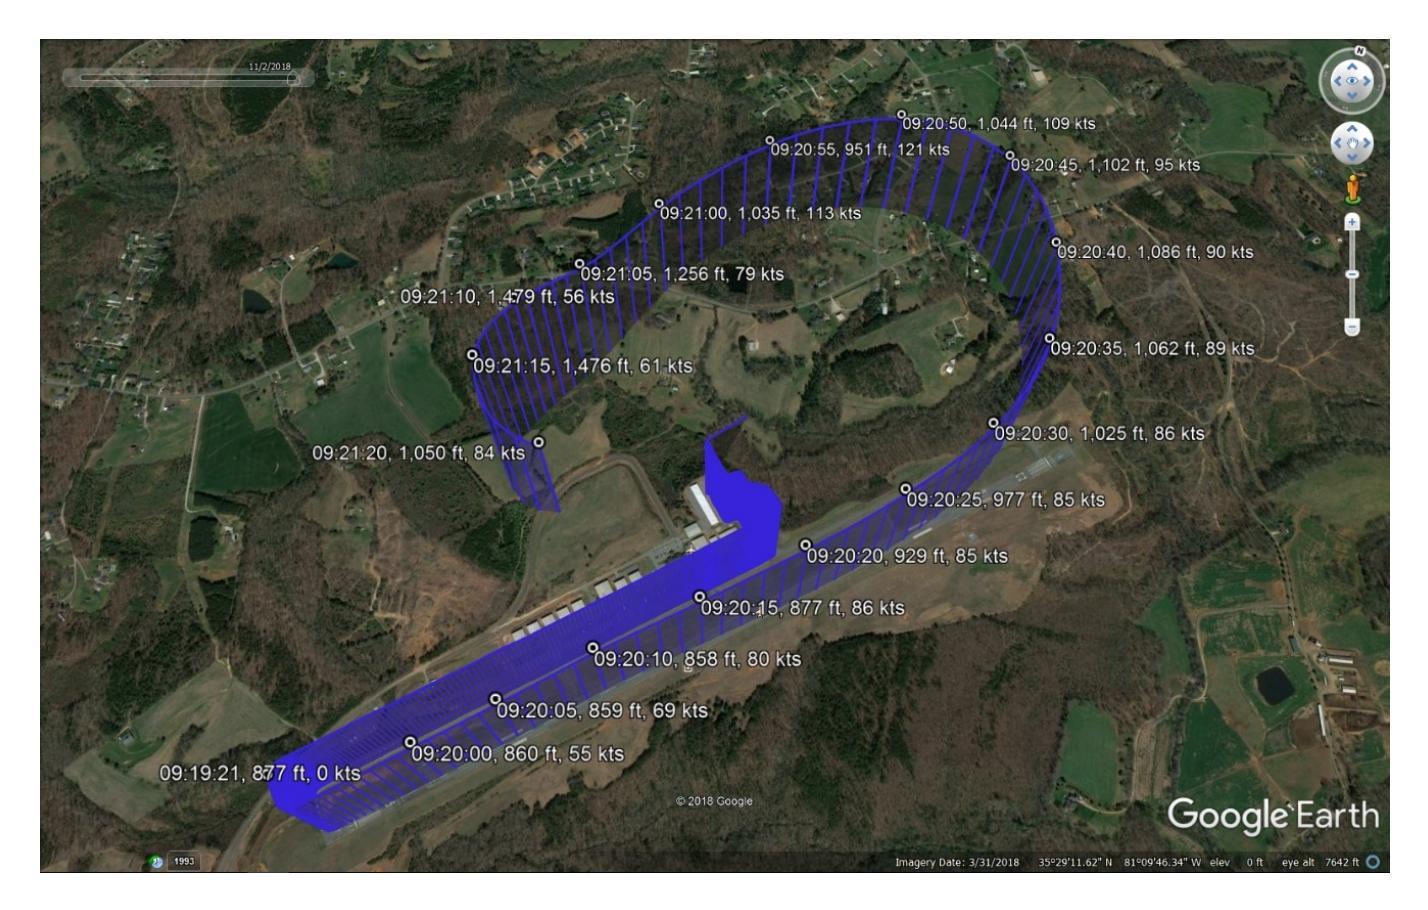
Data from the onboard Appareo Stratus 2S unit indicated that the airplane departed runway 05 about 0520; about 0520:25, the pilot initiated a left turn as it climbed from the runway. The airplane continued the climbing left turn to about 1,100 ft GPS altitude and a groundspeed about 95 knots, then descended to about 950 ft GPS altitude and accelerated to a groundspeed about 121 knots on an approximate left downwind leg for runway 05. About 0521:10, the airplane was about 1,480 ft GPS altitude and a groundspeed about 56 knots. The airplane subsequently entered a descending left turn; the final recorded data point captured a GPS altitude of 1,050 ft and a rate of descent greater than 4,000 ft per minute. (see Figure 1.) A witness near the accident site reported that he was sleeping when he heard a low-flying airplane followed by a "thud." He drove to the airport and located the airplane in an open field about 1/2-mile northwest of midfield.

Googl e Earth overlay showing accident flight track data
