Aviation Investigation Final Report

Location:	Honolulu, Hawaii	Accident Number:	WPR18LA221
Date & Time:	August 8, 2018, 09:20 Local	Registration:	N369MH
Aircraft:	Hughes 369	Aircraft Damage:	Substantial
Defining Event:	Flight control sys malf/fail	Injuries:	4 None
Flight Conducted Under:	Part 135: Air taxi & commuter - Non-scheduled - Sightseeing

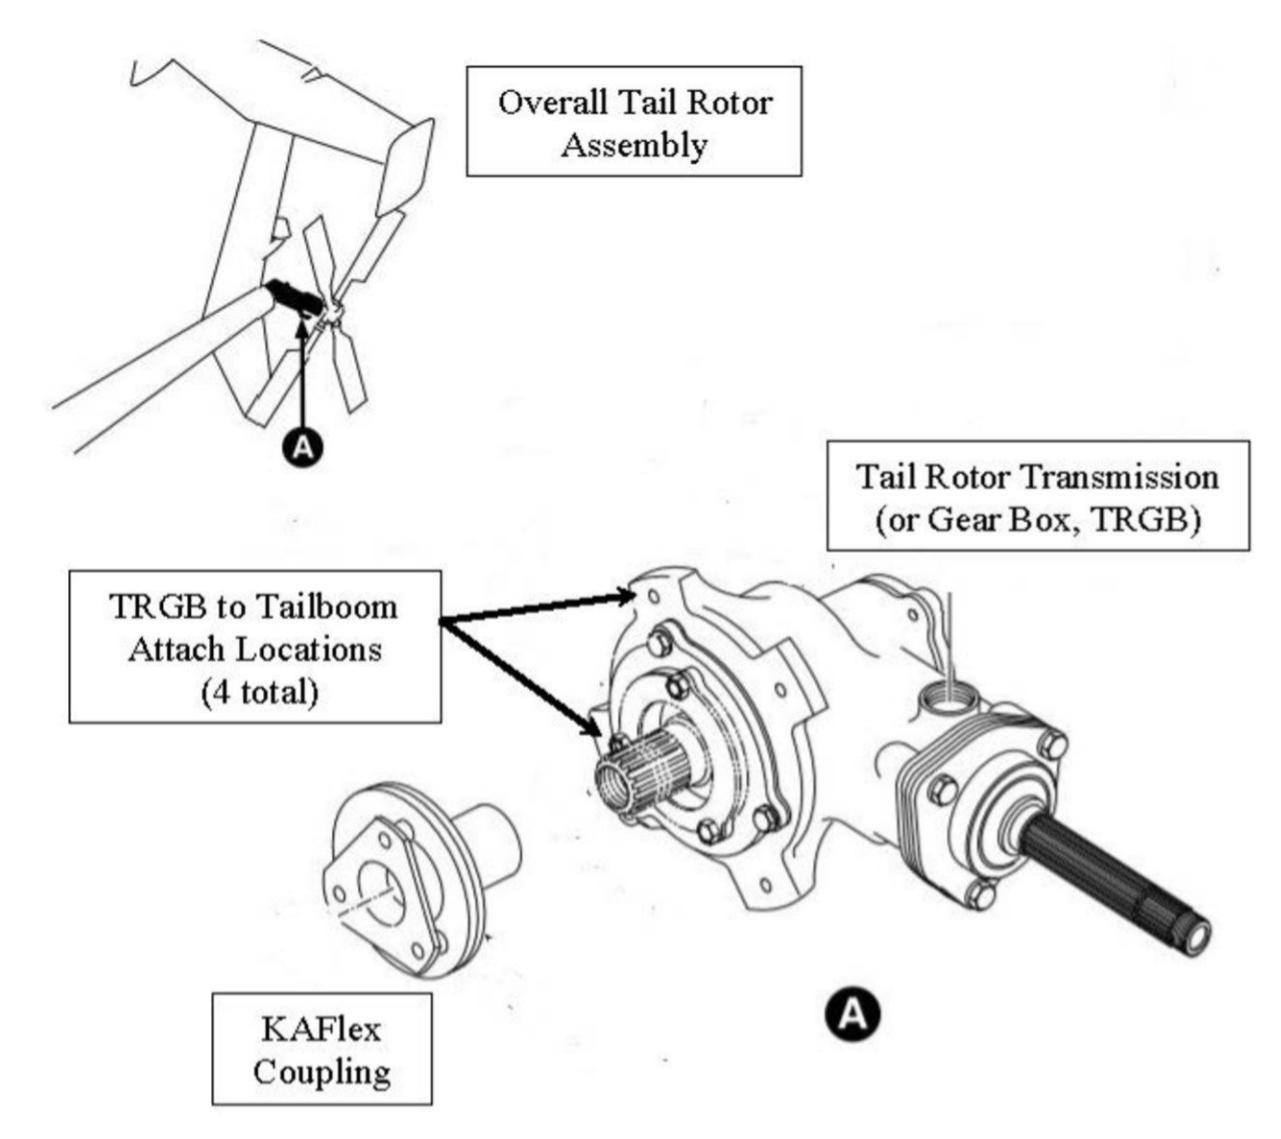
Figure 1. Overview of TR Assembly

Each TR blade assembly was mounted in one pair of fork arms. It was suspended by its two teeter bearings, secured by a fork (or "teeter") bolt that extended through the TR hub, and through the bearing near each end of the fork bolt. The nickel alloy tension fork/teeter bolts (369A1602-3) and their nuts (VCU0001) were MDHI parts. (see Figures 1 through 3)
