# **Aviation Investigation Final Report**

Location:	Prescott, Arizona	Accident Number:	WPR18FA245
Date & Time:	August 29, 2018, 20:35 Local	Registration:	N6500W
Aircraft:	Cessna P210	Aircraft Damage:	Destroyed
Defining Event:	Controlled flight into terr/obj (CFIT)	Injuries:	1 Fatal
Flight Conducted Under:	Part 91: General aviation - Personal

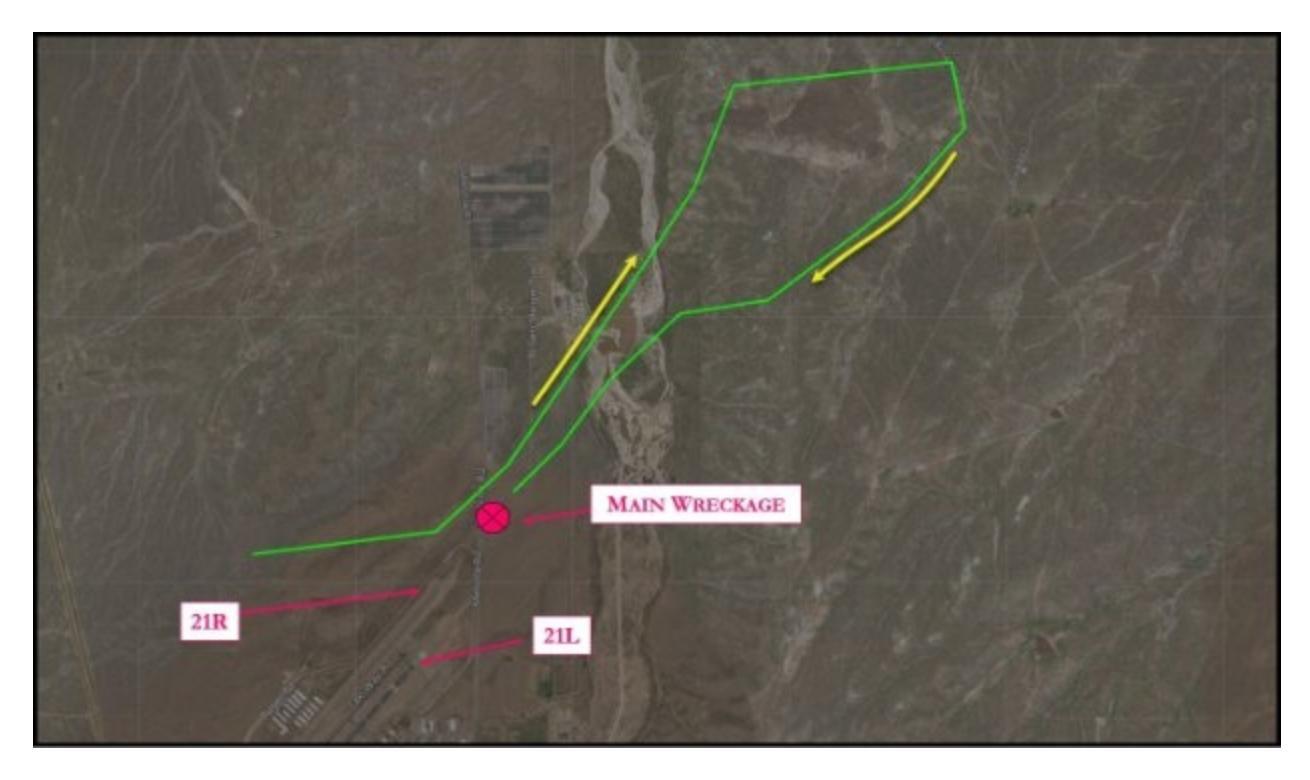
Figure 1: Radar Track

A review of the radar track data indicated that after departure, the airplane joined a right traffic pattern for runway 21R (see figure 1). On the downwind leg, the track was not parallel to the runway and neared the approach end. The track then progressed into a long teardrop-shaped 180° turn; about 2.8 nautical miles (nm) from the approach end of runway 21R, the airplane's heading turned right toward the runway. At 2032:59 the tower controller stated to the pilot, "just verifying you're lining up for runway 21R." Four seconds later the pilot replied, "roger that, 21R, 6500W." At 2033:19 the controller told the pilot to go around.

The last recorded data point was at 2034:17 and about 740 ft northeast of the accident site. At that time, the airplane was about 5,050 ft mean sea level (msl), which was about 145 ft above ground level (agl), at a ground speed of 99 kts. At 2034:24, the controller again told the pilot to go around, to which another pilot in the pattern responded that the airplane was on fire.

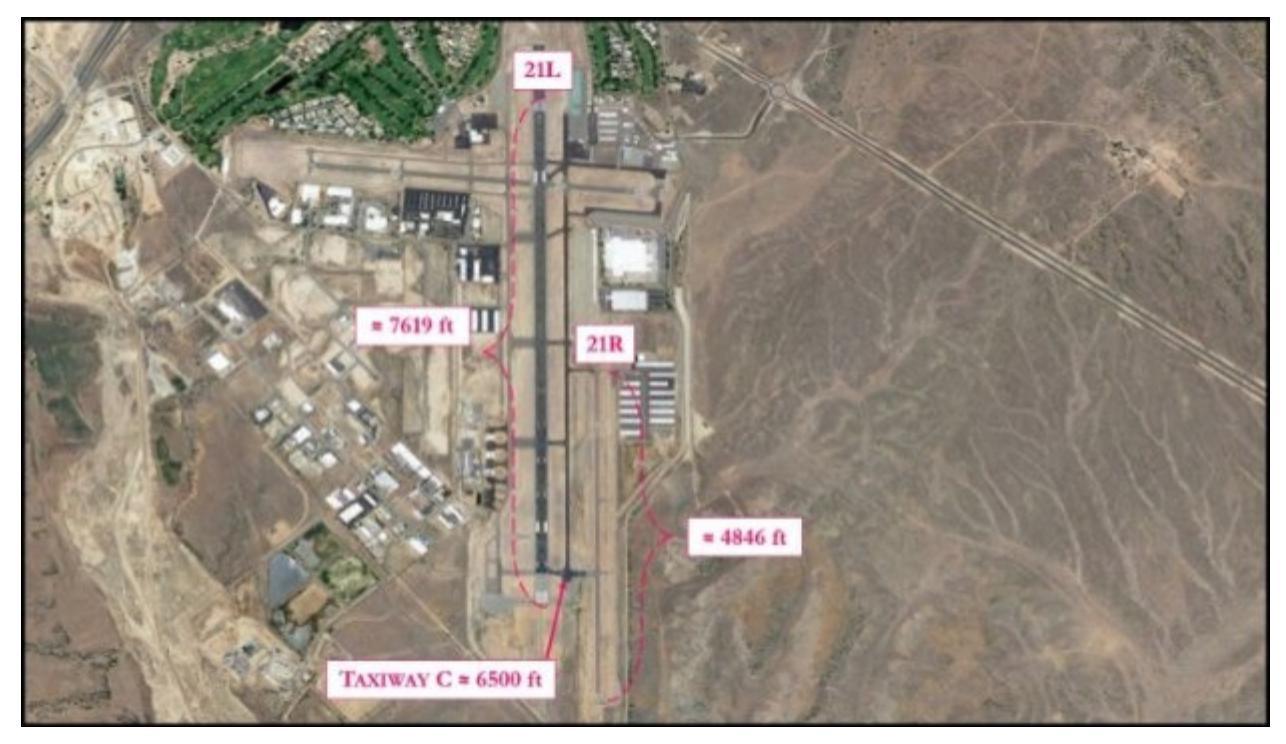
### Figure 2: Airport

Runway 21R was 4,846 ft long by 60 ft wide, and runway 21L was 7,619 ft long by 150 ft wide. The threshold for runway 21L was 1,500 ft beyond the threshold for runway 21R (see figure 2). Further, a lighted taxiway was between the two runways.

Runway 21R was equipped with a 2-light precision approach path indicator (PAPI) system with an approach angle of 3.00° located to the left of the runway that provided a threshold crossing height of 48 ft. The runway was equipped with medium intensity edge lights. The runway 21R threshold was at an elevation of 4,938 ft and it sloped up at 0.8% to 4,975 ft at the runway end.

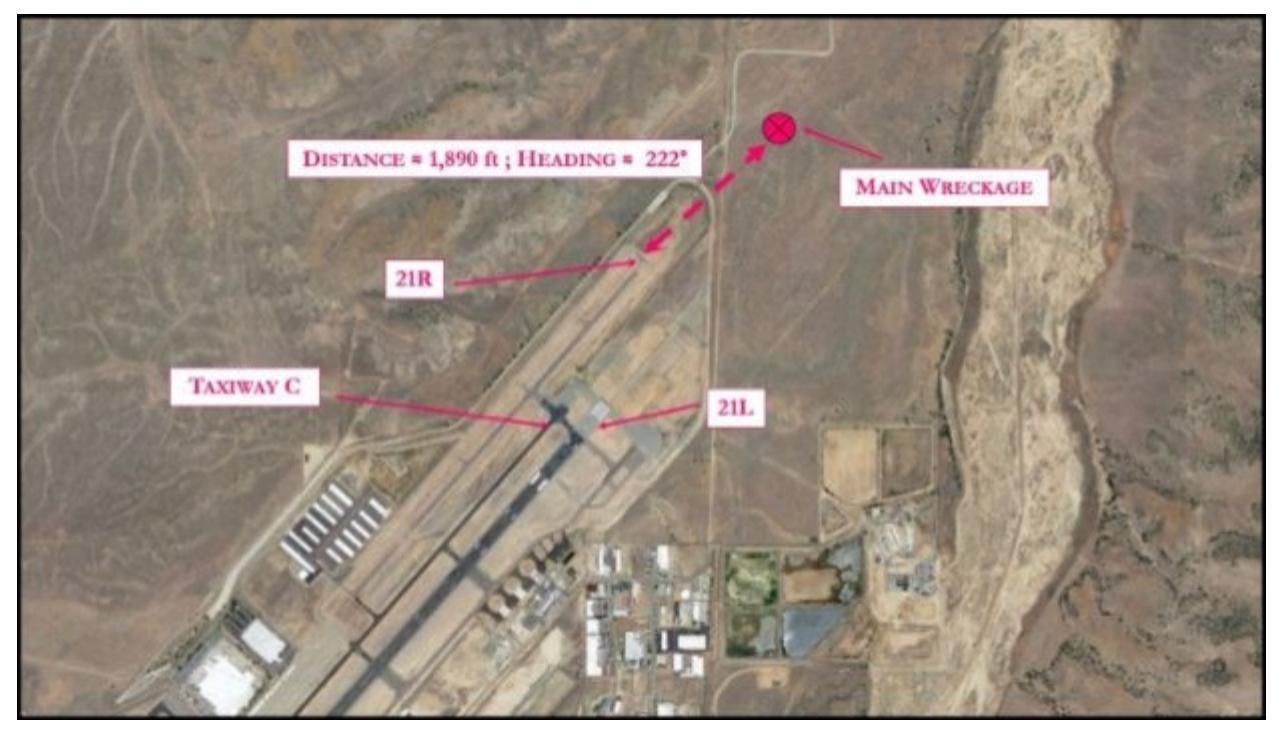
Figure 3: Accident Site in Reference to the Airport

The accident site was located in desert terrain about 1,890 ft from the runway 21R threshold (see figure 3). The wreckage was found distributed over a 240-ft distance on a median magnetic track of about 222°.
