# **Aviation Investigation Final Report**

| Location: | Forks, Washington | Accident Number: | WPR19FA091 |
| Date & Time: | March 8, 2019, 07:05 Local | Registration: | N64RA |
| Aircraft: | Bell UH1B | Aircraft Damage: | Destroyed |

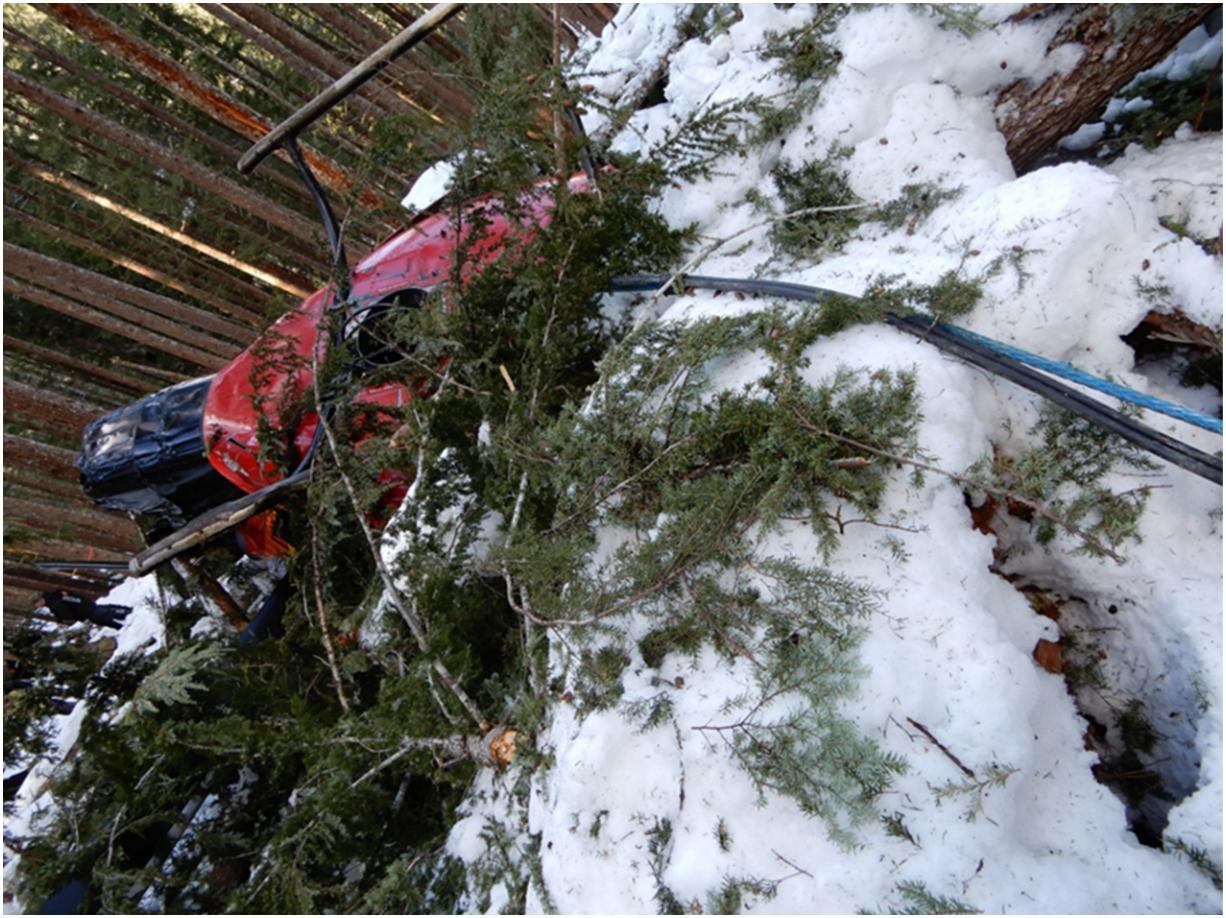
Figure 1. The helicopter at the accident site. A blue cargo line and two black hydraulic hoses can be seen running uphill to the grapple hook.

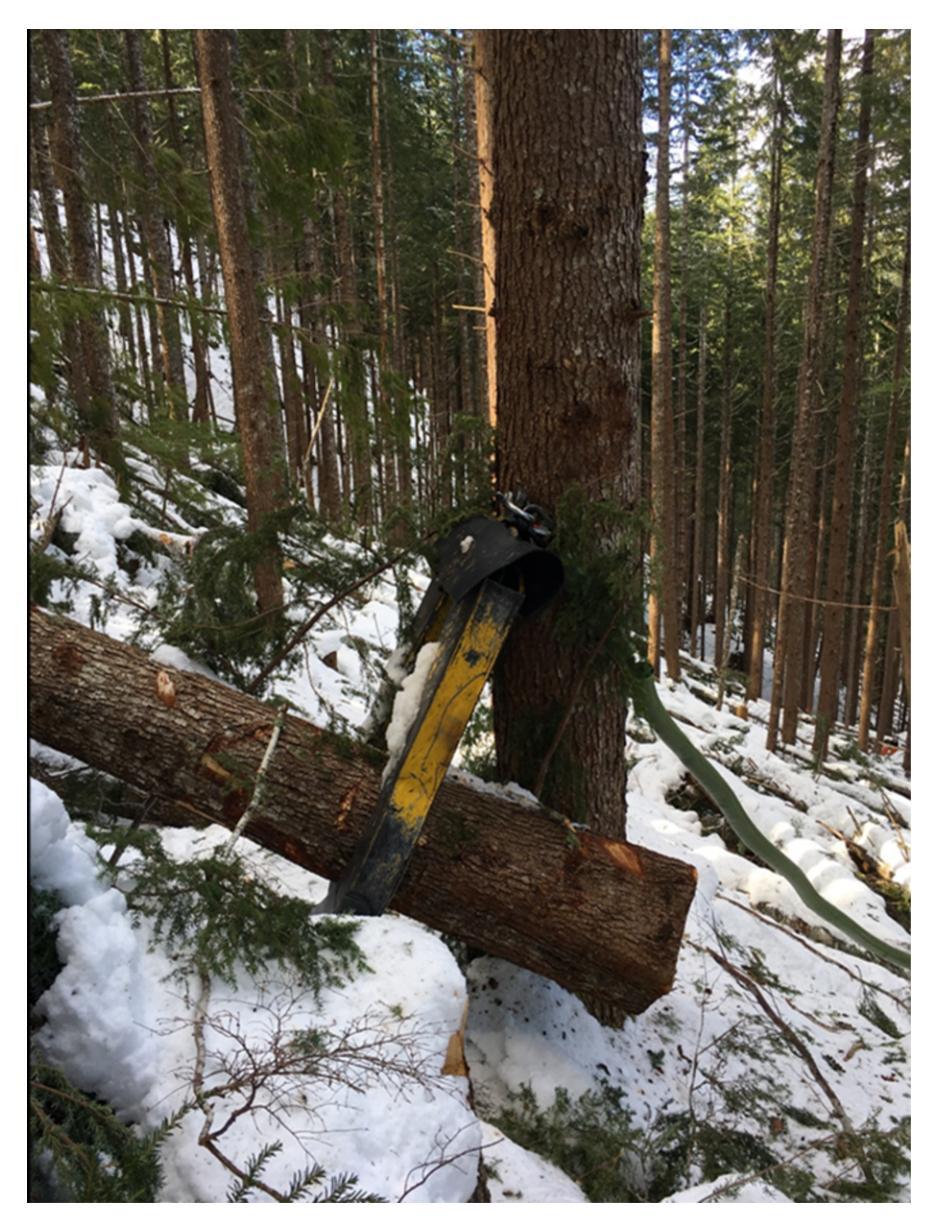
The helicopter came to rest on steep, mountainous terrain about 1/4 mile from the company's staging area. The area was covered with felled and standing trees. All major structural components of the helicopter were located within a very small debris field around the helicopter. There was no post-crash fire. A cargo line remained attached to the cargo hook and extended uphill 180 feet to a hydraulic grapple hook. Two hydraulic fluid hoses extended from the belly of the helicopter and followed the cargo line uphill and were attached to the grapple. The grapple was resting against a standing tree and held a log in its jaws. (See figure 2.) Visual examination of the area around the grappled log revealed the grappled log rested perpendicular to the cargo line running downhill to the helicopter, and a portion of the grapple had caught the standing tree consistent with establishing an anchor point.

Figure 2. The grapple hook, attached to a log, and learning against a standing tree. The cargo line and two hydraulic lines are contained in a green protective sheath and run downhill to the helicopter.
