NATIONAL TRANSPORTATION SAFETY BOARD
Vehicle Recorder Division
Washington, DC 20594

Time Alignment Study

Specialist's Study Report By Christopher Babcock

Location: Philadelphia, Pennsylvania
Date: July 7, 2010, 14:37 Eastern Daylight Time (EDT)
NTSB Number: DCA10MM025

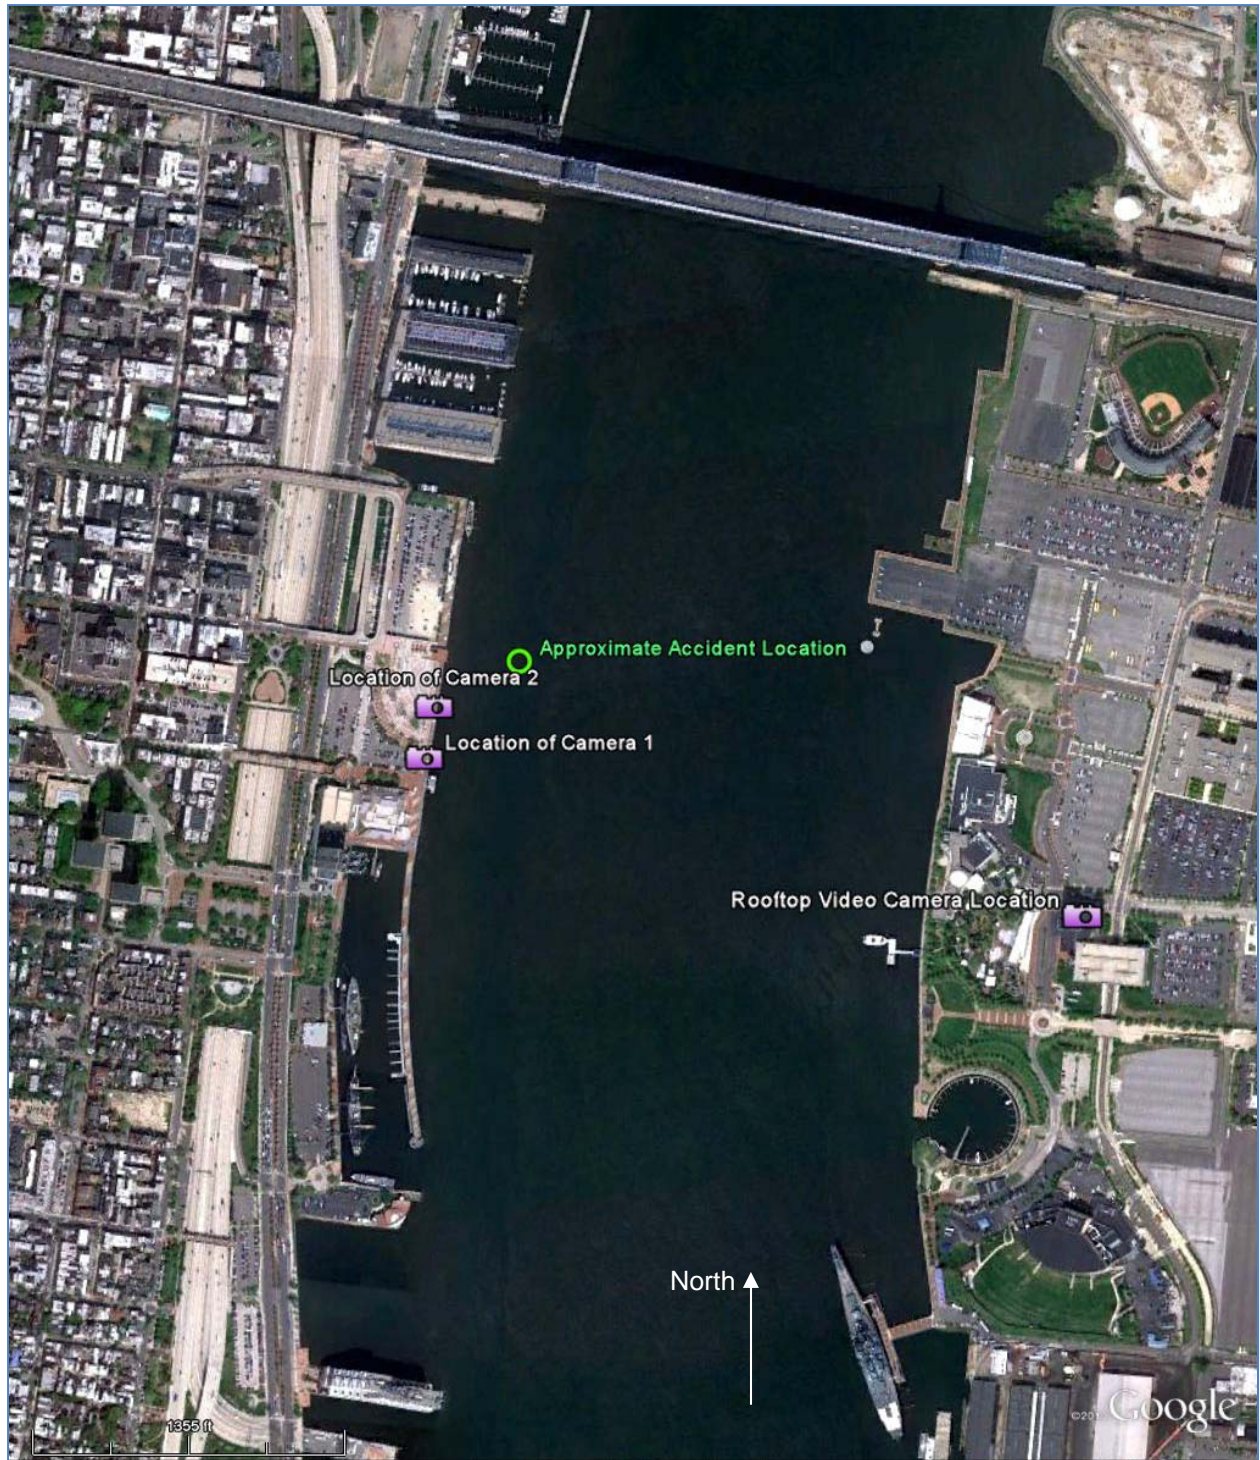
Figure 1. Locations of electronic data sources.

Investigators obtained several sources of electronic data during the course of the investigation including Automatic Information System (AIS) data and video and still imagery. Figure 1 identifies the locations of each image data source.

A camera operated by a research and development lab operated by an Army contractor in Camden, New Jersey, captured the accident sequence and postaccident response. Figure 1 shows the location of the camera and the accident site. The video captured by the system was variable frame rate and contained two timestamps. The timestamp in the upper left of the frame closely approximated local EDT. The timestamp in the lower right of the frame approximated UTC, but the two timestamps did not agree with one another (Figure 5).

Still digital imagery from two witnesses was recovered (see Figure 1 for locations). The metadata² attached to the photographs captured the time each image was taken. The timebase of each camera was not tied to a global time, but is set by the user. The cameras were later secured by Safety Board investigators and a series of photographs was taken over several months to account for drift in the camera clock and align the timebase of the camera with UTC.

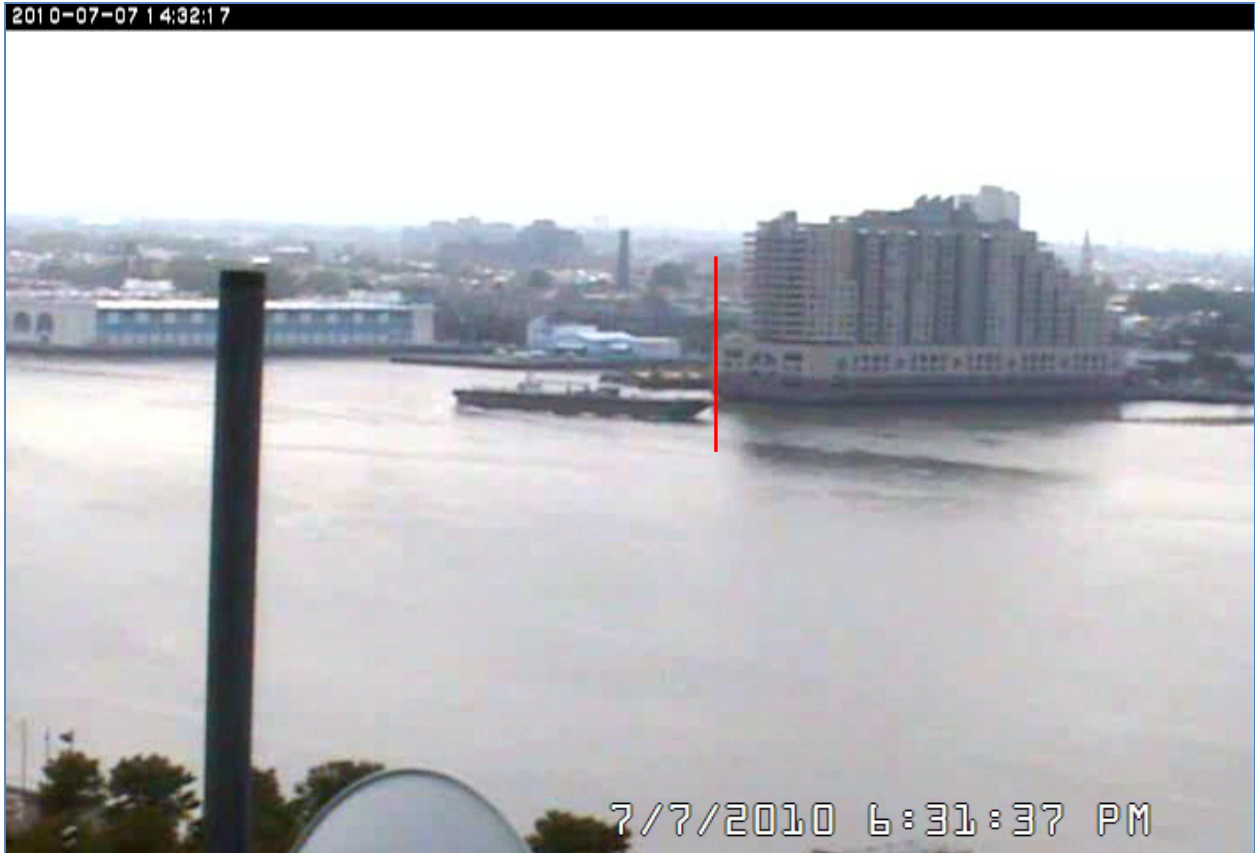
Figure 7. Bow alignment with southeast corner of condo tower pier.

In order to synchronize the timing for the video with the EDT timestamp from the AIS data, several points were selected from the video where identifiable parts of the tug/barge combination were aligned with reference points on the Philadelphia side of the river.

Event	Approximate Local Time from Video	Interpolated AIS Message Local Time	Offset
Barge bow aligned with SE corner of condo tower pier	14:32:17	14:32:10	:07
Barge bow aligned with Columbus monument	14:35:32	14:35:26	:06
Barge bow aligned with SE support column	14:37:14	14:37:07	:07
Accident	14:37:30	14:37:23	:07
Tug stern aligned with SW corner of condo building	14:39:29	14:39:22	:07

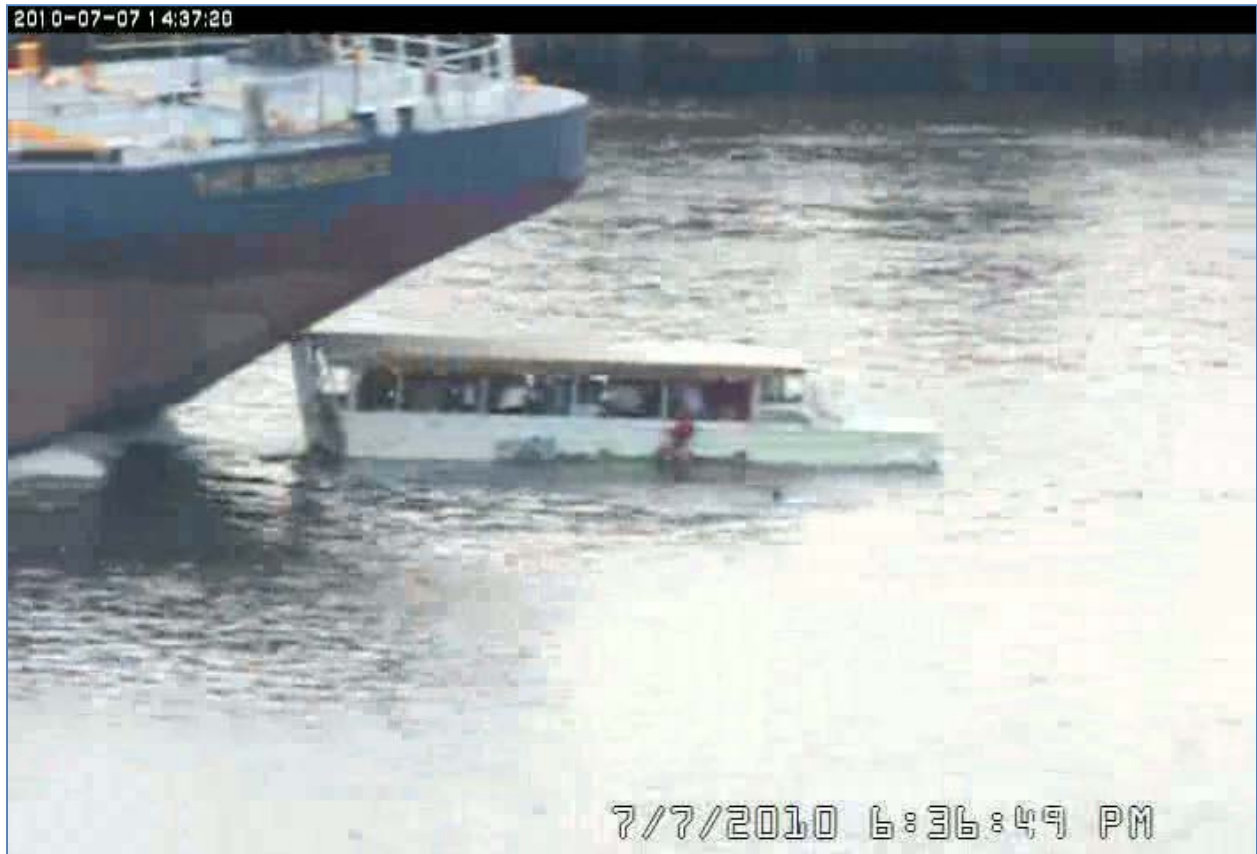
Figure 17. Frame capture from Army video at time of accident.

Figure 17 shows a frame from the video at the time of the accident. The approximate local time in the upper left hand corner appears to show “14:37:20”, however the frame was captured in the process of the seconds field “:29” advancing one second to “:30”.

Table 1 shows the timing and offset of each frame capture in the series. To correct the time displayed in the upper left hand corner of the video to local EDT, 7 seconds should be subtracted.

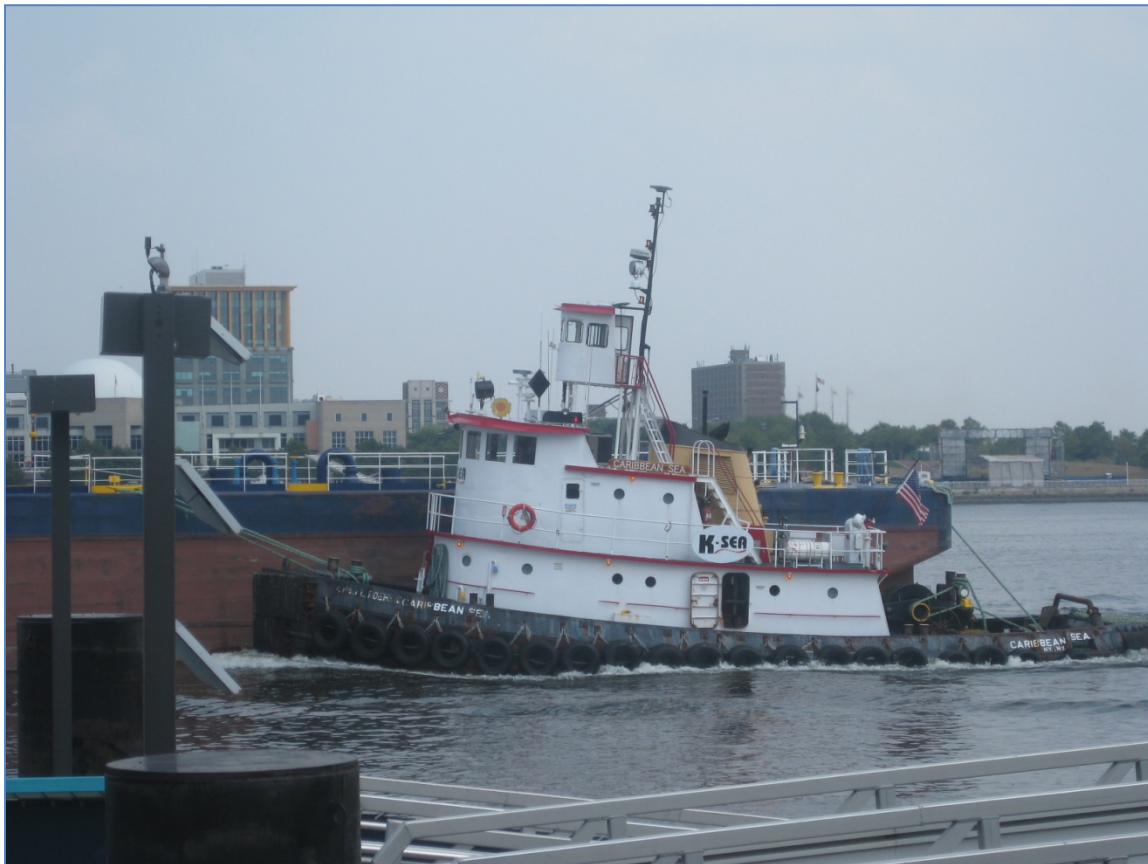
Figure 18. Image captured from camera 1.

Figure 18 shows the single image capture by camera 1, a Canon PowerShot SD1100IS Digital Elph. Table 2 shows the timing and offset for the series of images taken to identify the EDT time of the image taken prior to the accident. The series of images show the drift between 8/20/10 and 1/7/11 was both linear and predictable (Figure 19). The dataset was used to extrapolate back to the time of the accident image and determine the offset for the accident image was 2:54:26. When the offset was applied to the accident image, the extrapolation showed the image was taken at approximately 14:36:40 EDT. The AIS position of the tug at the time of the photo is also shown in Figure 20. The extrapolation indicates the image was taken 43 seconds and approximately 150 yards downriver before the accident.

Investigators did not have immediate access to the camera so the extrapolation outlined in section 4.1.3.1 was necessary. The uncertainty of the time of the photo in Figure 18 was bounded by the necessity of the GPS antenna on the tug in the foreground being between the two buildings identified in Figure 20 in the background. The maximum uncertainty for the timing of the image in Figure 18 was 14:36:40 plus 3 seconds, minus 0 seconds.

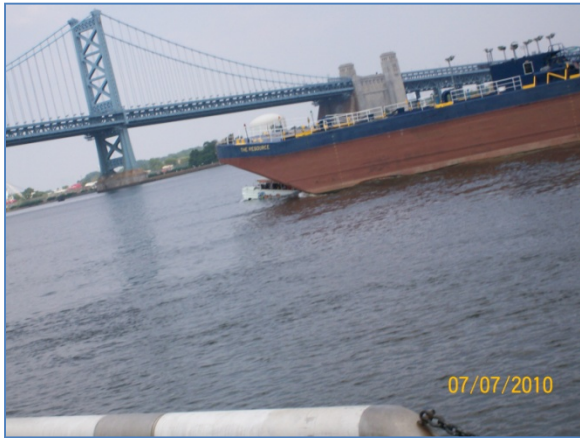
Figure 21. Witness camera 2 accident image.

Figures 21 & 22 show an image from the witness camera at the time of the accident and a frame capture from the Army video at approximately the same time.

Metadata for the image in Figure 21 indicates the image was captured at 17:34:22. Using the time offset calculated in section 4.1.2. the video frame capture occurred approximately 2 seconds after initial impact, at 14:37:25 EDT, resulting in an offset of 2:56:57.

The uncertainty of the time alignment of the images from camera 2 lies in the frame capture used to reference the image in Figure 21. The video shows the bow of the barge pushing the stern of *DUKW 34* downwards and propelling it forwards in the same orientation for 3-4 seconds before the bow of the *DUKW 34* moves to the left and then under the barge. The uncertainty can be reduced to 1-2 seconds using image 100_1135.jpg in Table 3, taken only three seconds before the image in Figure 21, which shows the anchored *DUKW* on a direct line-of-sight from the camera to a water tower in the background behind the bridge. The image used to derive the time alignment of camera 2 (Figure 21) shows the barge just after contact with the *DUKW*, but before it began propelling the *DUKW* forward, as the *DUKW* is still aligned with the water tower in the background.

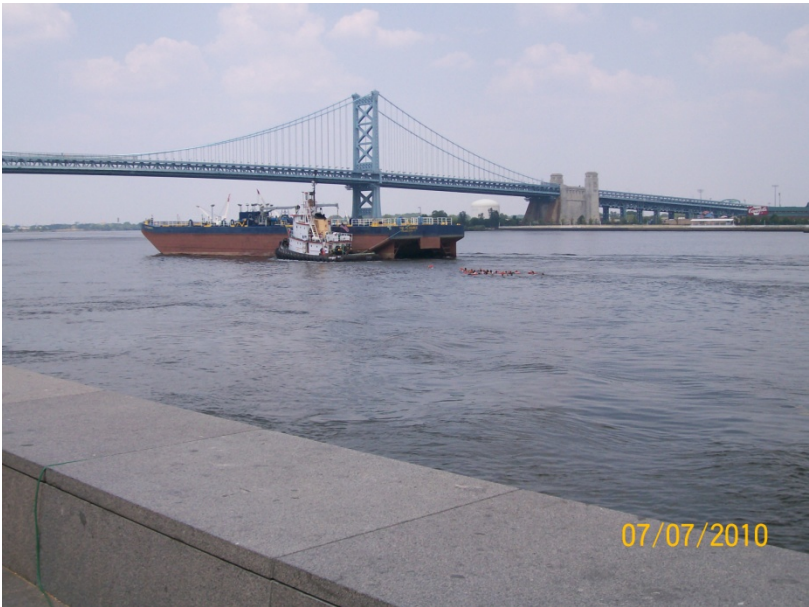
17:35:07	14:38:10
100_1142.jpg

Table 3 shows the image content, metadata time, and offset from local time using the accident time from the video, AIS position data, and image content. The full resolution images can be found in the public docket of this accident.
