NATIONAL TRANSPORTATION SAFETY BOARD

Vehicle Recorder Division

17 - GPS Factual Report

Location: Deming, New Mexico
Date: February 27, 2013, 12:30 Mountain Standard Time (MST)
Aircraft: Cessna 150M
Registration: N9172U
Operator: Private
NTSB Number: CEN13LA179

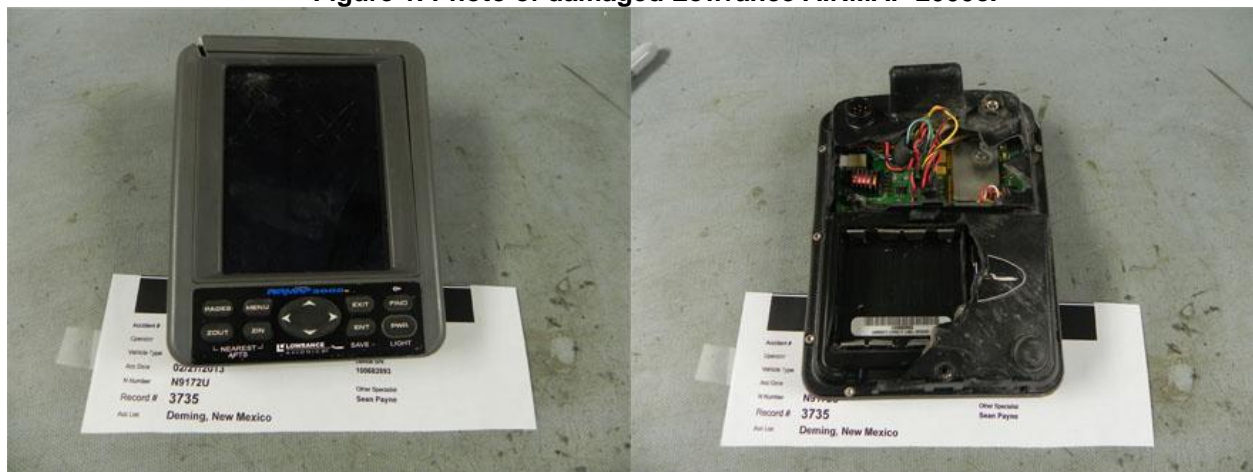
Upon arrival at the Vehicle Recorder Laboratory, an exterior examination revealed that the unit had sustained significant impact damage, as shown in figures 1 and 2. An interior inspection revealed damage to various components, including two broken and missing inductors, multiple broken wires and some screen damage. The SST 39VF1601 FLASH memory chip shown in figure 3, which contains the non-volatile memory, was identified on the printed circuit board. The chip was removed and the binary contents read. The track history was successfully extracted from the binary contents.

Figure 1. Photo of damaged Lowrance AIRMAP 2000c.

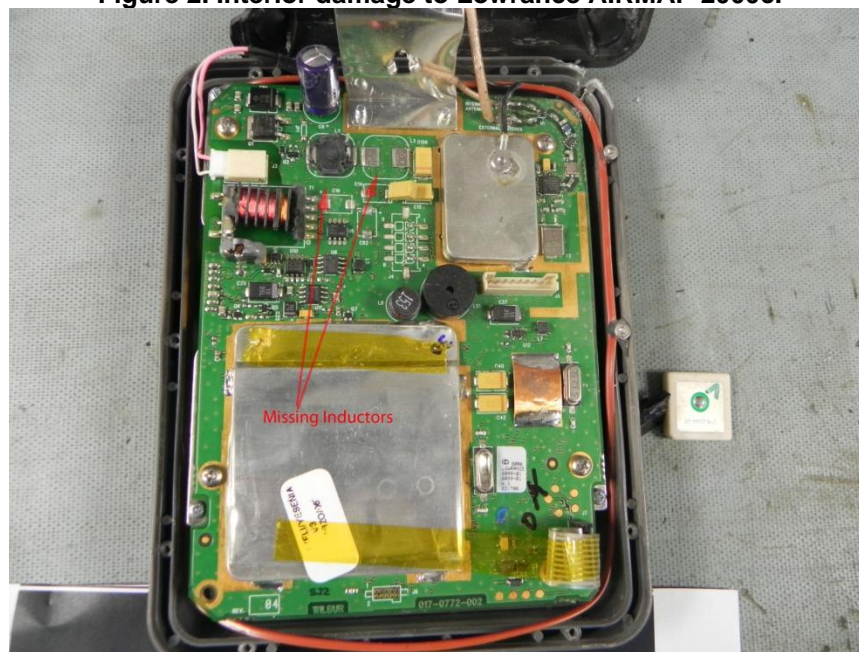
Figure 2. Interior damage to Lowrance AIRMAP 2000c.

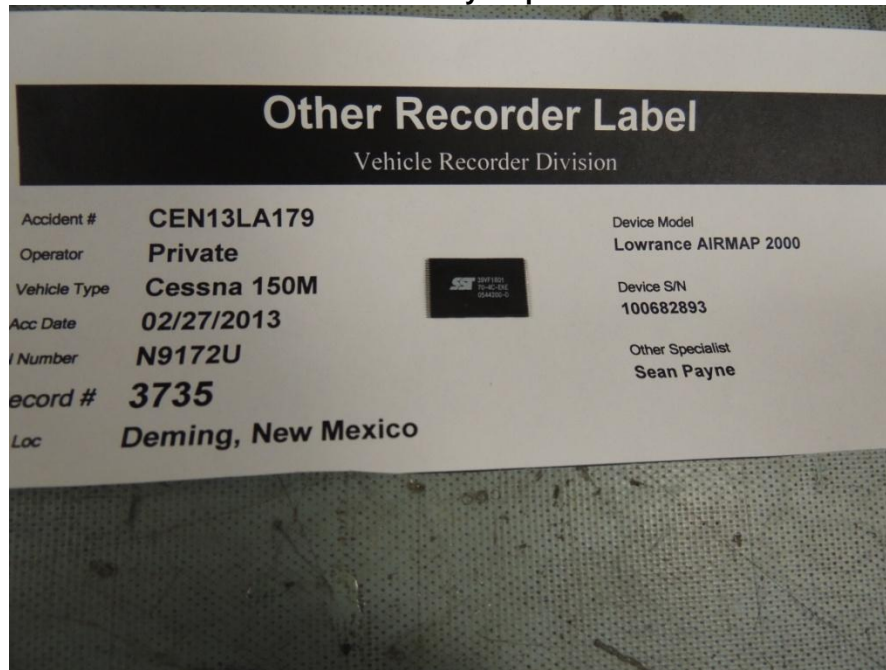
Figure 3. The SST 39VF1601 FLASH memory chip from the Lowrance AIRMAP 2000c.

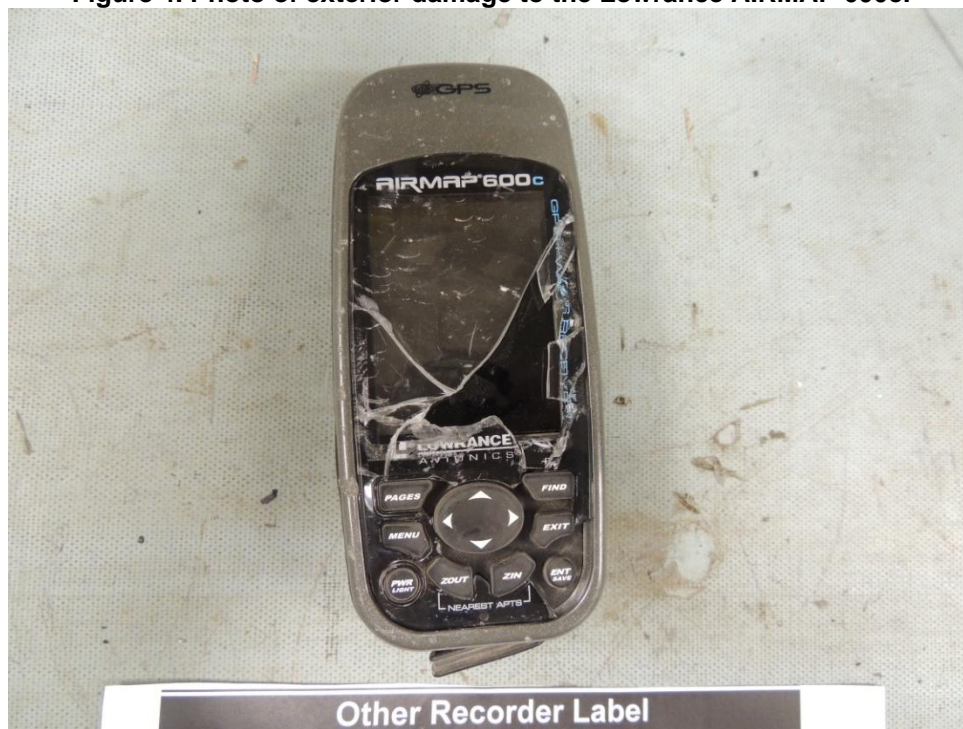
Upon arrival at the Vehicle Recorder Laboratory, an exterior examination revealed that the unit had sustained substantial damage to its display screen from impact forces. The unit was able to power on but displayed only broken white backlighting, rendering the unit unuseable. A chip level data recovery effort was attempted, but was not successful.

Figure 4. Photo of exterior damage to the Lowrance AIRMAP 600c.

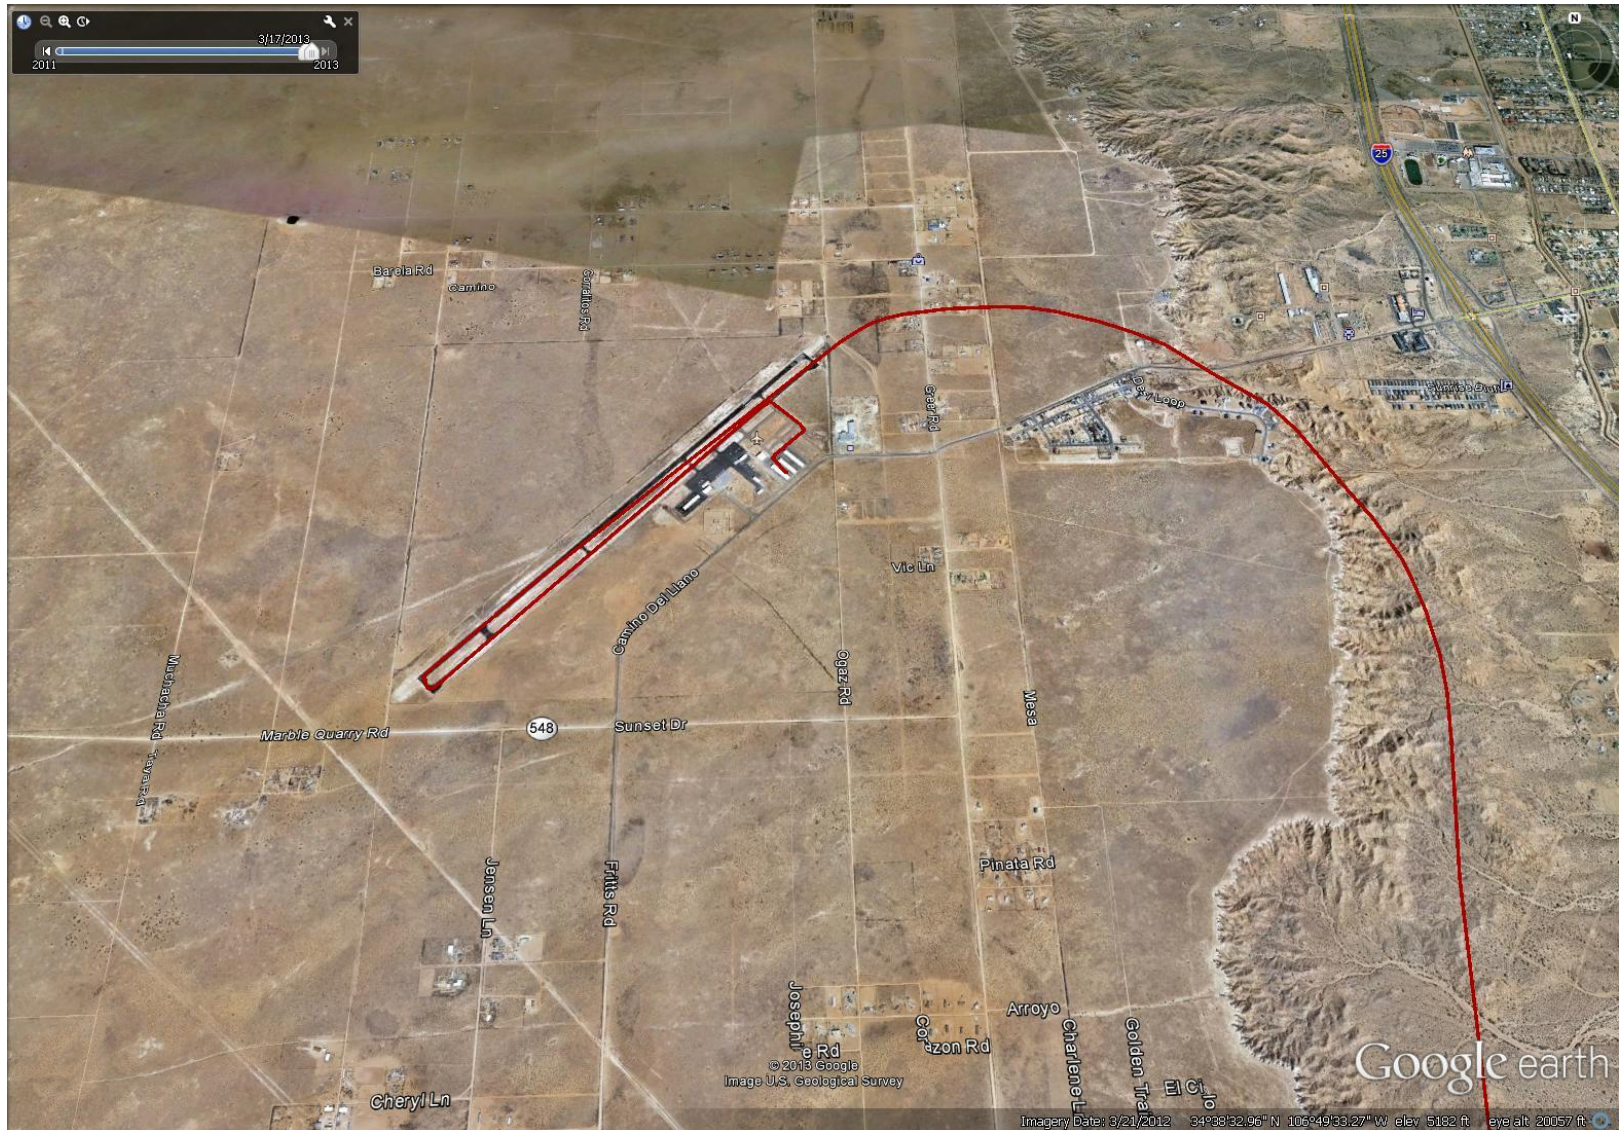
Figure 7 is a graphical overlay generated using Google Earth zoomed in to show the departure sequence of the accident flight. The tracks originate near the northeastern corner of the airport at a hangar complex. The aircraft taxis to Runway 03 and departs towards the north-northeast and then executes an immediate right turnout to the south.

Figure 7. A Google Earth Overlay showing the aircraft departing Runway 03 at Alexander Municipal Airport (E80), Belen, NM.

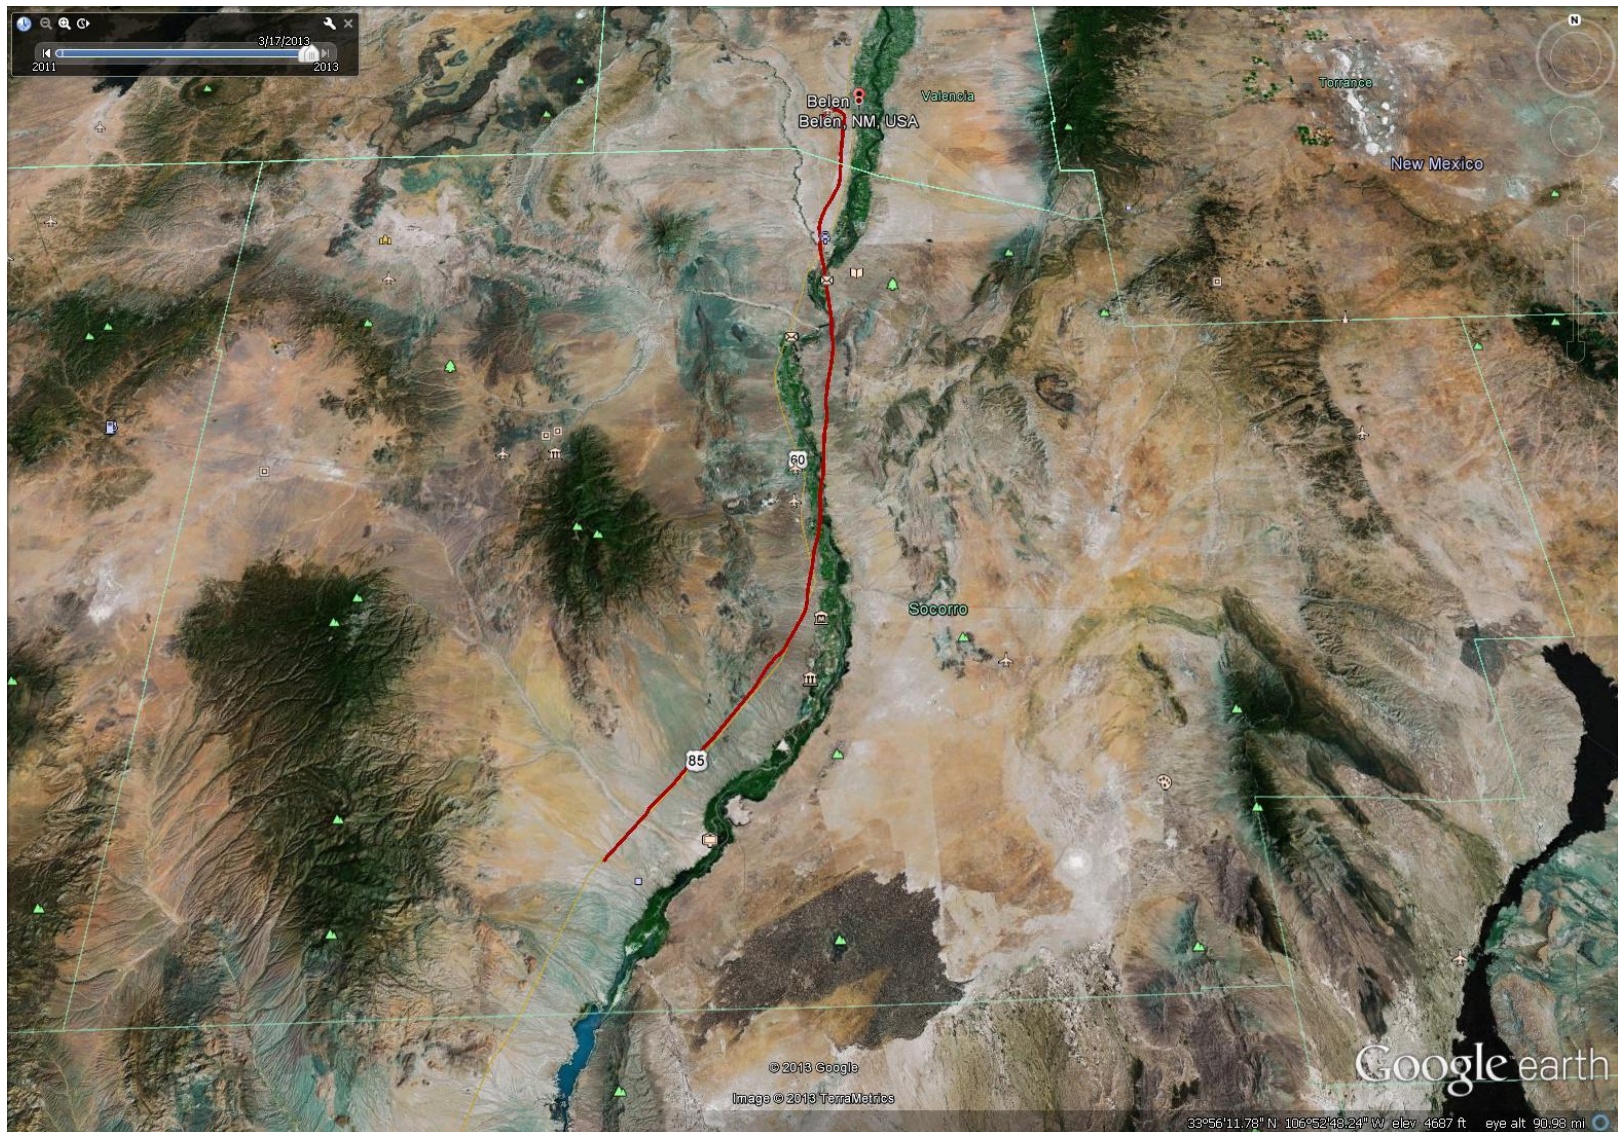
Figure 8 is a graphical overlay generated using Google Earth zoomed out to show the aircraft's entire enroute segment. The aircraft appears to parallel I-25 for most of the enroute portion, then intercepts the Interstate as it turns southwest-bound toward the wreckage location.

Figure 8. A Google Earth overlay showing the enroute portion of the airplane's accident flight.

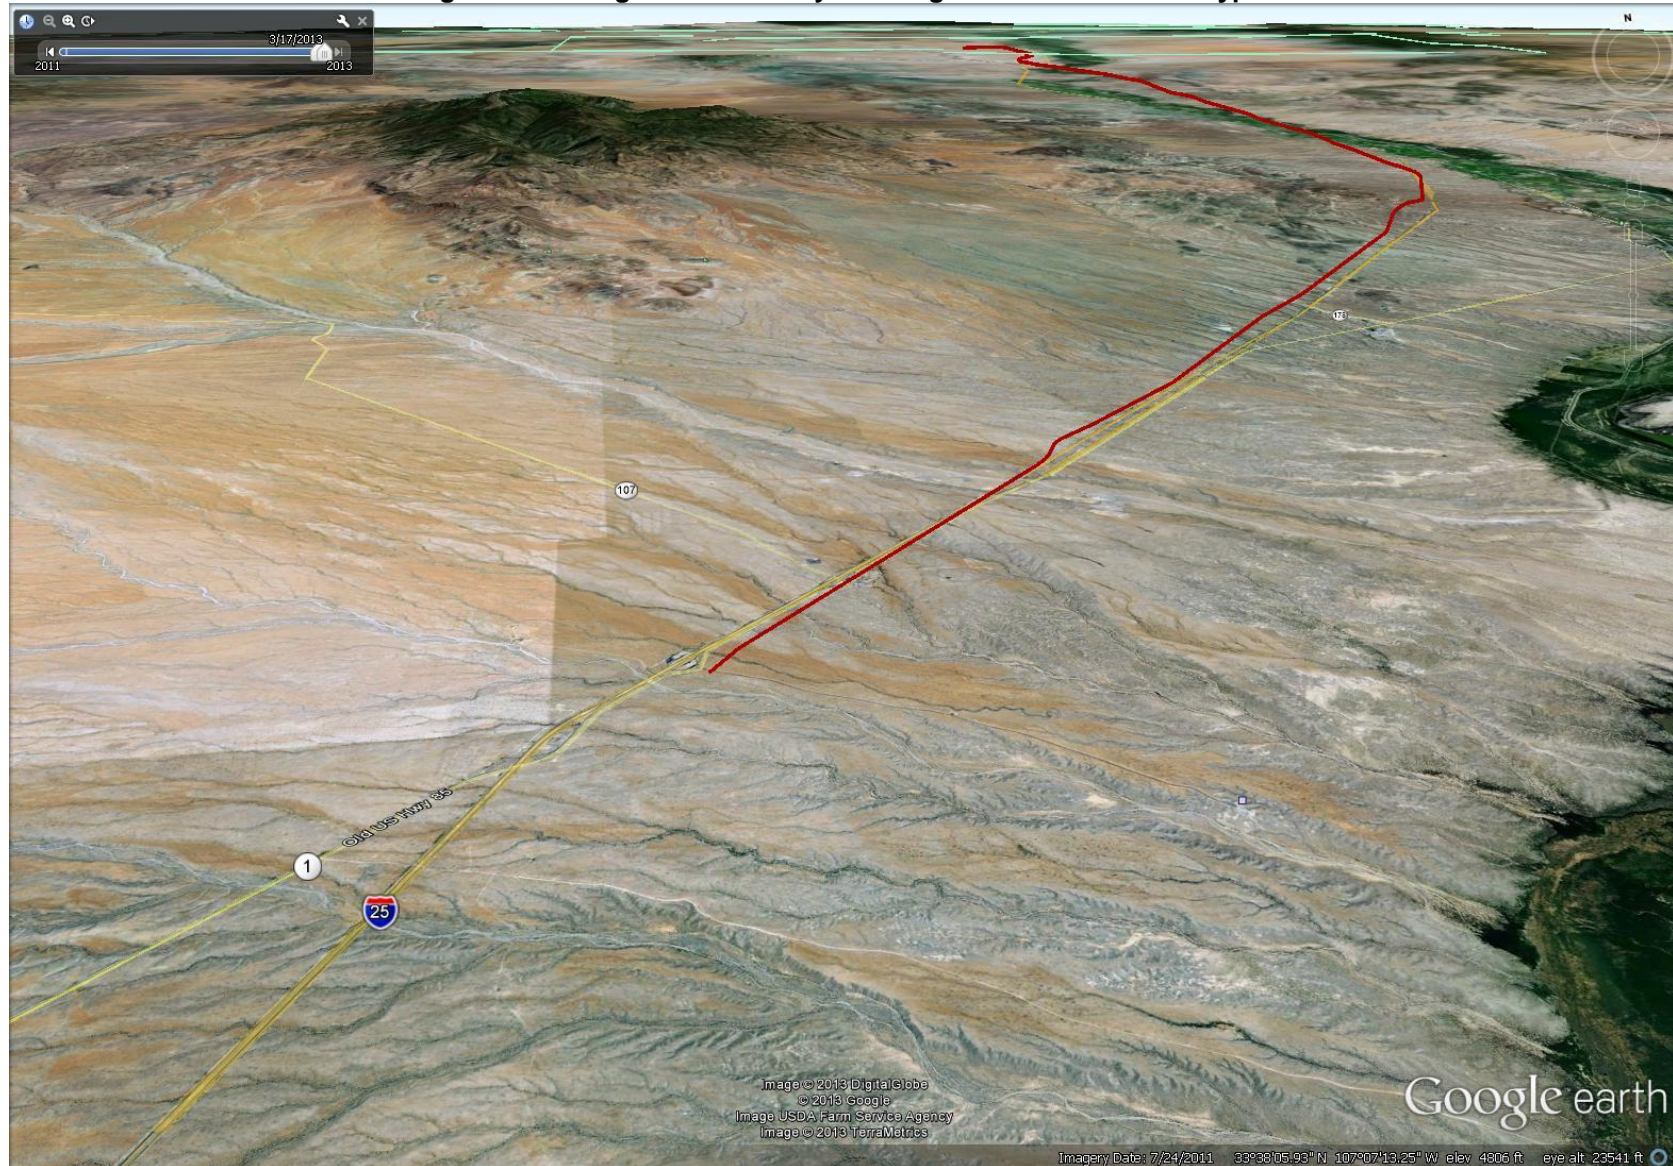
Figure 9. is a graphical overlay generated using Google Earth zoomed in to show the flight's final waypoints. Theses tracks end just to the southeast of Interstate 25.

Figure 9. A Google Earth overlay showing the aircraft's final waypoints.
