**NATIONAL TRANSPORTATION SAFETY BOARD
OFFICE OF MARINE SAFETY
WASHINGTON, D.C.**

**ENGINEERING GROUP CHAIRMAN'S
FACTUAL REPORT**

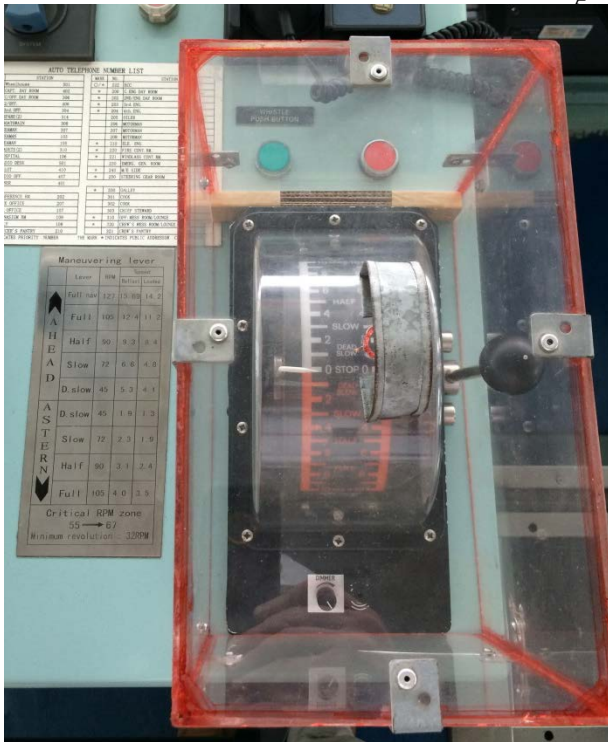
Figure 4, Bridge console Engine telegraph (NTSB)

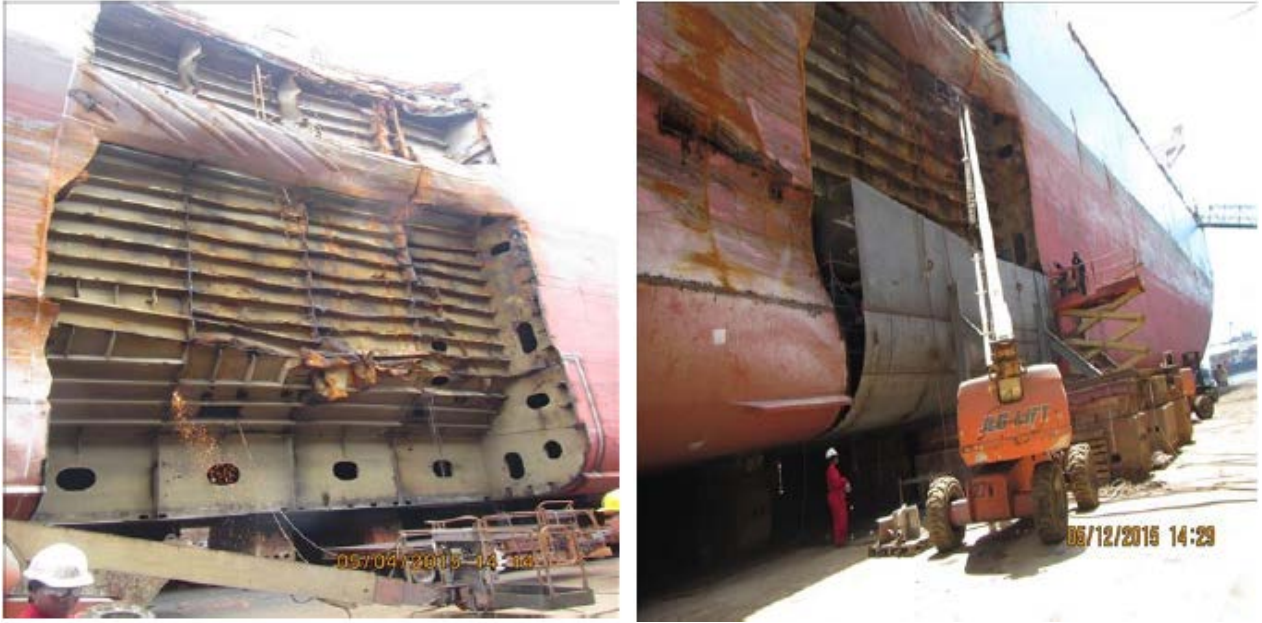
Figure 18, View of Ballast Water Tank # 2 Port after removal of damage side shell (left) and fabricated hull block inserted (right) photographs from DNV-GL Survey.⁴²
