National Transportation Safety Board

Group Chairman's Factual Report

Electronic Data Group

SS El Faro

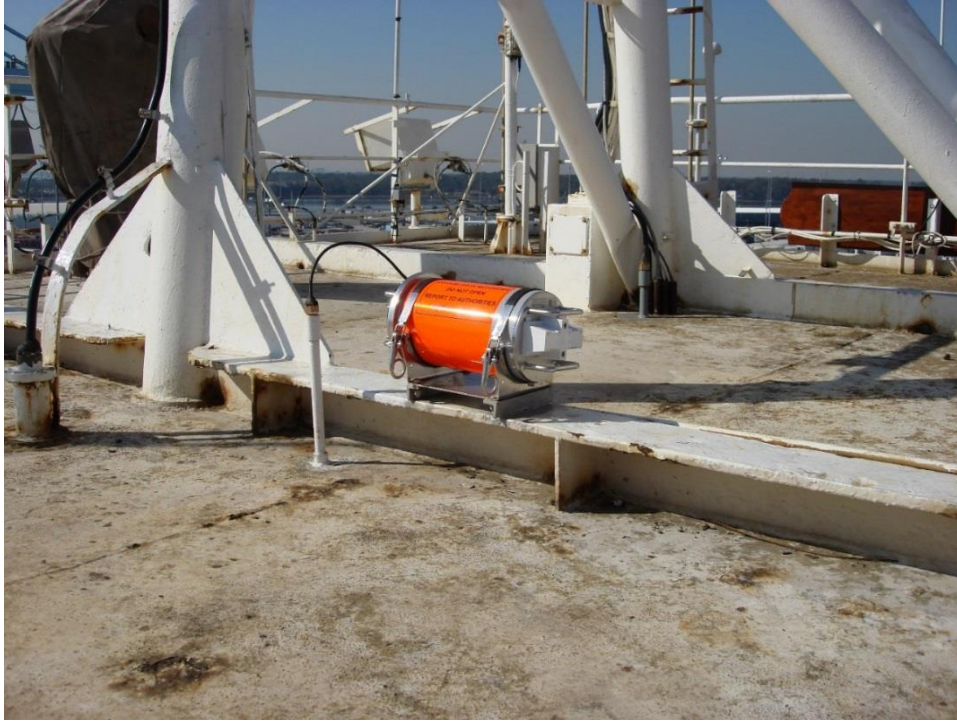
Figure 3. VDR capsule installed on El Faro’s weather deck, February 2009 (photo from Radio Holland).

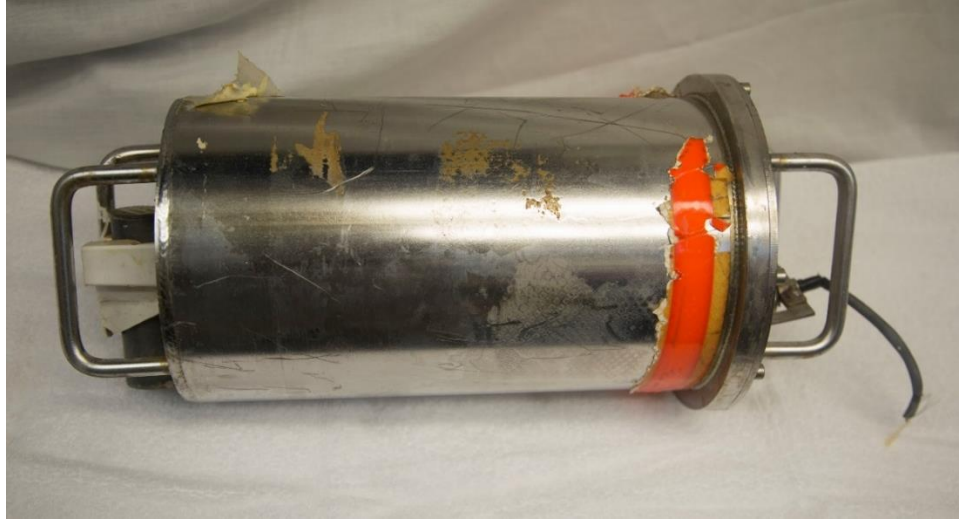
Figure 7. VDR capsule before disassembly.

After the VDR capsule was brought to the surface, it was disassembled and inspected for possible damage to the internal recording medium. Figure 7 shows the VDR capsule before disassembly. Inside the capsule, layers of protective materials housed an inner capsule containing the circuit board assembly that stored the non-volatile memory.⁴² The inner capsule assembly is shown in figures 8 and 9. The circuit board assembly was inspected for visible signs of damage or corrosion before being secured for transportation to the NTSB Vehicle Recorder Division laboratory in Washington, DC. Figures 10 and 11 show different sides of the inner capsule circuit board assembly during inspection on USNS *Apache* and at the NTSB laboratory, respectively.

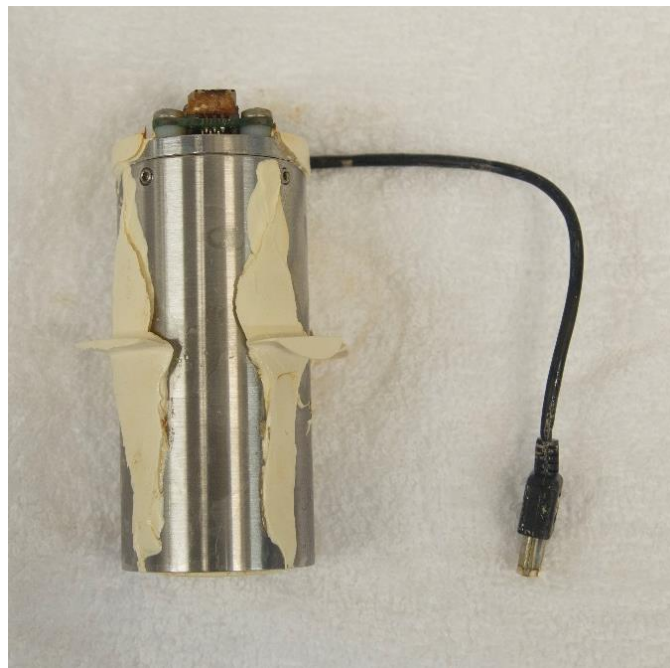
Figure 8. Inner capsule assembly after removal from VDR capsule.

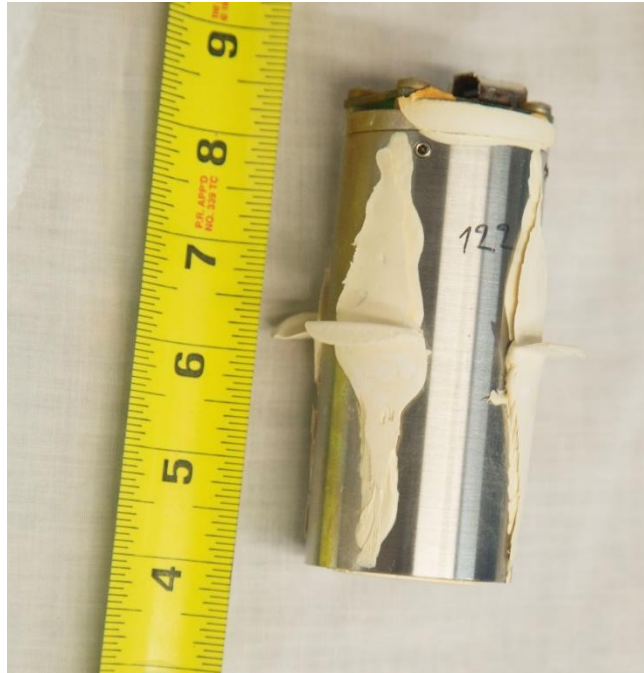
Figure 9. Inner capsule assembly after removal from VDR capsule.
