National Transportation Safety Board

Group Chairman's Factual Report

Meteorology Group

Stretch Duck 7

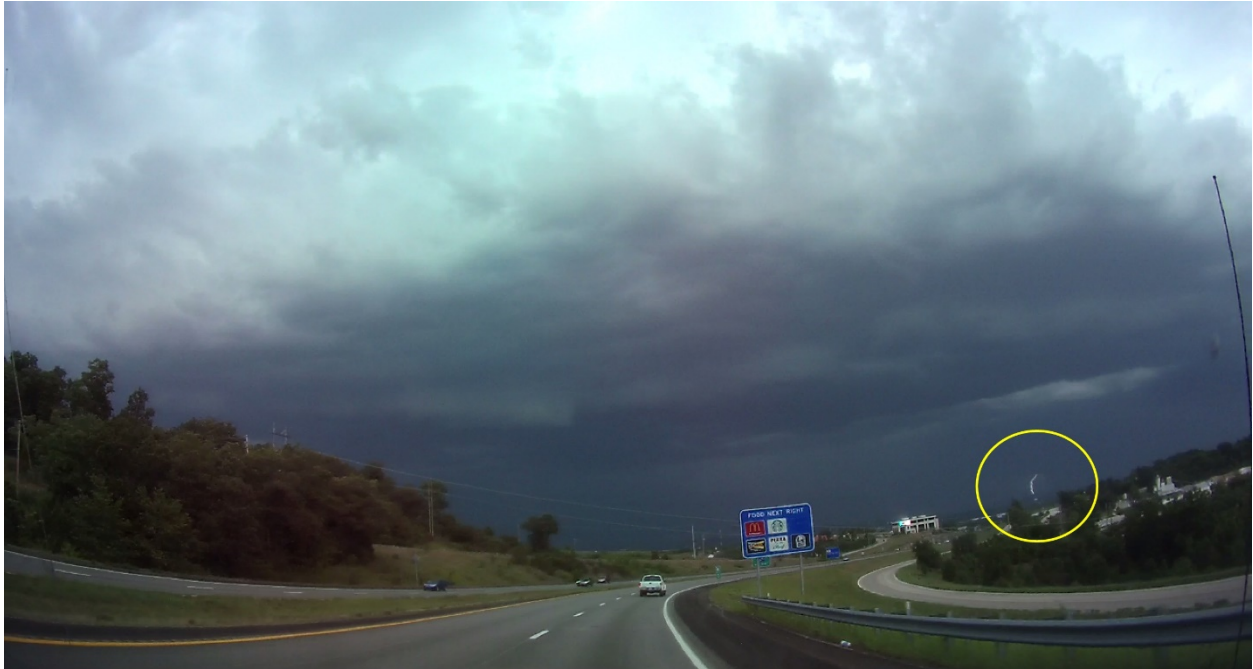
Figure 11 – Image from the Western Taney County Fire Protection District Battalion Chief’s dash cam at about 1858 CDT. At this time the Battalion Chief’s vehicle was located at about 36.596457, -93.235075 (about 4 miles east of the accident site) headed north-northwest.

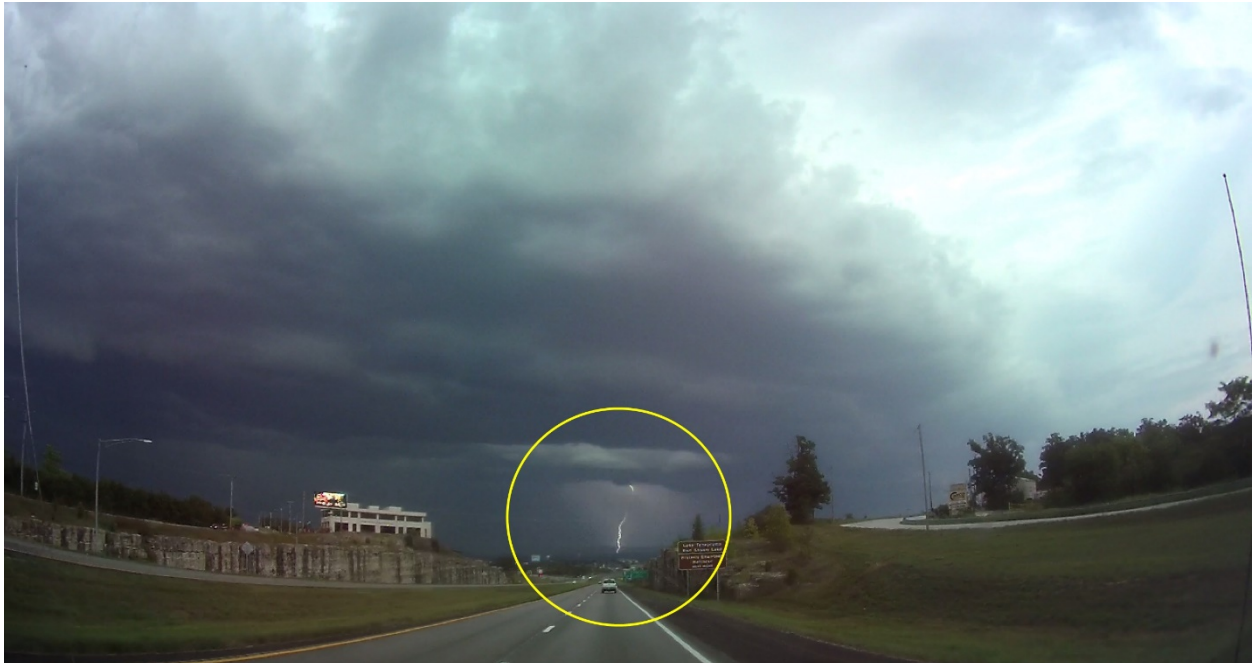
Figure 12 – Image from the Western Taney County Fire Protection District Battalion Chief’s dash cam at about 1859 CDT. At this time the Battalion Chief’s vehicle was located at about 36.601851, -93.235116 (about 4 miles east of the accident site) headed north-northeast.

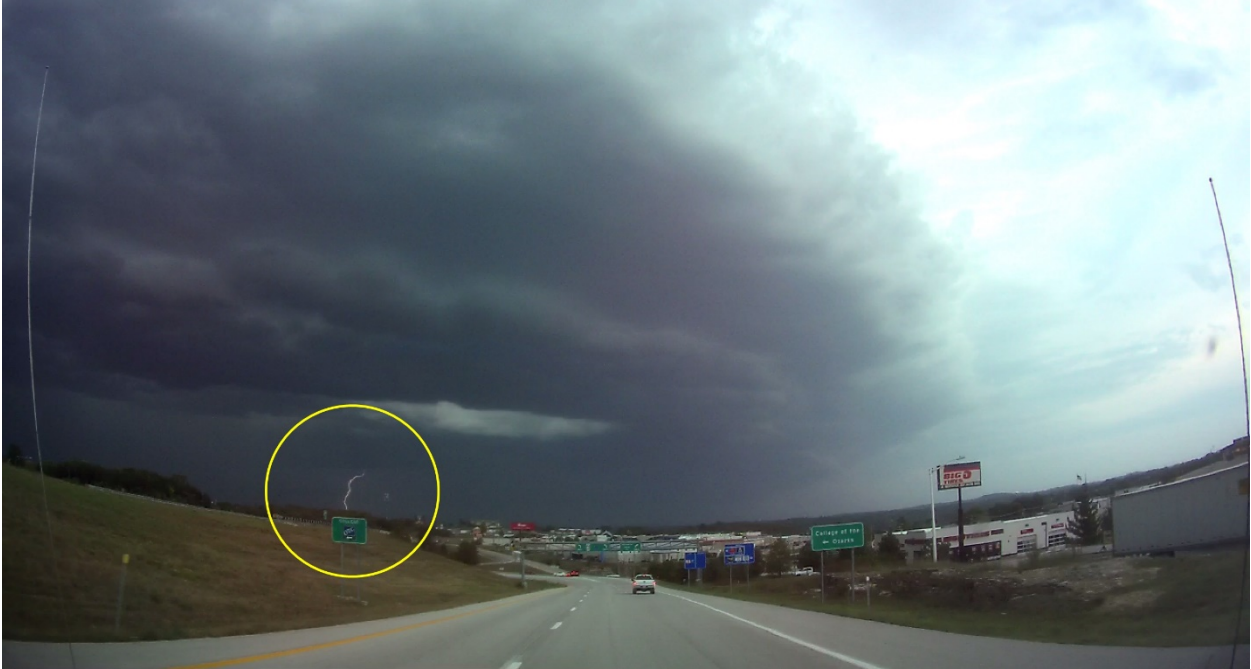
Figure 13 – Image from the Western Taney County Fire Protection District Battalion Chief’s dash cam at about 1859 CDT. At this time the Battalion Chief’s vehicle was located at about 36.608167, -93.232436 (about 4 miles east-northeast of the accident site) headed north-northeast.

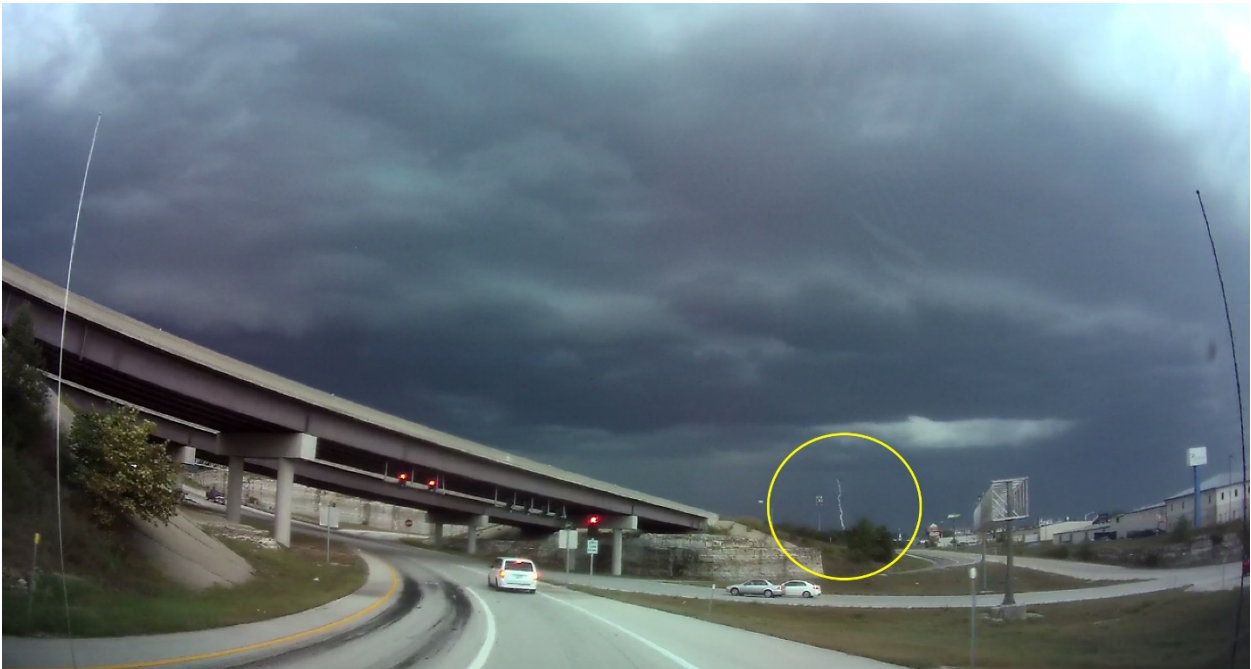
Figure 14 – Image from the Western Taney County Fire Protection District Battalion Chief’s dash cam at about 1859 CDT. At this time the Battalion Chief’s vehicle was located at about 36.609863, -93.231823 (about 4 miles east-northeast of the accident site) headed north-northwest.

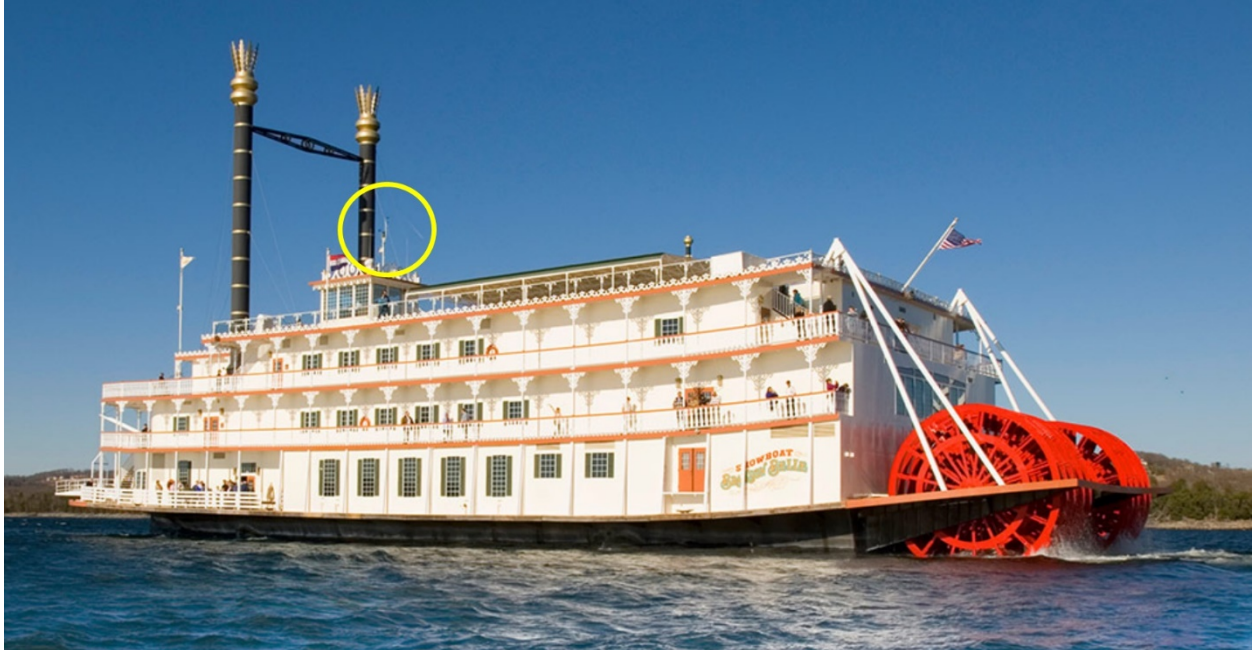
Figure 15 – Photo of the Showboat Branson Belle taken at an unknown date with the location of the anemometer circled in yellow.

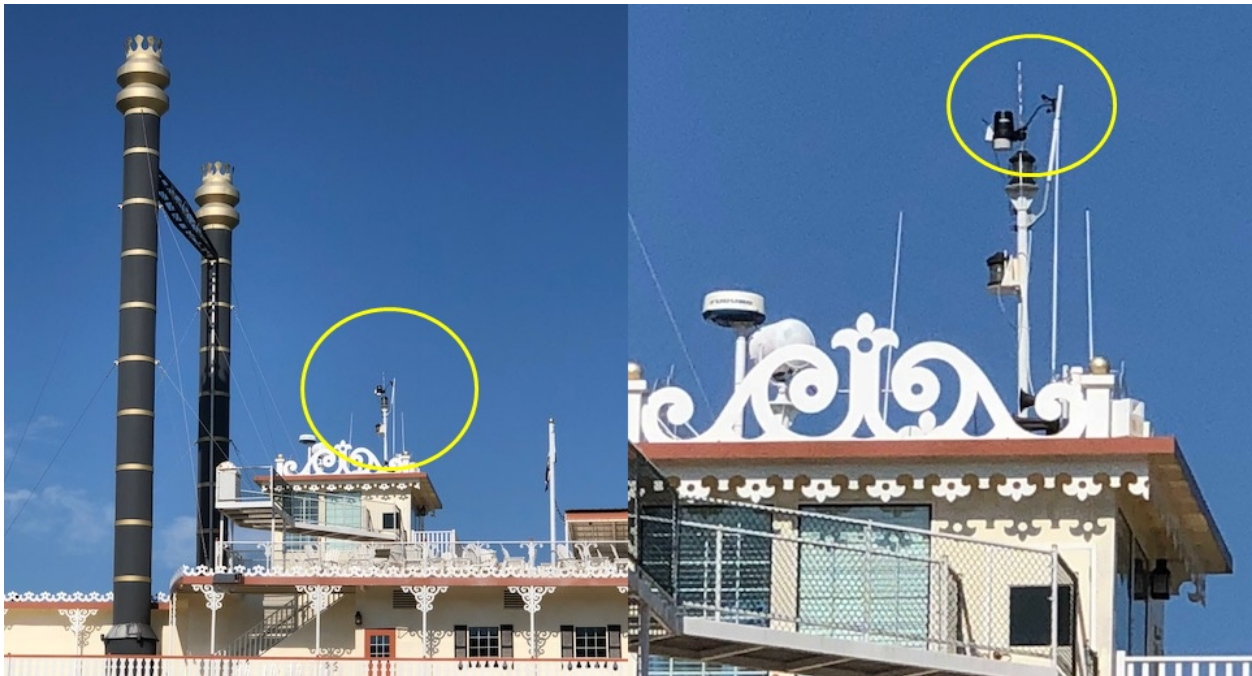
Figure 16 – Photos of the Showboat Branson Belle's anemometer taken two days after the Stretch Duck 7 accident.
