Figure 1 - Radar flight track of N669WR as it approached Spruce Creek (7FL6). Viewed from directly overhead and overlaid on a geographical area map with the top of the figure being north. Radar data provided by the FAA.

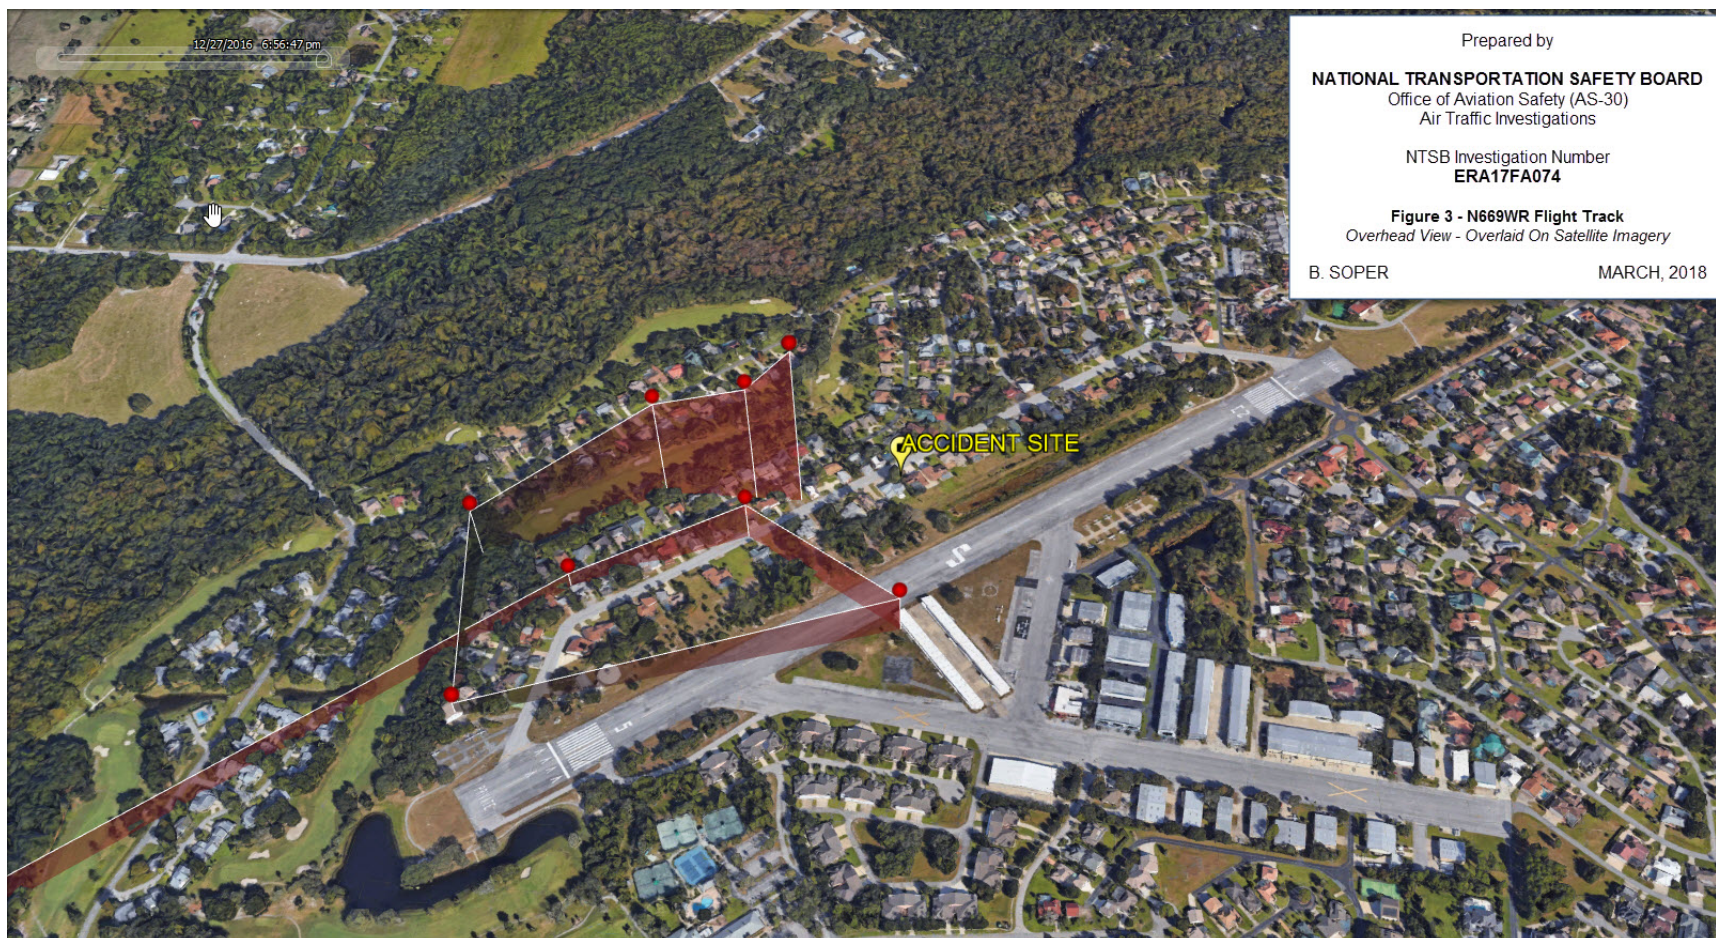
Figure 3 - Radar flight track of N669WR, final segment during the attempt to land at Spruce Creek Airport (7FL6). Viewed from above at a slight angle and overlaid on satellite imagery with the top of the figure being north. Radar data provided by the FAA.
