**NATIONAL TRANSPORTATION SAFETY BOARD
Office of Aviation Safety
Washington, DC 20594**

ATC RADAR STUDY

CEN11FA599

Aircraft: N352LN, Eurocopter AS-350-B2

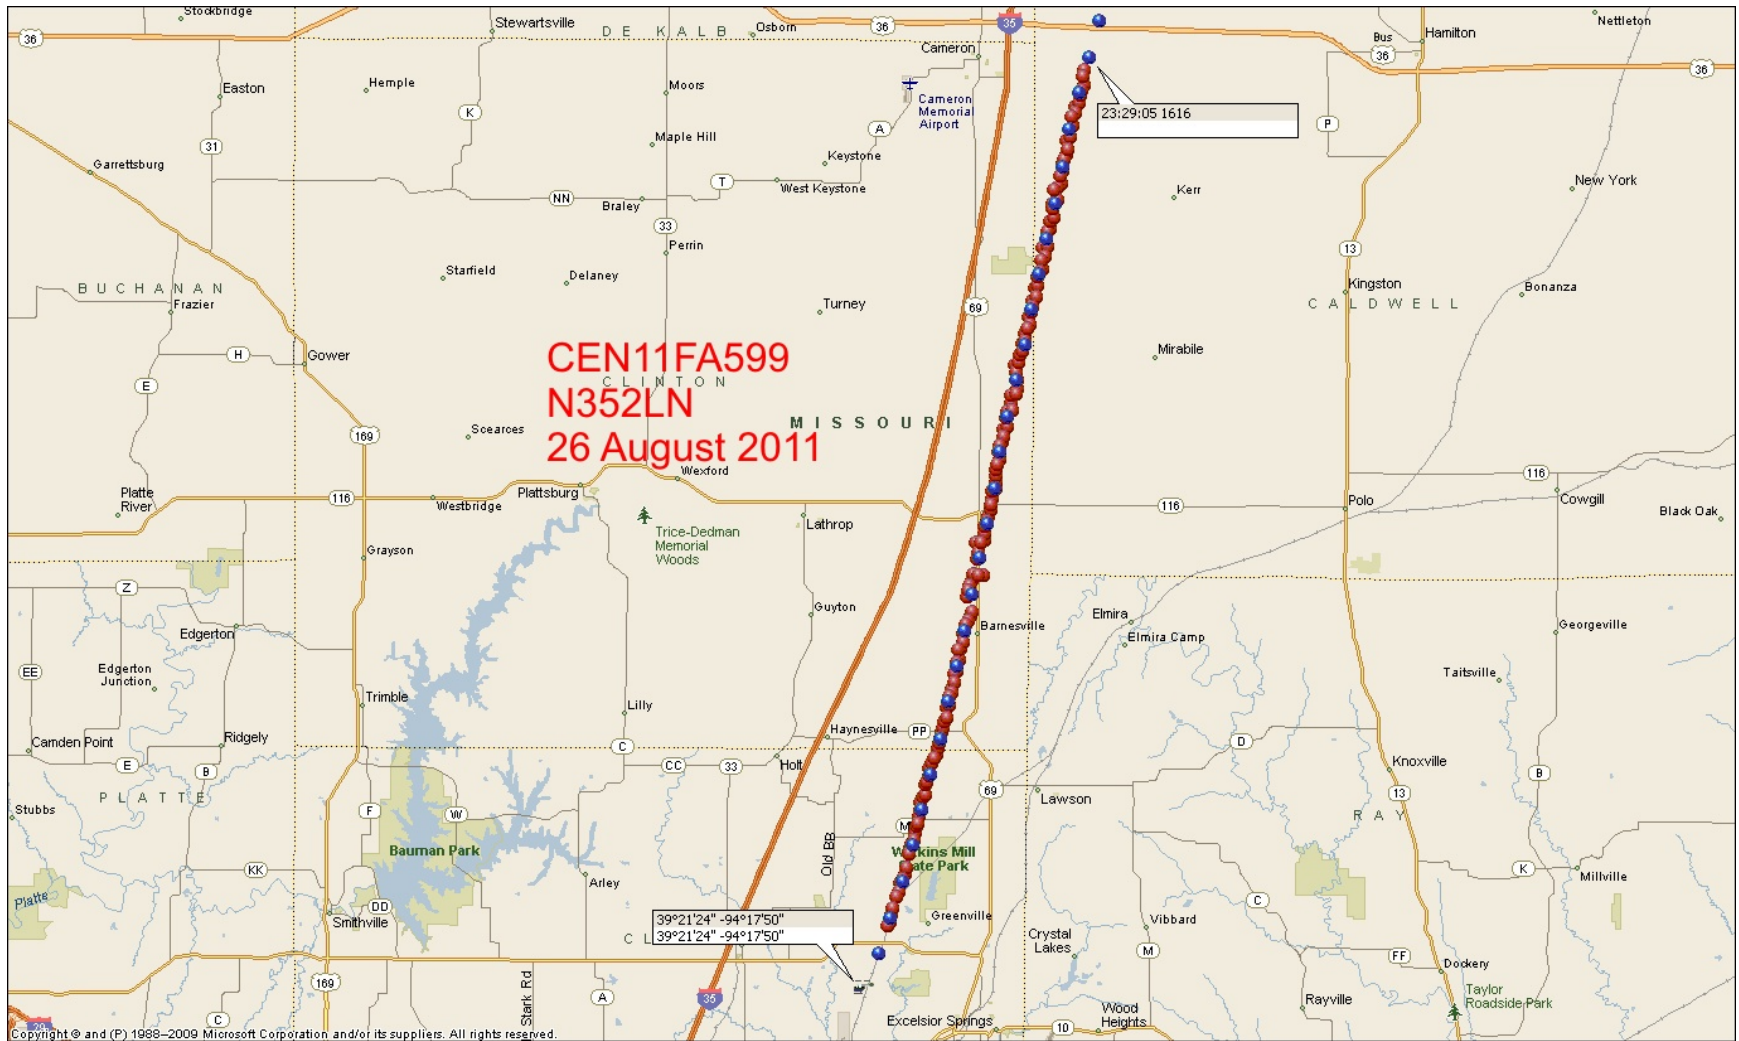
Figure 2 – KCI radar data (red dots) and Air Methods tracking data (blue dots) from 2329Z until the end of the flight.

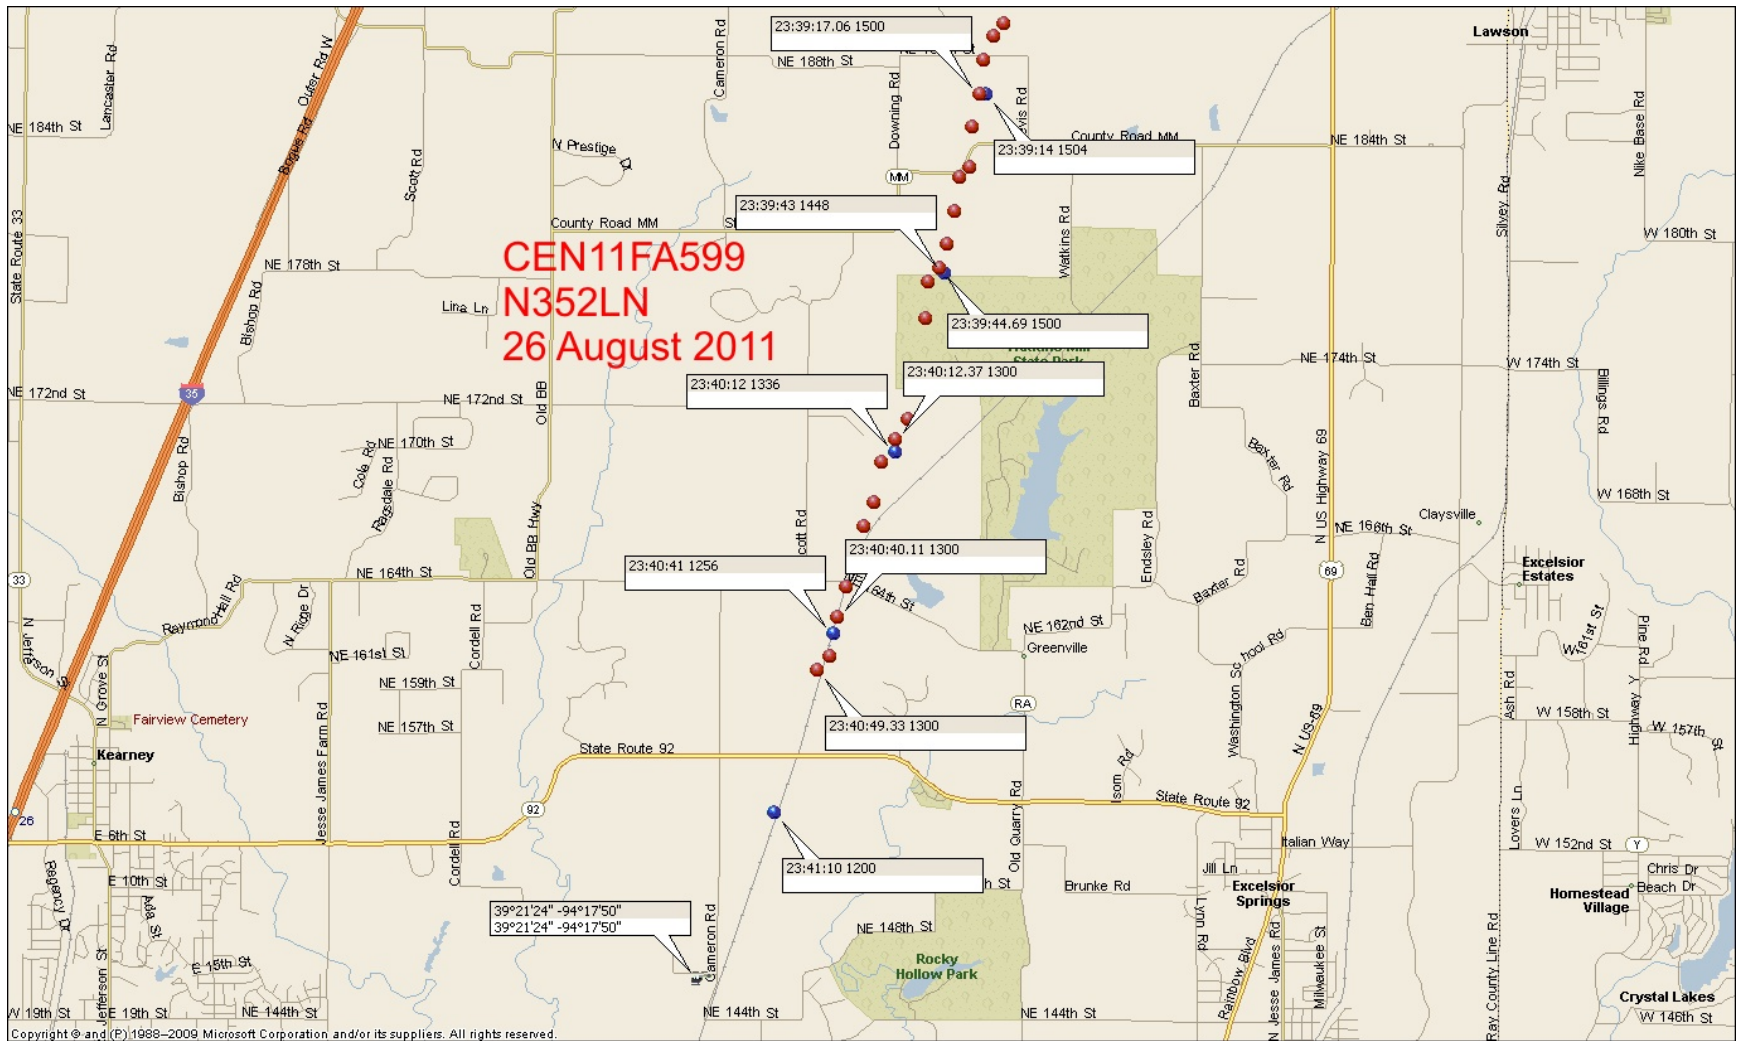
Figure 3 – KCI radar data (red dots) and Air Methods tracking data (blue dots) for approximately the last two minutes of the flight. Tags show mode C altitude reports from KCI and GPS-derived altitude from Air Methods.

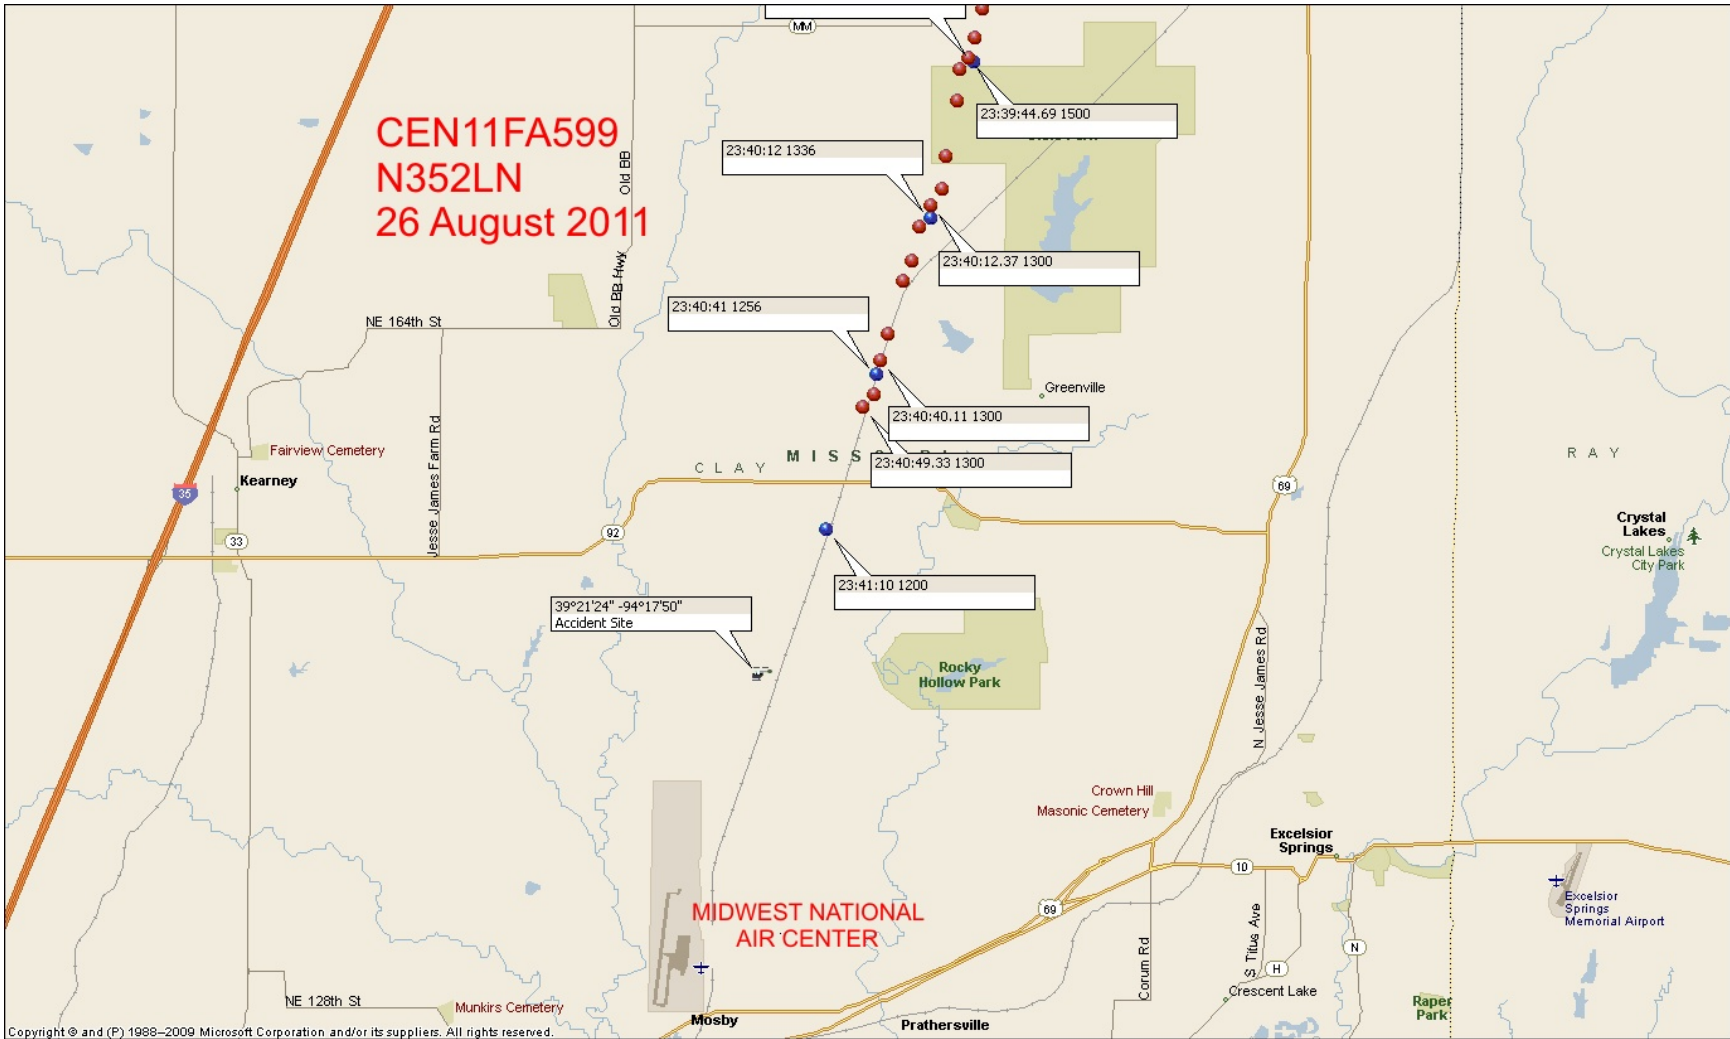
Figure 5 – Last radar targets and GPS position reports, along with the location of the destination airport.
