Attachment #1 – Lewiston Police Reconstruction

HWY17SH008

COLLISION RECONSTRUCTION

PROGRESS REPORT

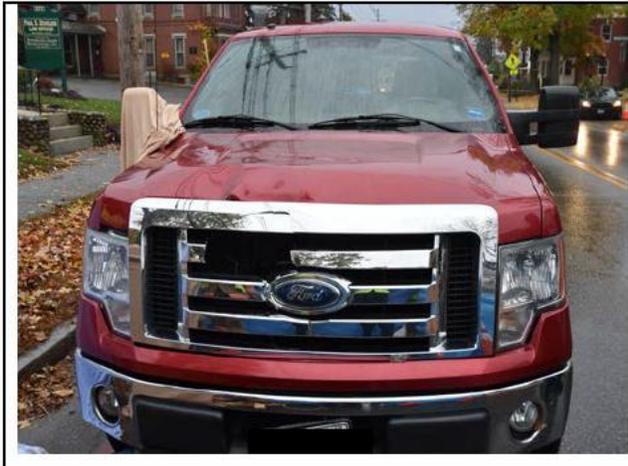
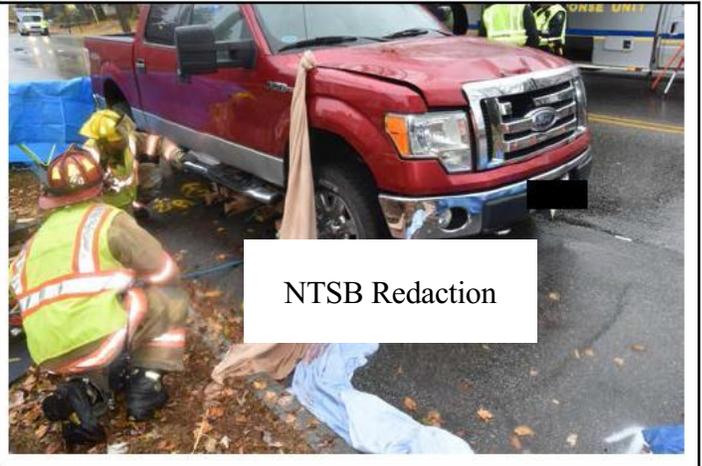
Overall Damage to [REDACTED]'s vehicle was minimal as a result of this crash. Damage was located on the grill by the center of the vehicle which extended towards the passenger side area. Denting was also observed above the grill which too extended towards the passenger side. No airbag deployment. See attached pictures.

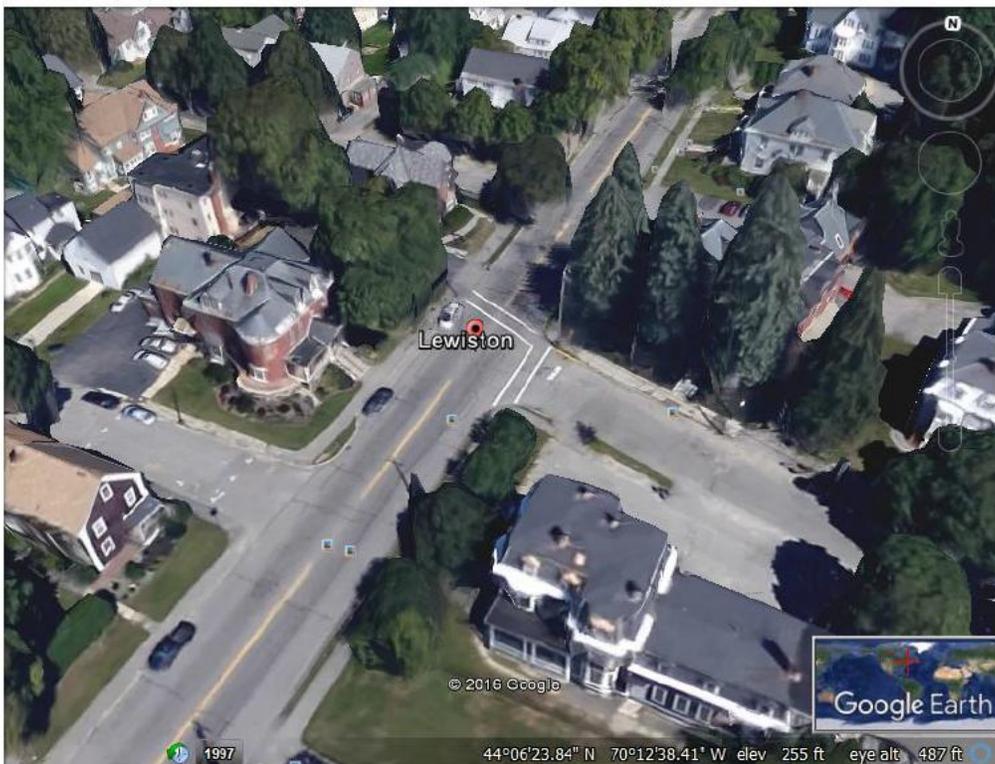
This crash occurred on Main St by Frye St. In the area of the crash, Main St predominately runs northeast and southwest. In the area of the crash there are 2 lanes of travel; one lane is allotted for northeast bound traffic and one lane is allotted for southwest bound traffic. Both lanes are separated by a double yellow centerline. Also

present at this location is a marked crosswalk that starts on the northwest side of Main St and goes to the southeast side of Main St

Main St is comprised of asphalt and is in good condition. All roadway lines and markings are visible. Note: There is also a pedestrian crosswalk sign by the crosswalk. The posted speed limit in the area of the crash is 25 MPH. The roadway was wet at the time of the crash.

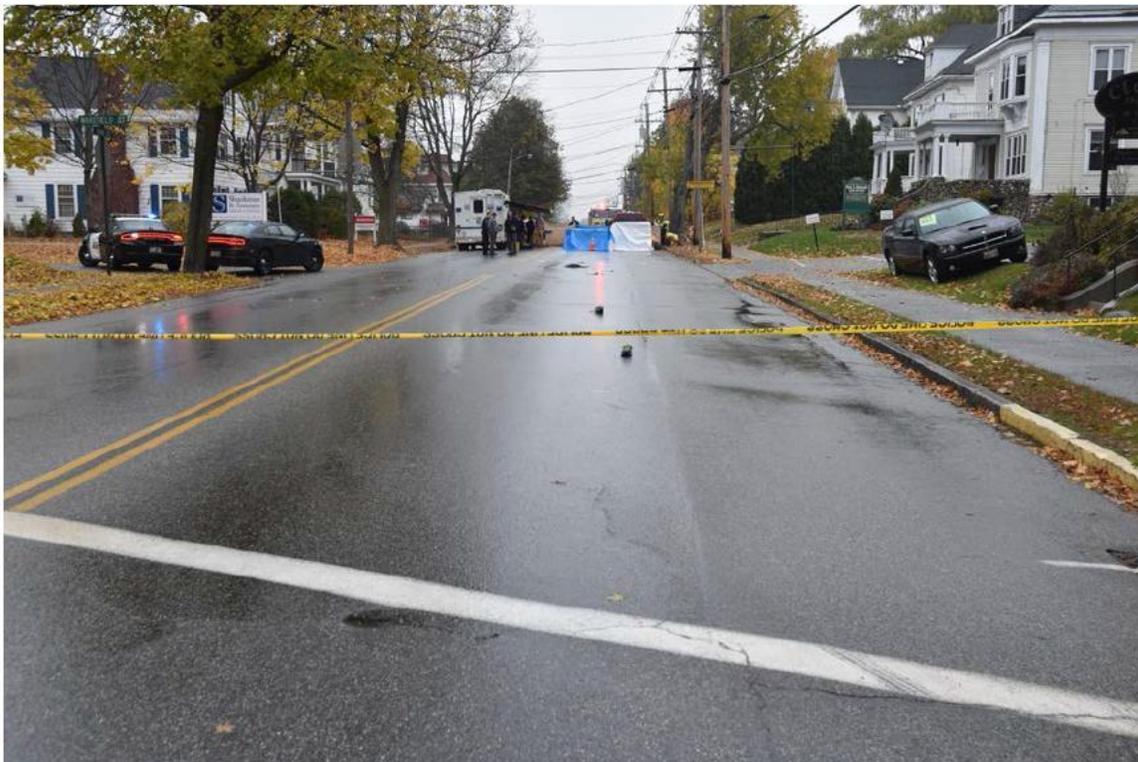
At this point I took additional photographs of the crash scene. I observed that in the northeast bound lane just beyond the crosswalk was a pair of sneakers in the middle of the roadway. See attached picture.

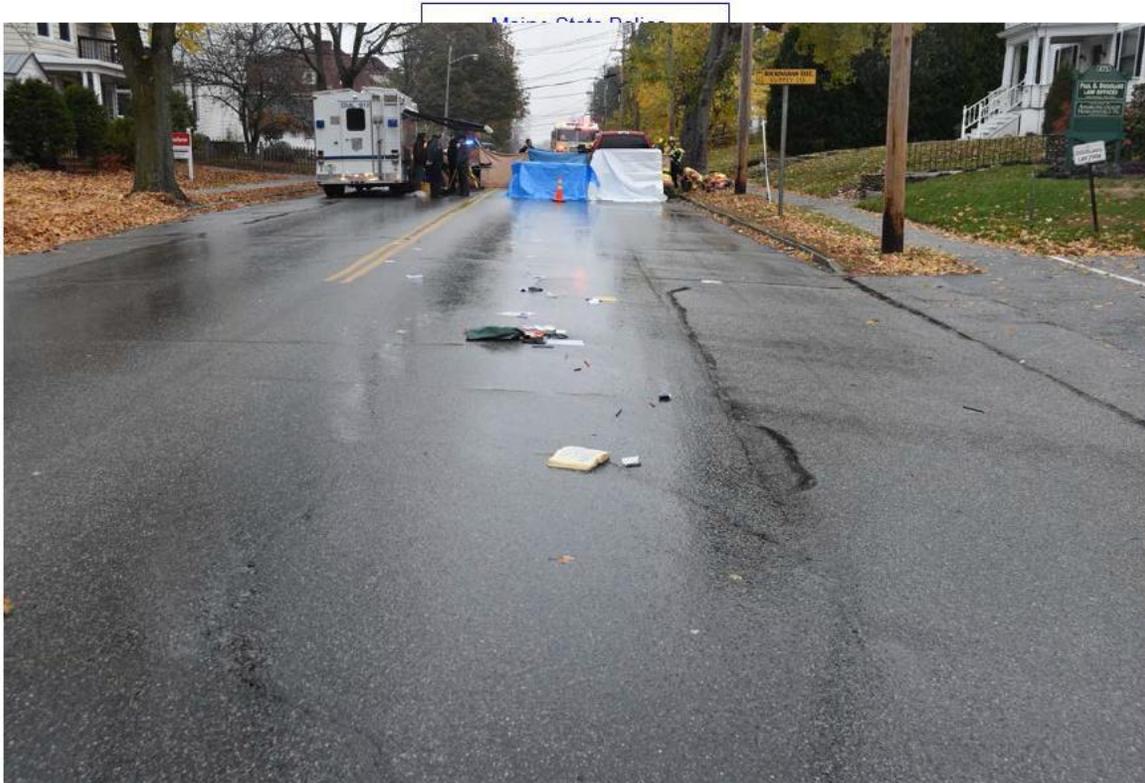
As I walked further northeast bound on Main St. I came across a piece of the vehicle's grill and a book bag. Around the book bag I observed school books and papers.

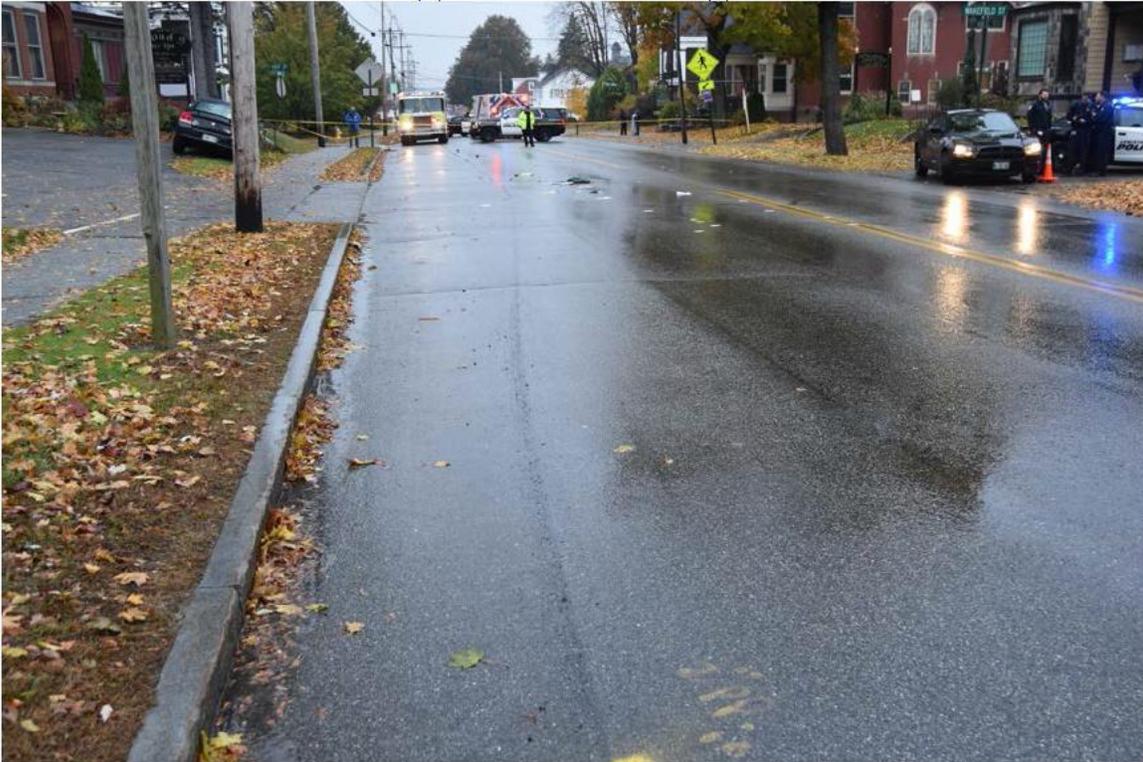
This photograph was taken looking southwest bound of the tiremark.

Note: This tiremark was made in conjunction of rubbing materials and the body of [REDACTED] as it came to a stop. This is not a normal braking mark you would see from the tire alone.

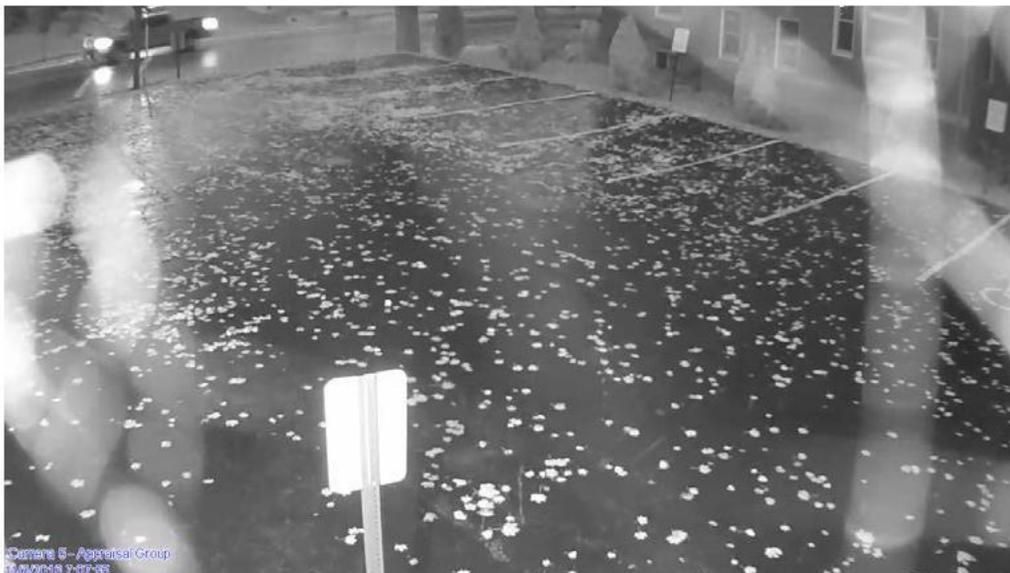
The video showed [REDACTED] walking northeast bound on the sidewalk. [REDACTED] positions himself in the crosswalk (western side) on the side of the road. He appears to wait until traffic continues by. When there is a lull in traffic he proceeds to walk across Main St still in the crosswalk. As he passes the centerline he stops briefly and appears to look right to see [REDACTED]'s vehicle heading towards him. [REDACTED] attempts to get out of the way by running east bound. [REDACTED] was not able to get out of the way of [REDACTED] Vehicle. [REDACTED] is struck just beyond the crosswalk. See attached picture from security camera. This appears to be just before impact.

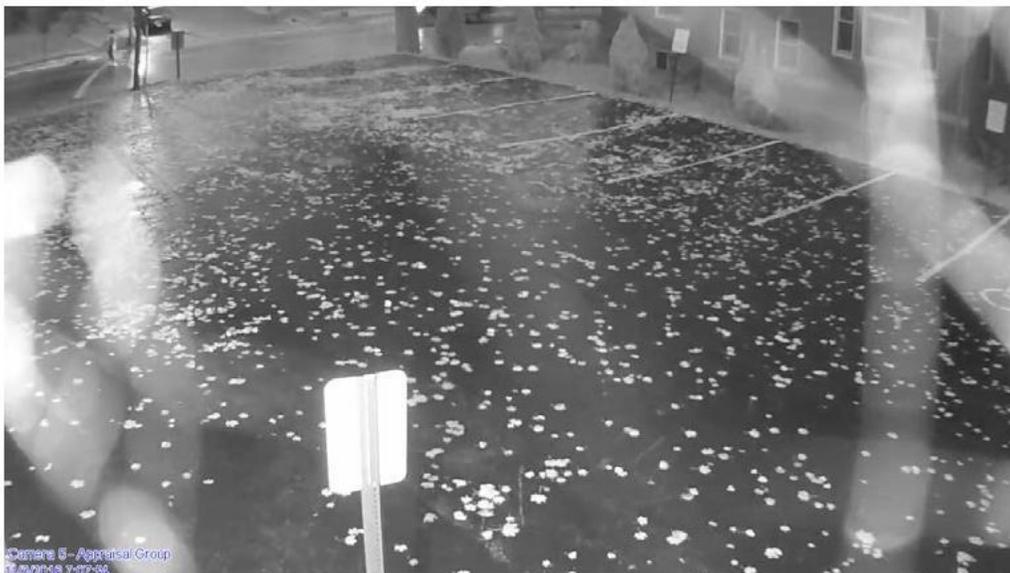
In the surveillance video, I am able to observe [REDACTED] vehicle as she approached from the right side in the camera view. The vehicle goes between two fixed objects (two trees). See attached still image from the security video.

Note: The still image does not display the time bar like the video shows. It should be noted that I observed the time on the video to be 7:07:54.759 seconds.

The time that it took the vehicle to travel on Main St (between two trees) up to right before impact (edge of crosswalk) took (1.1) seconds.

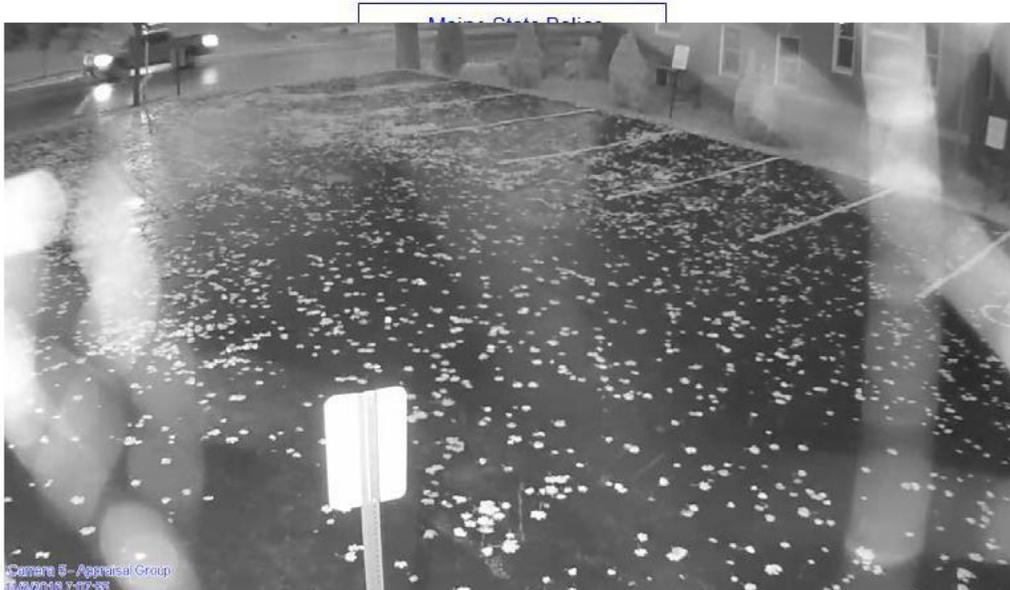
In the next still image you are able to view [REDACTED] vehicle just prior to impact. The truck is at the end of the crosswalk. See attached still image.

Note: The time bar on the security video indicates 7:07:55.859.

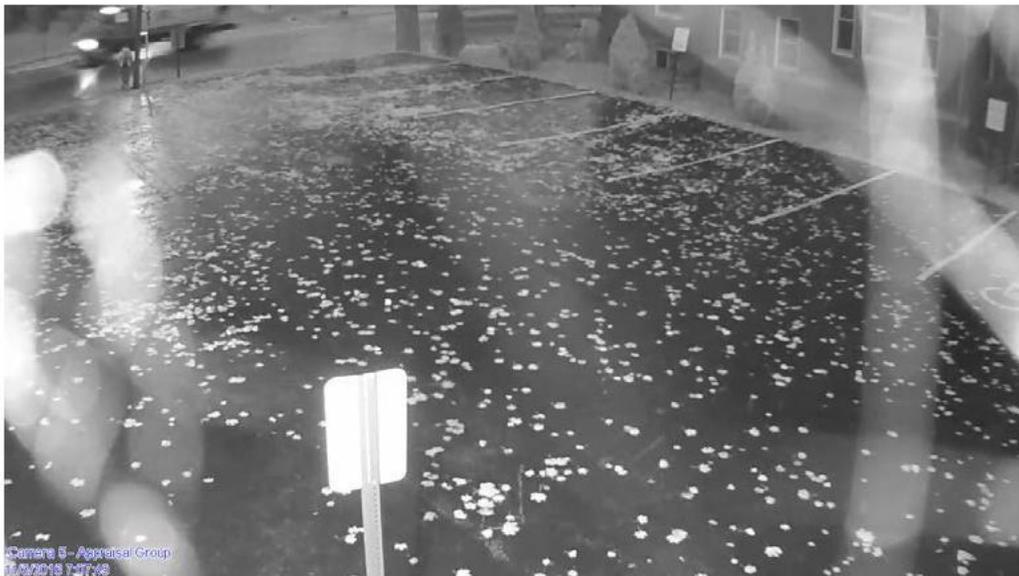
Again using the aid of the security video I am able to see when [REDACTED] begins to walk across Main St in the crosswalk. He begins walking at a 07:07:49.427. See attached still image.

07:07:53.994 - 07:07:49.427 = 4.567 seconds. Again this represents the time he started from edge of the sidewalk walked to the centerline.

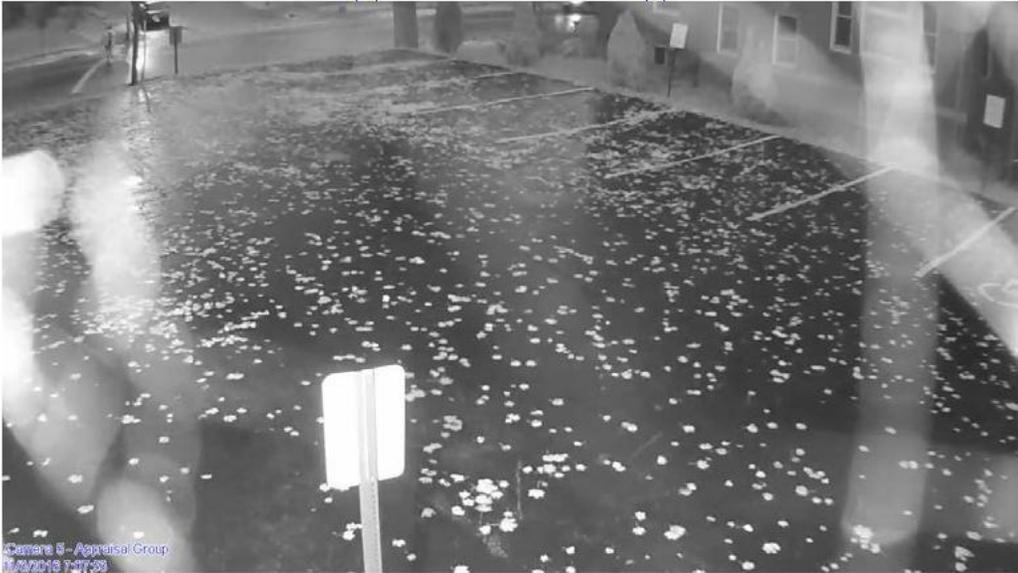
██████████ reaches the area of the centerline at 07:07:53.994. See attached still image.

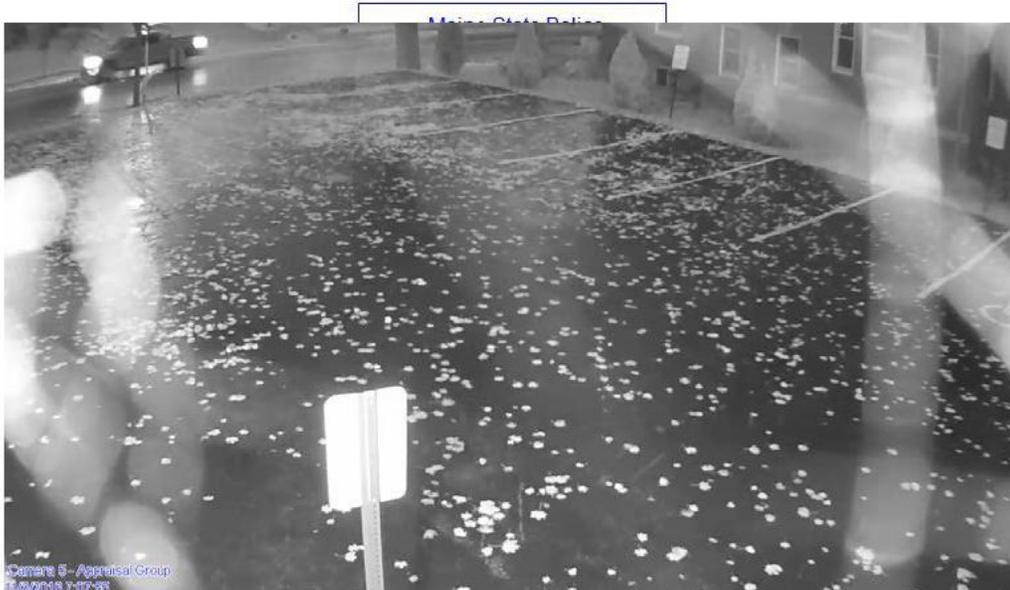
██████████ vehicle impacts ██████████ at 07:07:55.892. See attached still image.

Using the impact time and the time that [REDACTED] began walking across Main St it took (6.465) seconds.

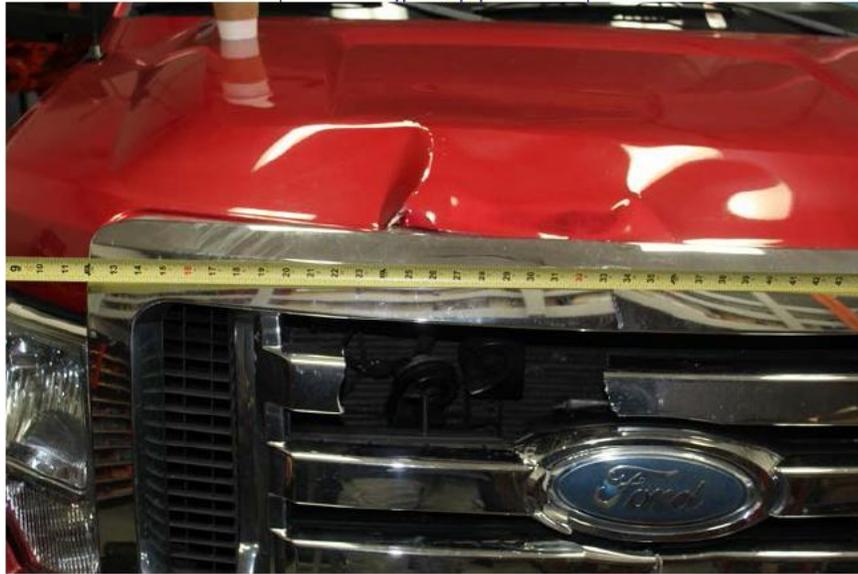
Ofc Wade and I measured the damage on the front of [REDACTED] vehicle (passenger side to driver's side). The damage did not go past 41 inches (3.41 feet). See attached picture.

Note: The brunt of the damage was more in the area of 18 inches to 38 inches. However I will be using 41 inches (3.41 feet). This is being conservative to [REDACTED]
