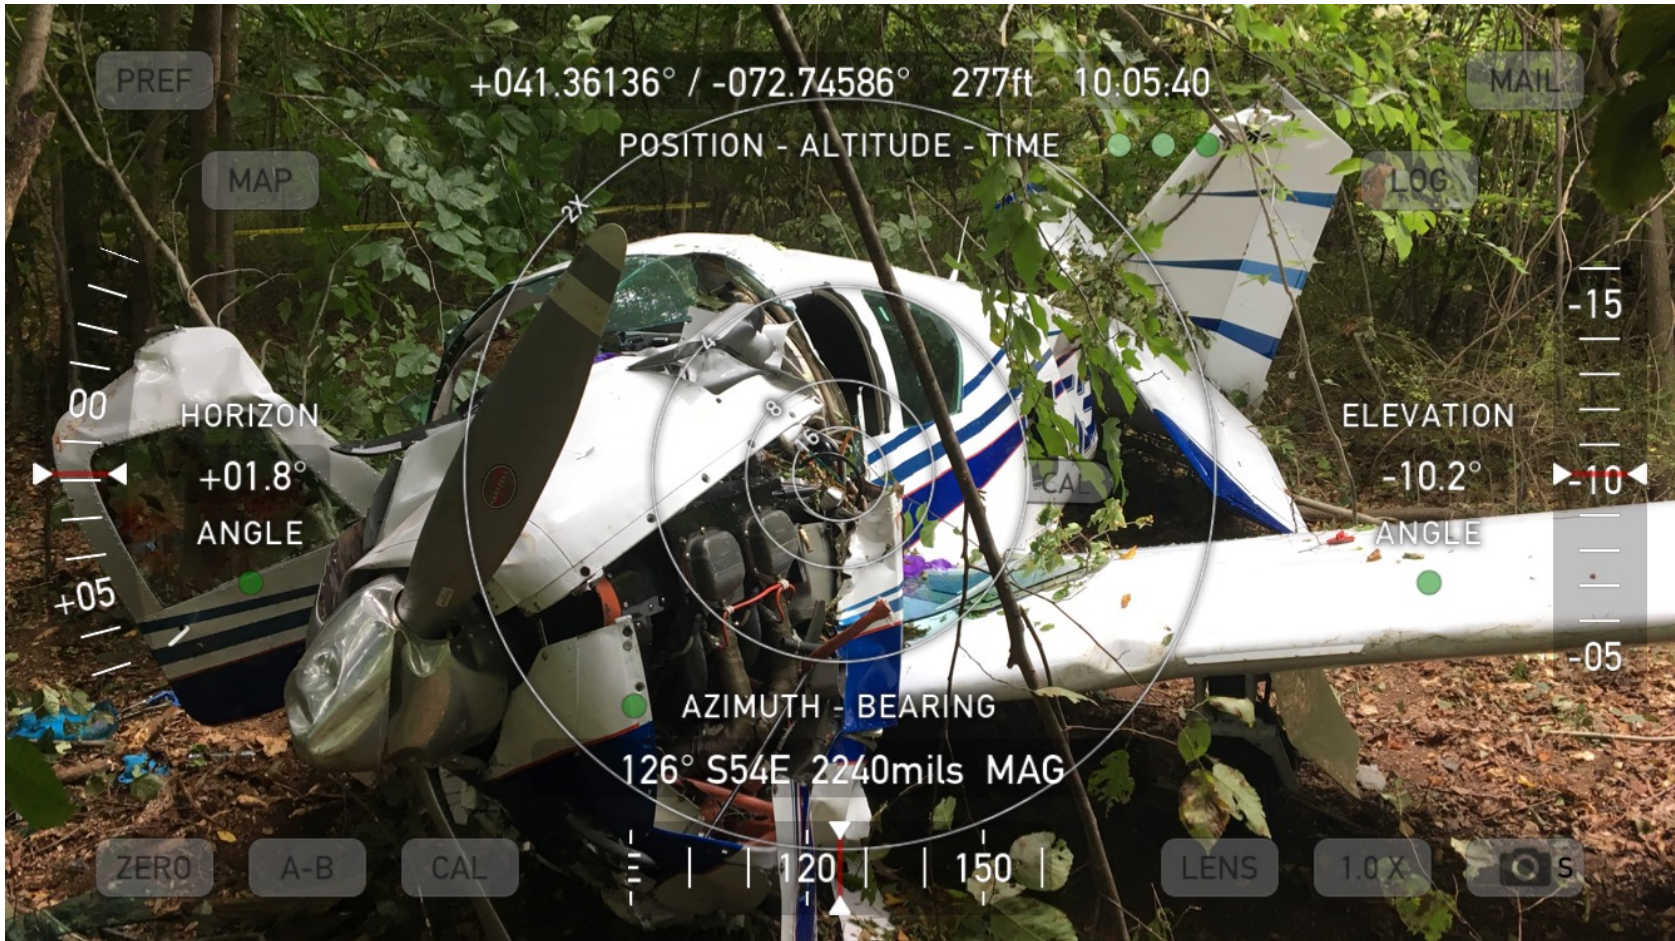
Photo 1 – Forward view of propeller, spinner, engine and fuselage damage.

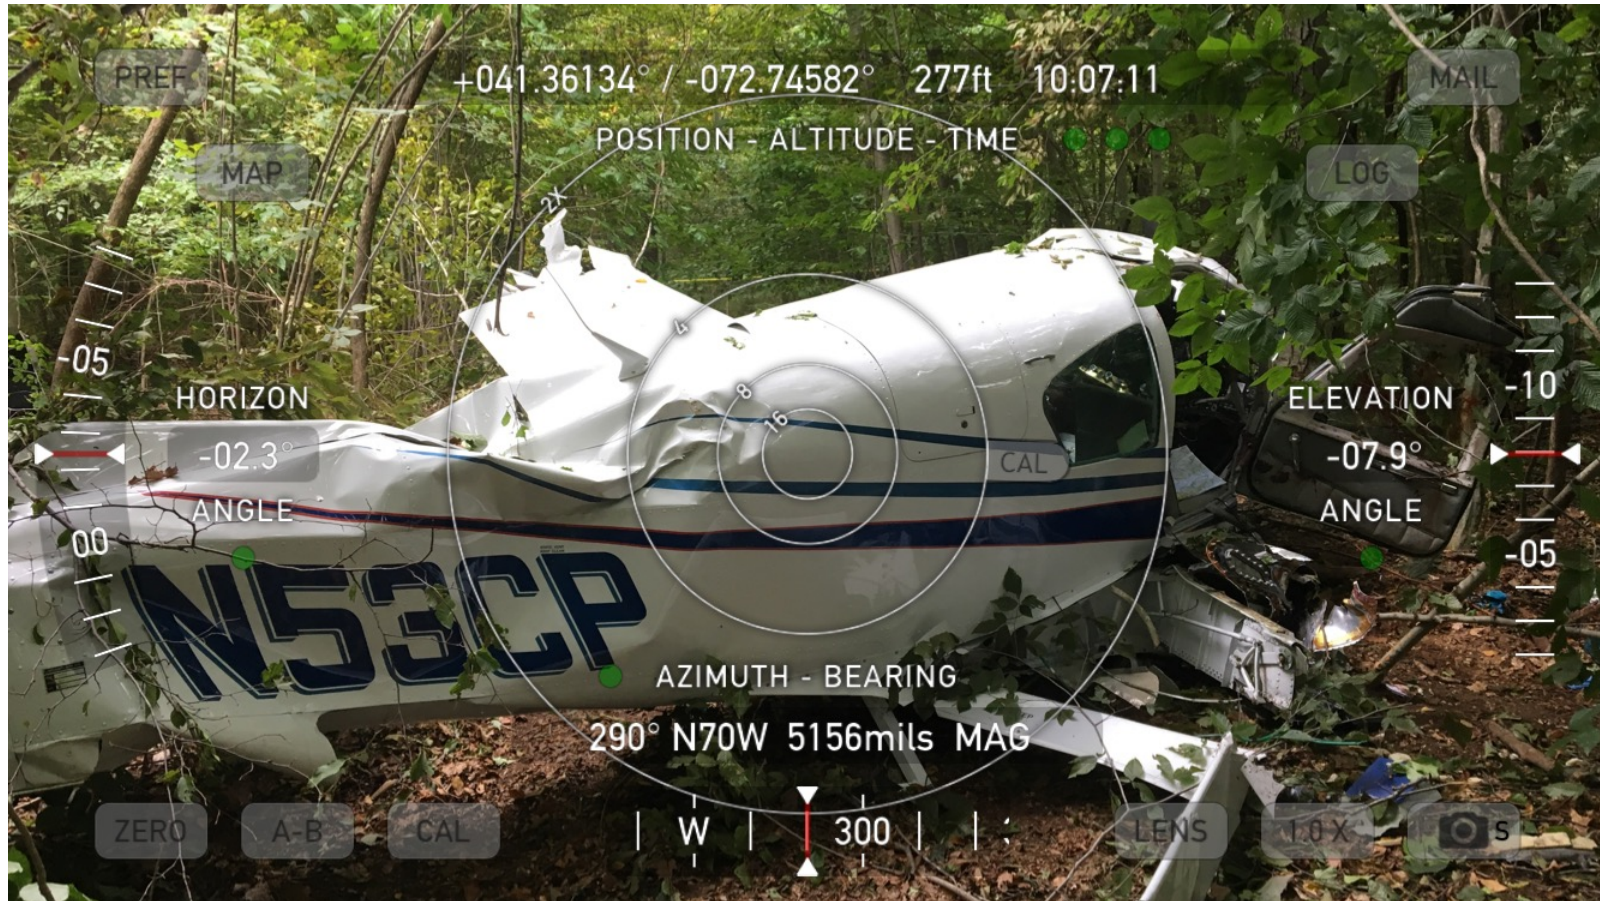
Photo 2 – Right side view of fuselage damage.

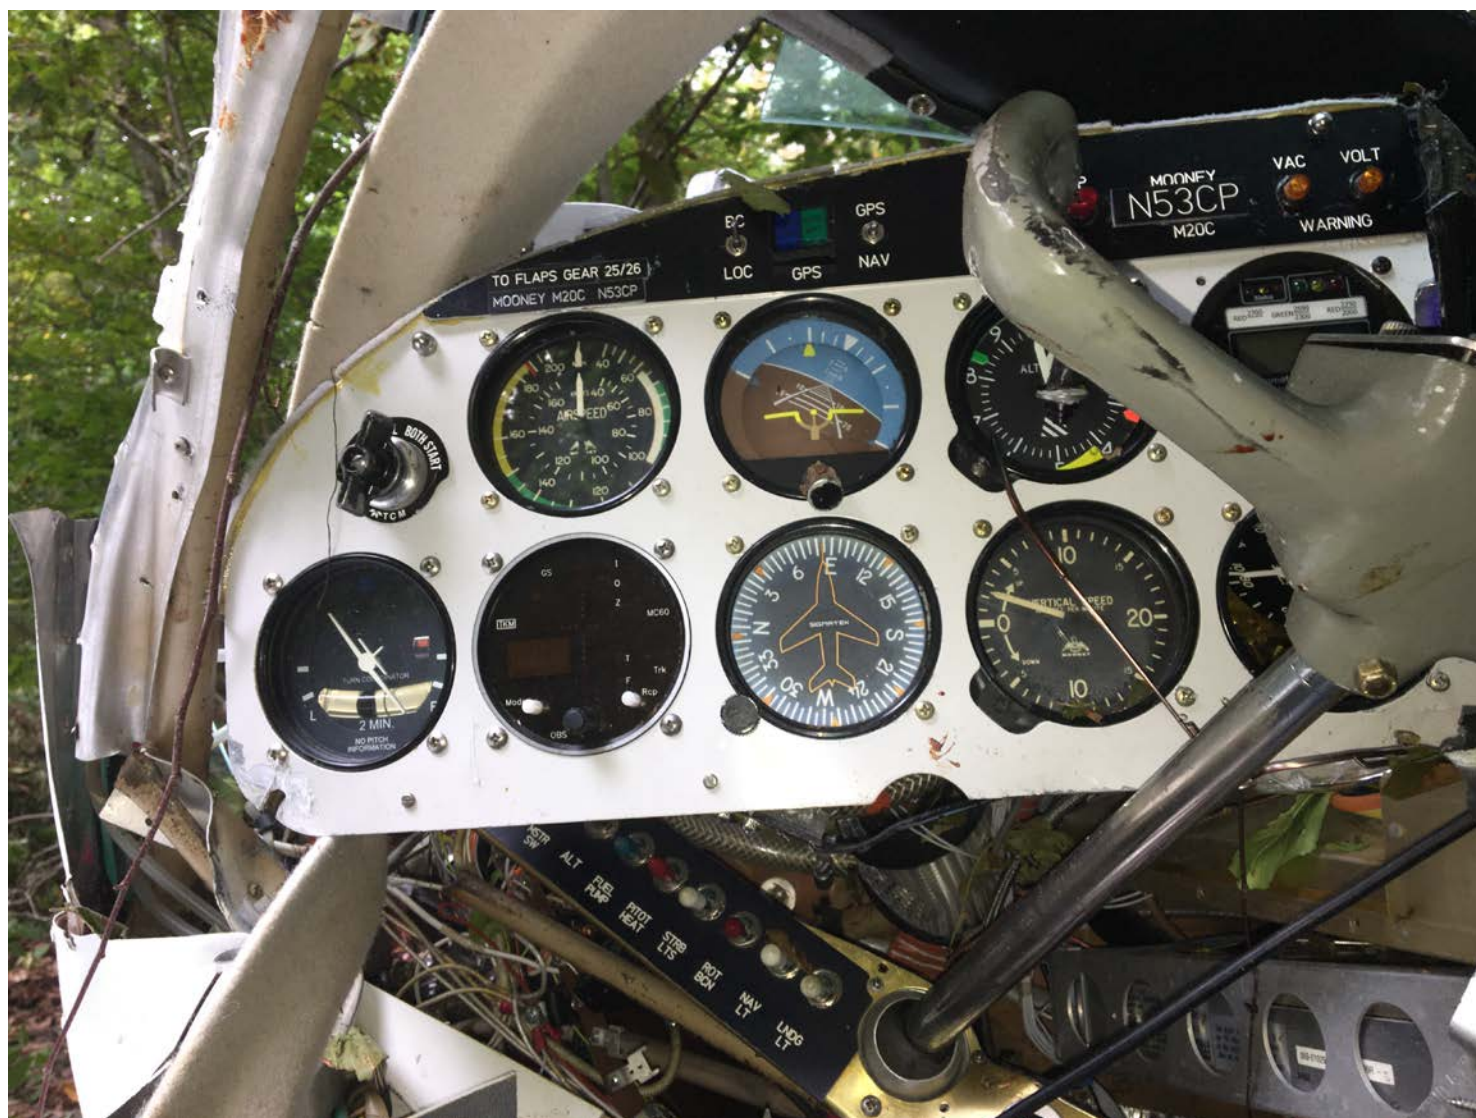
Photo 3 – Photograph of cockpit damage showing left seat pilot instruments.

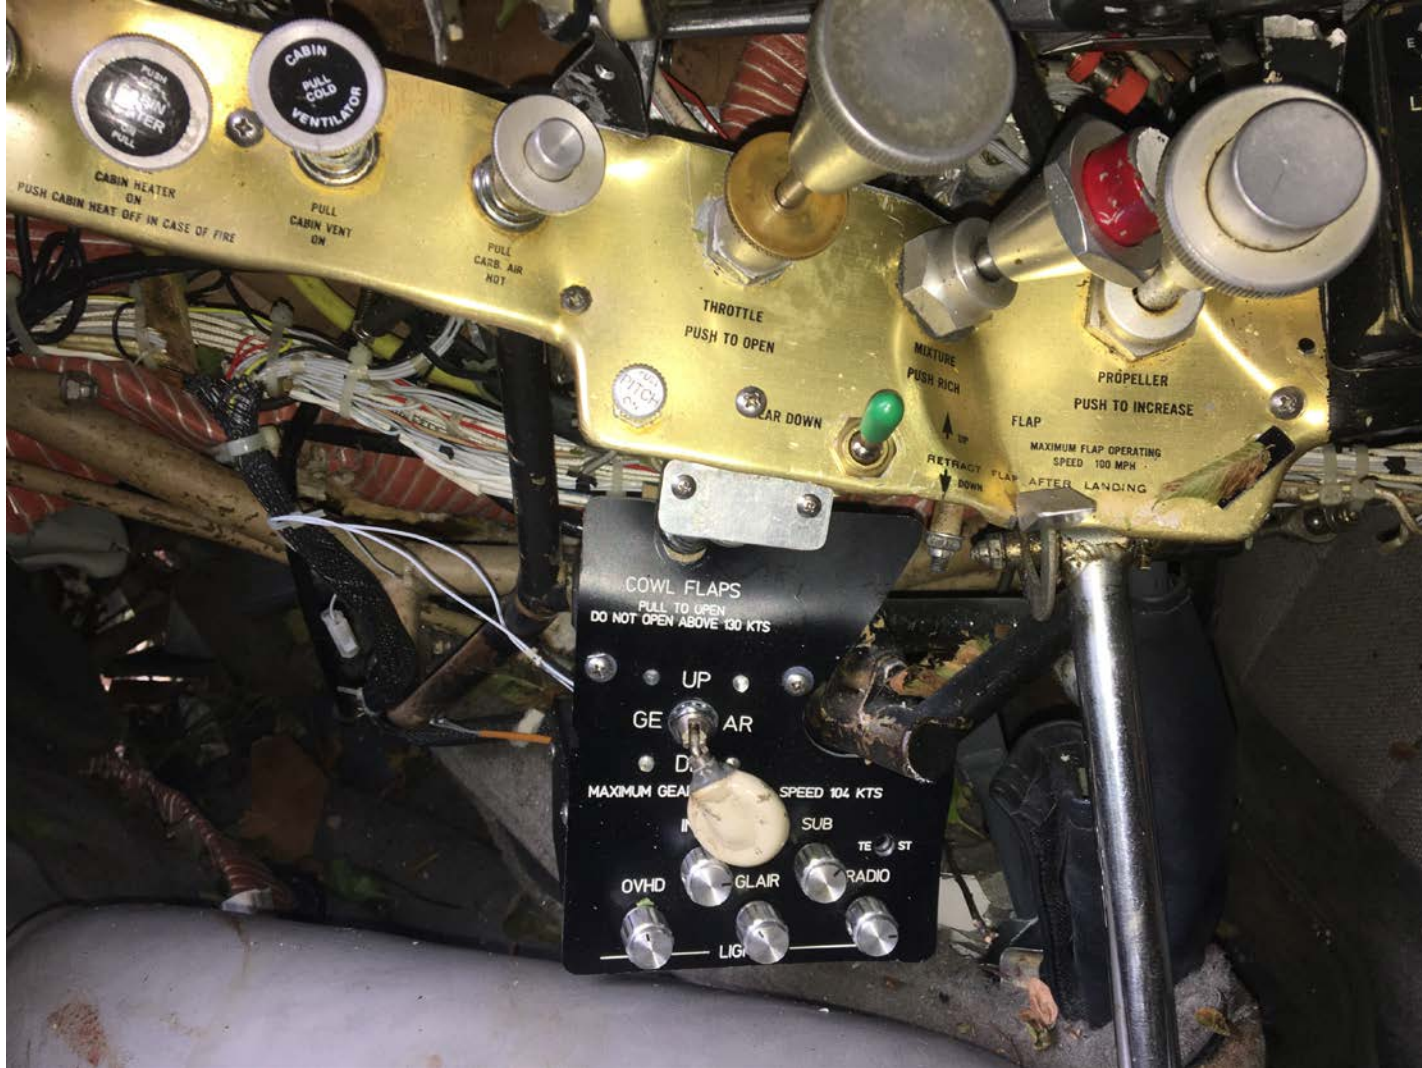
Photo 4 – Photograph of cockpit damage showing throttle, mixture, propeller and landing gear controls.

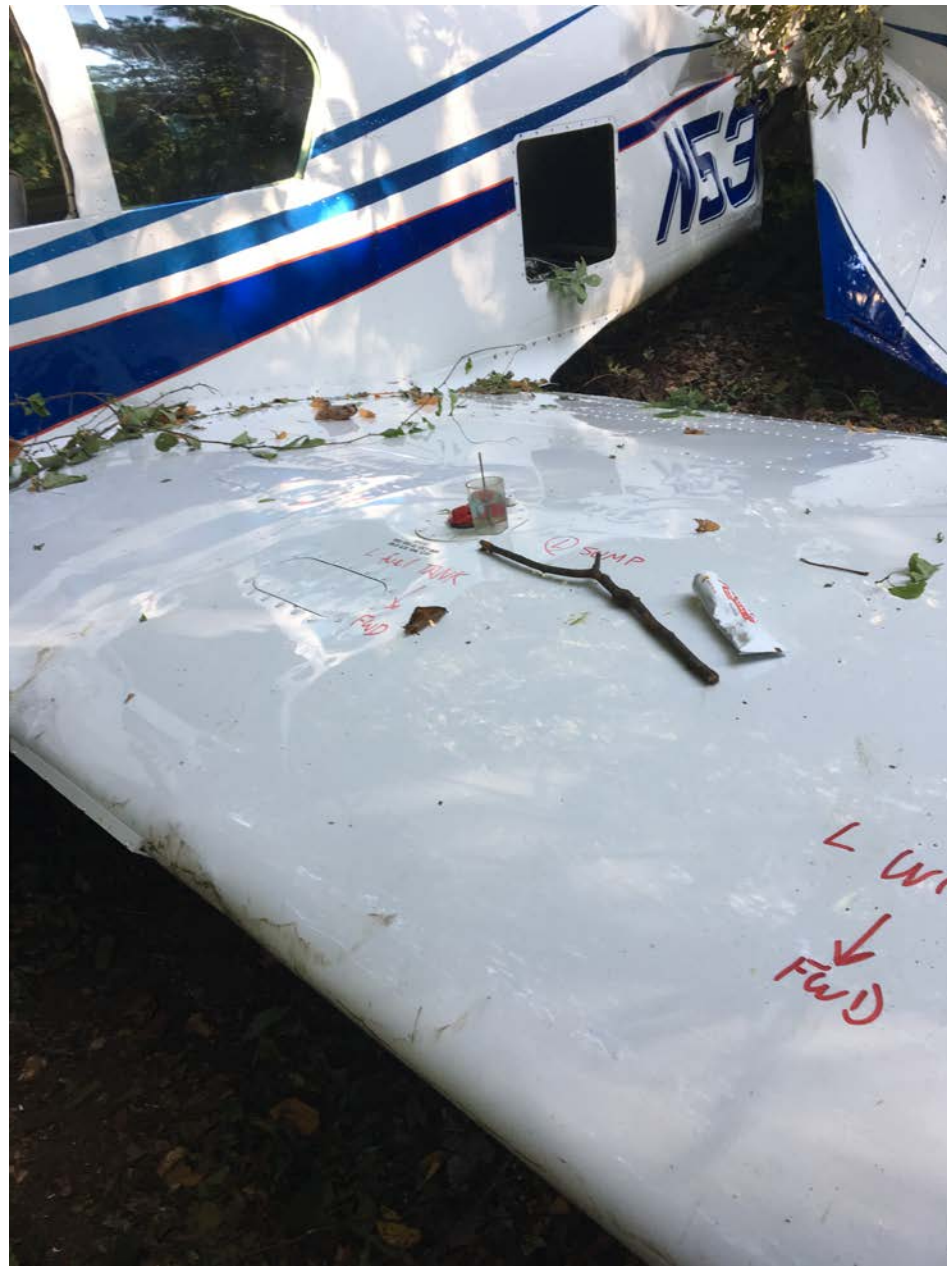
Photo 5 - Left wing leading edge looking towards fuselage. The fuel tank sump tester is full of aviation fuel.

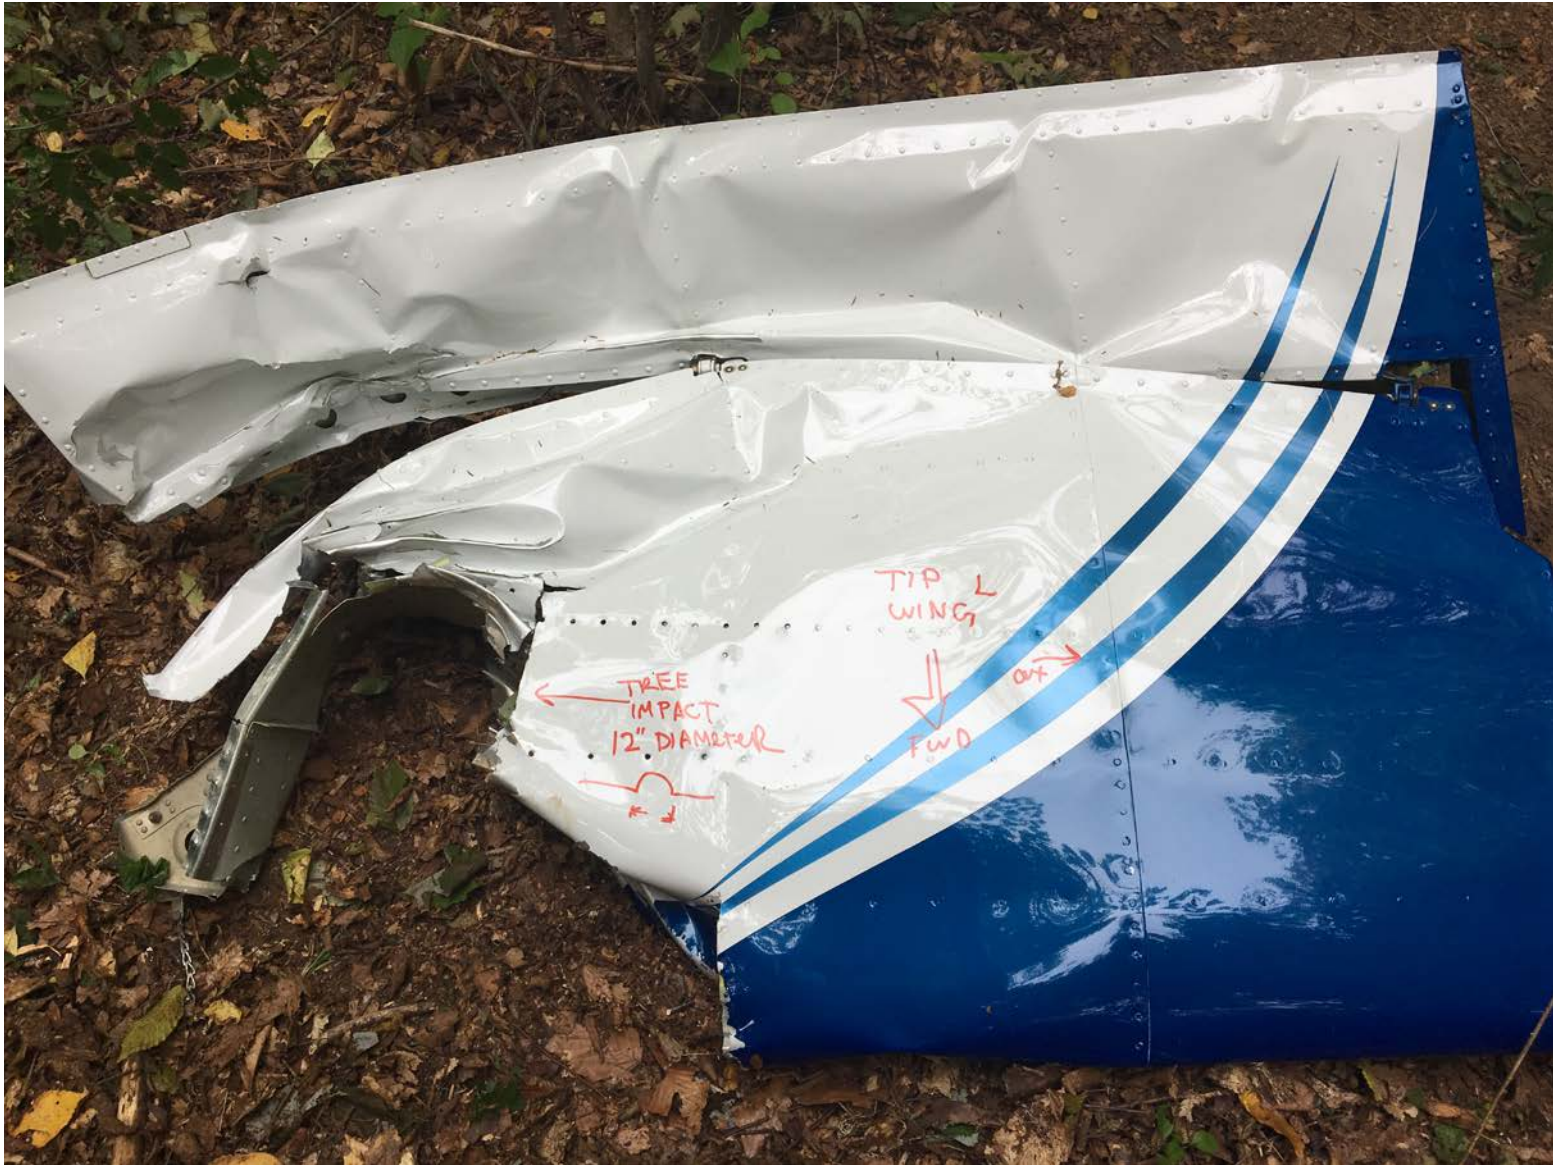
Photo 6 – Separated left wingtip and aileron showing tree impact damage.

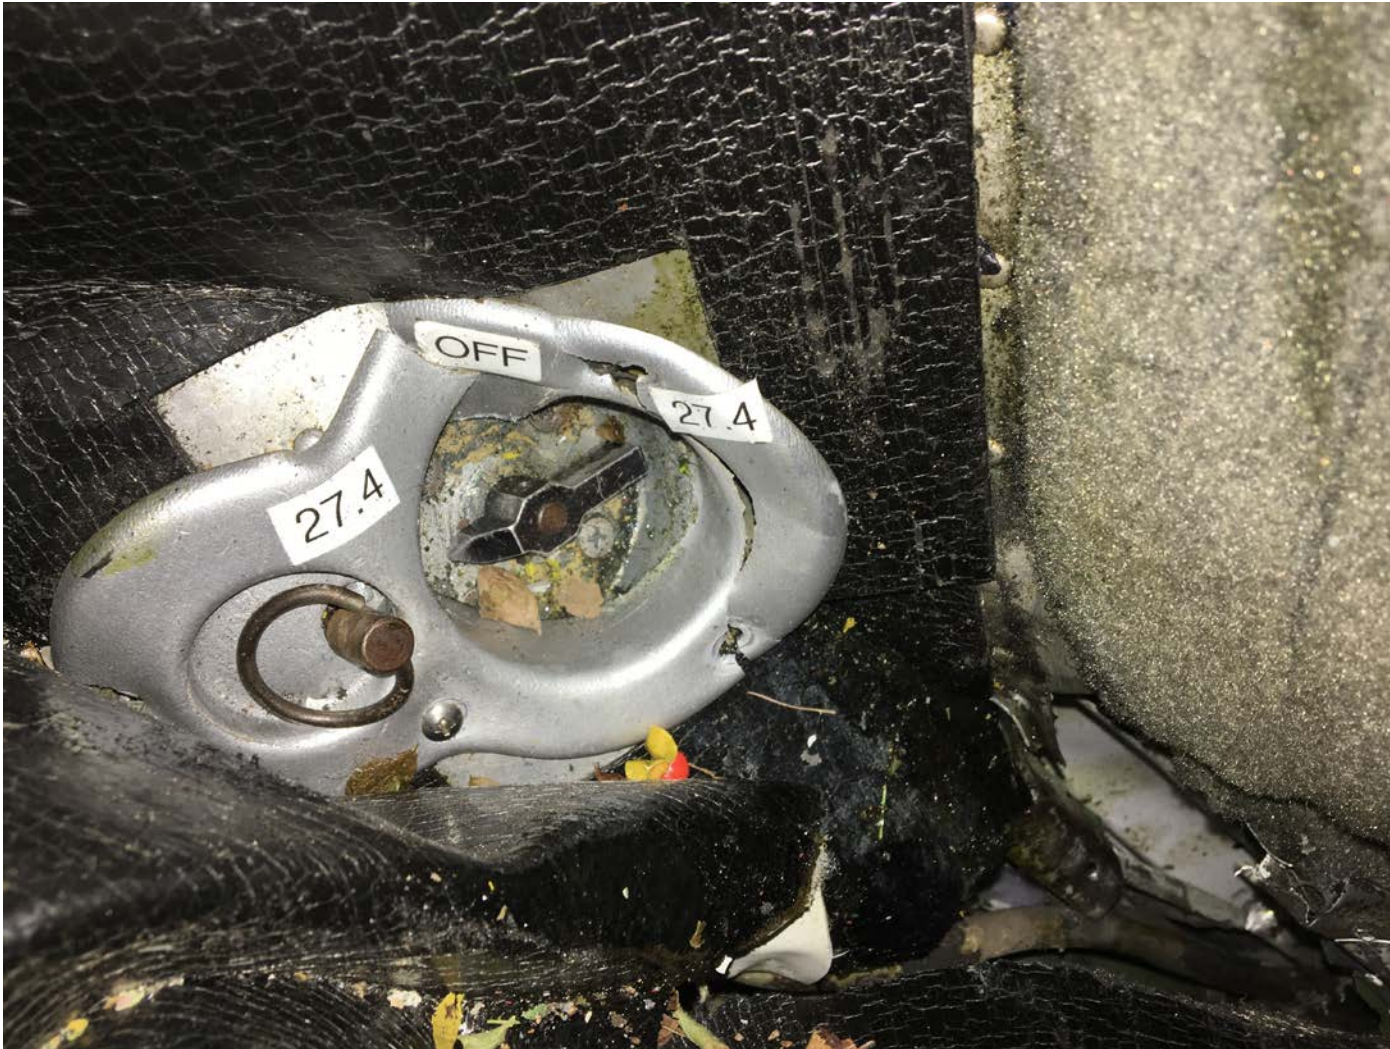
Photo 7 – Photograph of fuel selector indicating the left tank.

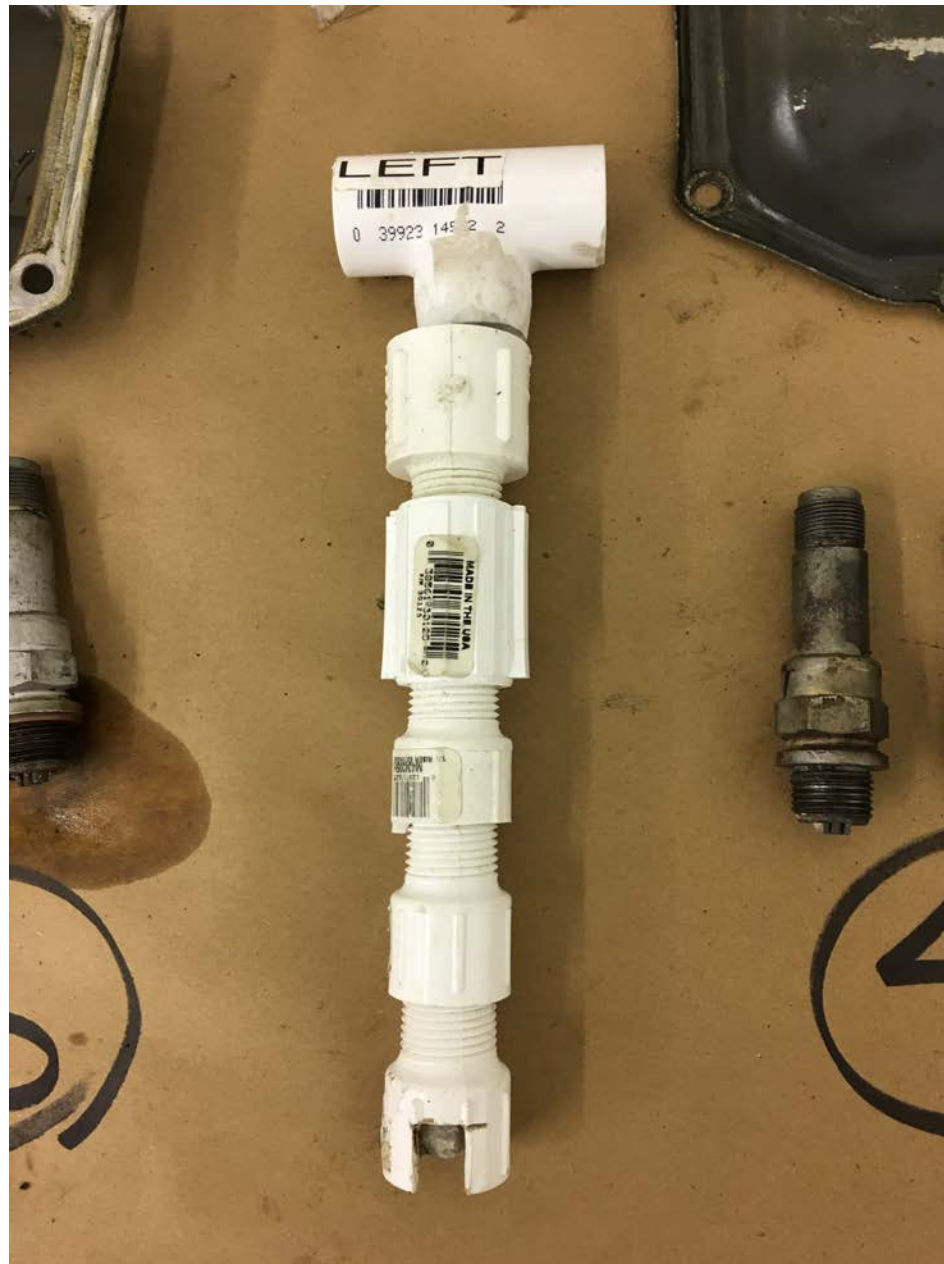
Photo 8 – Photograph of homemade PVC handle used to change the fuel selector. The handle is broken at the top and separated from the bottom attachment.

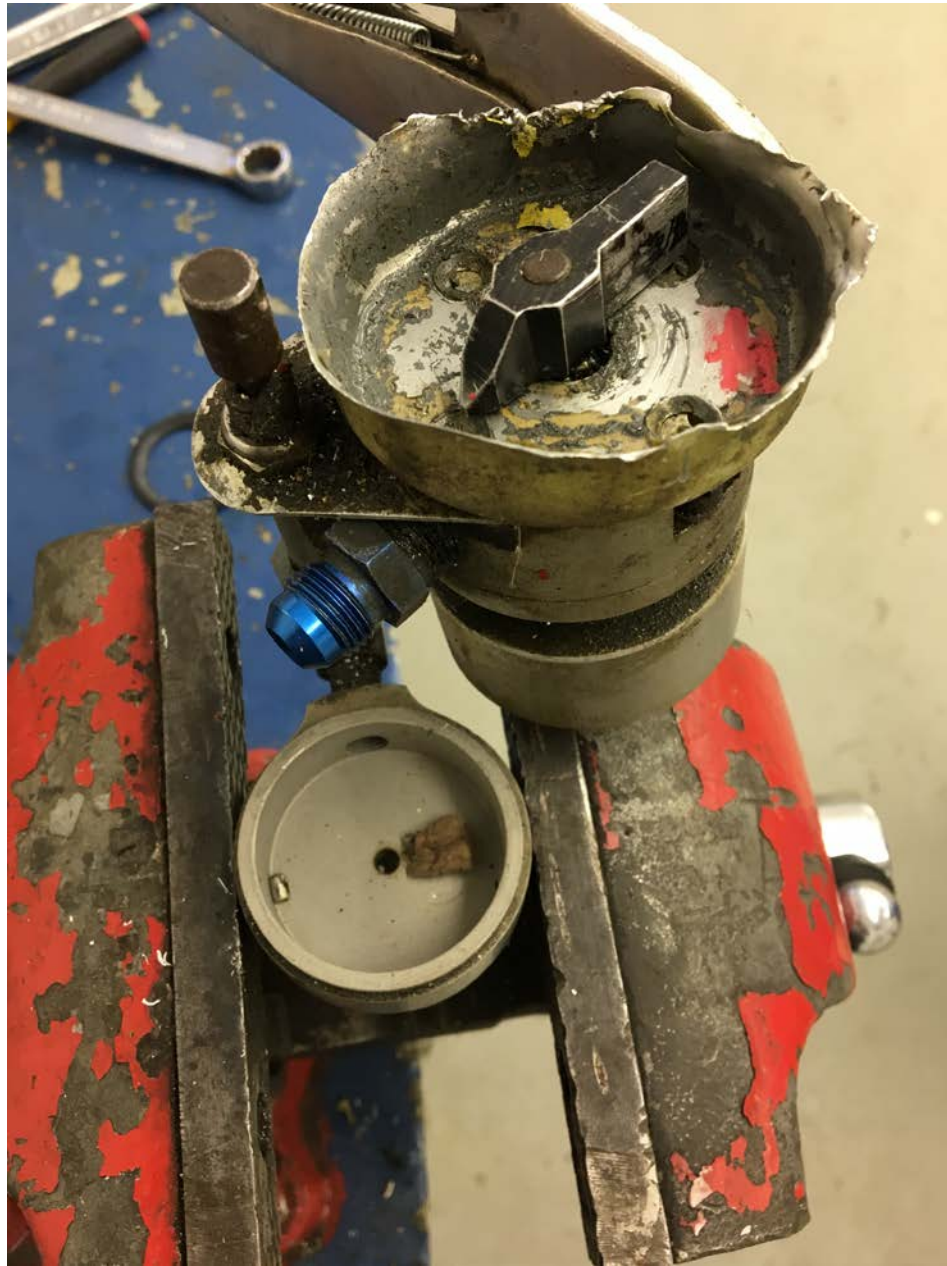
Photo 9 – Fuel selector valve partially disassembled showing fibrous debris in selector cavity.

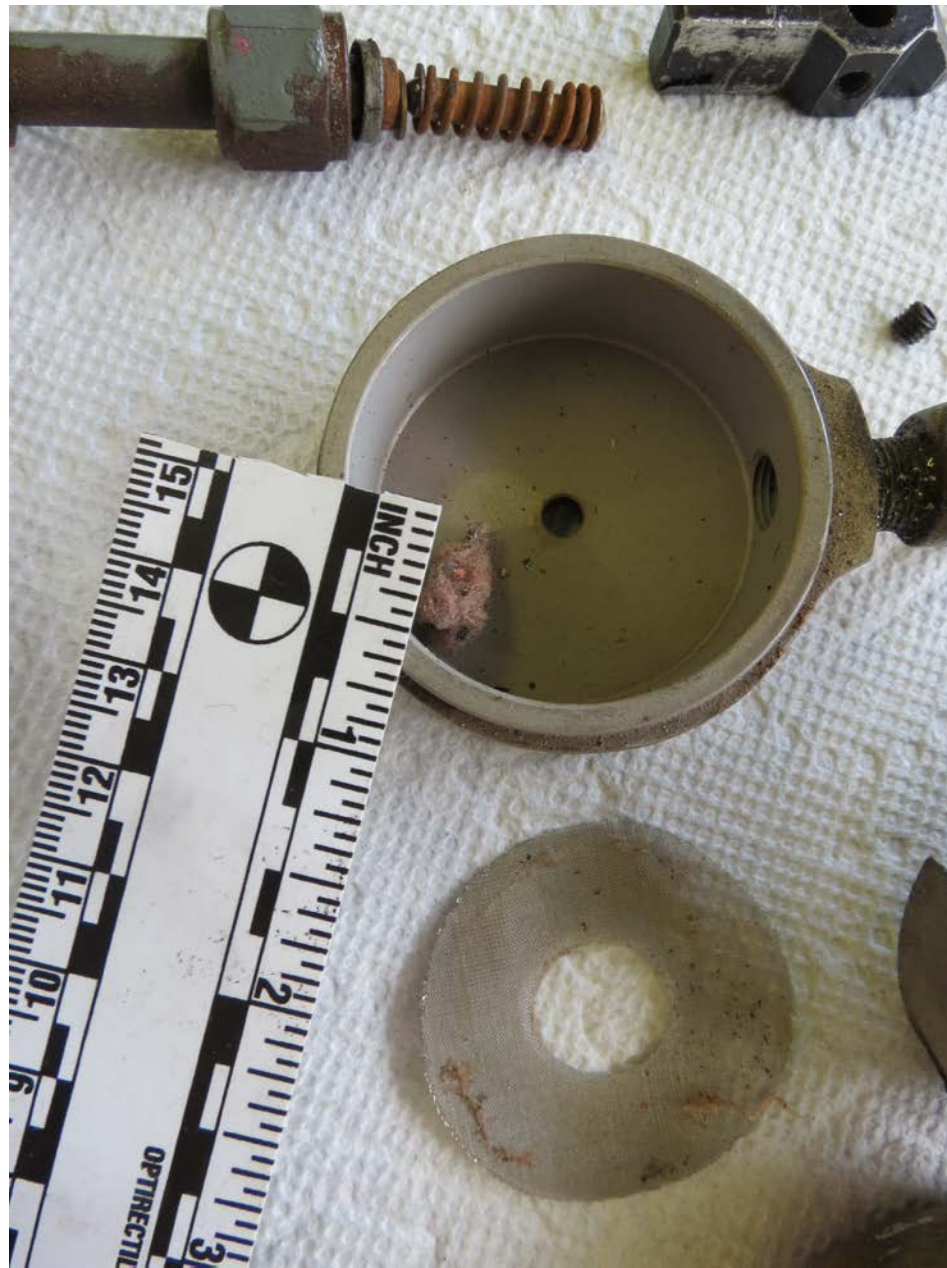
Photo 10 – Close up view of red tinted fibrous material on drain screen and in fuel selector cavity.
