American Airlines Flight 587
Belle Harbor, New York
November 12, 2001

Animations and Videos from Public Hearing **October 29-November 1, 2001**

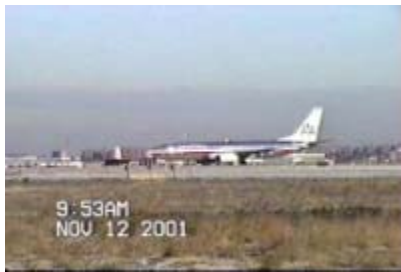
Takeoff View from Construction Site [645 KB]
[Windows Media Format - requires *Media Player*]

This is a video taken from a construction site located at JFK International Airport. The accident airplane can be seen on the runway prior to takeoff. A brief portion of both the takeoff roll and the initial climbout can be seen separately in the video. The video stops after the initial climbout, and then resumes at some time after the accident has occurred. After the accident, the camera view briefly shows black smoke rising up from the horizon. *NOTE: the time shown imprinted in the lower left corner of the video is not the actual time of day.*

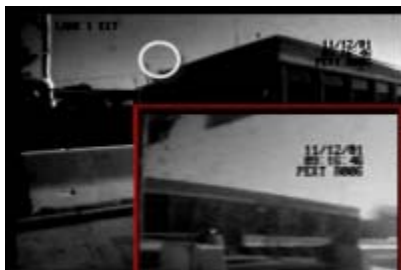
Toll Booth View [4.32 MB]
[Windows Media Format - requires *Media Player*]

This is a collection of video recordings captured by a security system that was operated by the Triborough Bridge and Tunnel Authority in New York, NY. This video contains views from three separate cameras located at the northwest end of the Marine Parkway Bridge.

- In the first view, the airplane can be seen as a small 'dot' moving from left to right across the screen (a white circle has been added to the video to highlight the position of the airplane) until it is obscured by a building in the foreground. Just before the airplane is obscured in the first view, it appears in the second view, which is displayed as an inset in the lower right corner of the screen.

- In this second view, the airplane can be seen emerging from the left side of the view from behind a wall, again as a small 'dot'. The airplane travels from the upper left portion of the view toward the lower right. As the airplane moves downward, a 'streak' can be seen trailing behind it during a portion of this view. Just after the airplane descends behind a building in this second view, the video from the third camera is displayed in the background.

- In this third view, the airplane is not visible, however smoke can be seen rising up from the horizon in the top center area of the view.

NOTE: The times seen in each of these views is provided by a clock that is part of the video security system. This clock differs from the one used to align the various recorded data sets for this investigation. For more information about this video, see Exhibit 17A - Video Study.

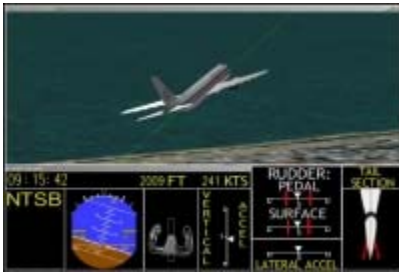
Accident Reconstruction[4.79 MB]

This three-dimensional animated accident reconstruction shows most of the flight for American Airlines Flight 587, which crashed shortly after takeoff from JFK International airport on November 12, 2001. The reconstruction exhibits information selected from the Flight Data Recorder, excerpts from the Cockpit Voice Recorder transcript, recorded radar data and aircraft performance data. This reconstruction does not depict the weather or visibility conditions at the time of the accident.

The animation shows a three-dimensional model of the airplane and its motion in the upper portion of the view. Selected comments from the Cockpit Voice Recorder transcript or other annotations are superimposed as text in this area at the time they occurred.

The lower portion of the view depicts a set of instruments and indicators, which display selected parameters from the flight data recorder. From left to right these are:

- Attitude indicator showing pitch and roll attitude, control wheel/column icon depicting the control wheel (rotating right or left) and control column (moving up or down) inputs, and an indicator showing vertical acceleration.
- The next box to the right depicts the data from the rudder pedal, rudder control surface, and the lateral acceleration parameters.
- The last box shows a representation of the tail section as viewed from above and depicts the rudder control surface position relative to the vertical stabilizer. The red bars on the rudder pedal, rudder surface, and tail section indicators represent the relative position of the rudder limiting system. Additionally, the time of day (based on the FAA's Air Traffic Control clock), Altitude in feet, and Airspeed in knots are depicted at text.

The animation starts with the airplane on the ground, taxiing to runway 31L. It shows the airplane's taxi, takeoff, climbout, and initial turn to the left. The rudder parameters are blanked out at the time the tail section separates from the airplane. The screen turns black at the point in time when the Flight Data Recorder information ends (only CVR text or annotations are shown after this point).
